TUMBY BAY JETTY

WSCAM Assessment INSPECTION REPORT

6 FEBRUARY 2024

Infrastructure Consulting Pty Ltd
Authored by: Keegan Steele
Revision: C

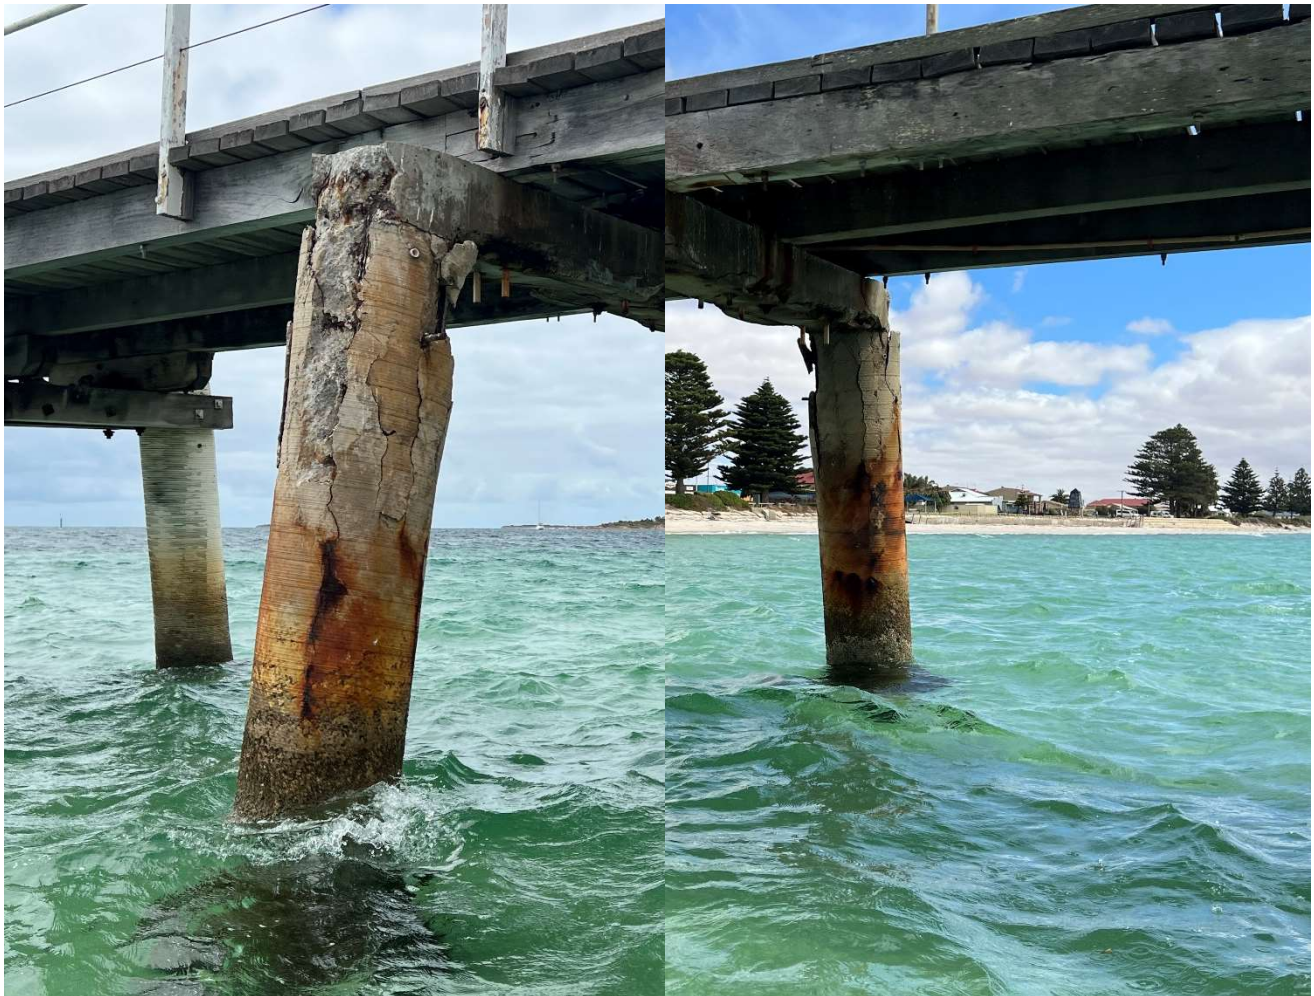
The concrete piles are typically rated 4 based on above water inspection. However, it is likely that the piles could be in a worse condition rating below water, primarily between the seabed and where the concrete casing have terminated short. This section of timber pile is exposed to the elements of the marine environment and susceptible to rot and borer attack. As these piles are mostly in groups at bents, failure of the piles will result in significant damage to the jetty structure. During the inspection it was noted that 1 concrete pile at bent 12 has undergone significant spalling and section loss as the pile is exposed to elements due to the original sleeve missing. The reinforcement has undergone corrosion visible in the Figure 13: . Other concrete piles have also failed in recent years, causing significant structural damage to the jetty. Due to this, it is recommended that all concrete encased timber piles be replaced with sister piles.

- Figure 13 represents a condition rating 6 concrete encased timber pile, where the pile has undergone significant spalling and section loss with corrosion to reinforcement visible.

Figure 13: Pile 12A at bent 12, looking from north and south respectively. Condition 6 concrete pile

- Replace all rating 6 & 7 Piles
- Replace all concrete encased timber piles (all condition ratings)
- Replace all rating 4 & 5 timber piles in 10 years.
- Blast clean and paint condition rating 5 steel piles in 10 years.

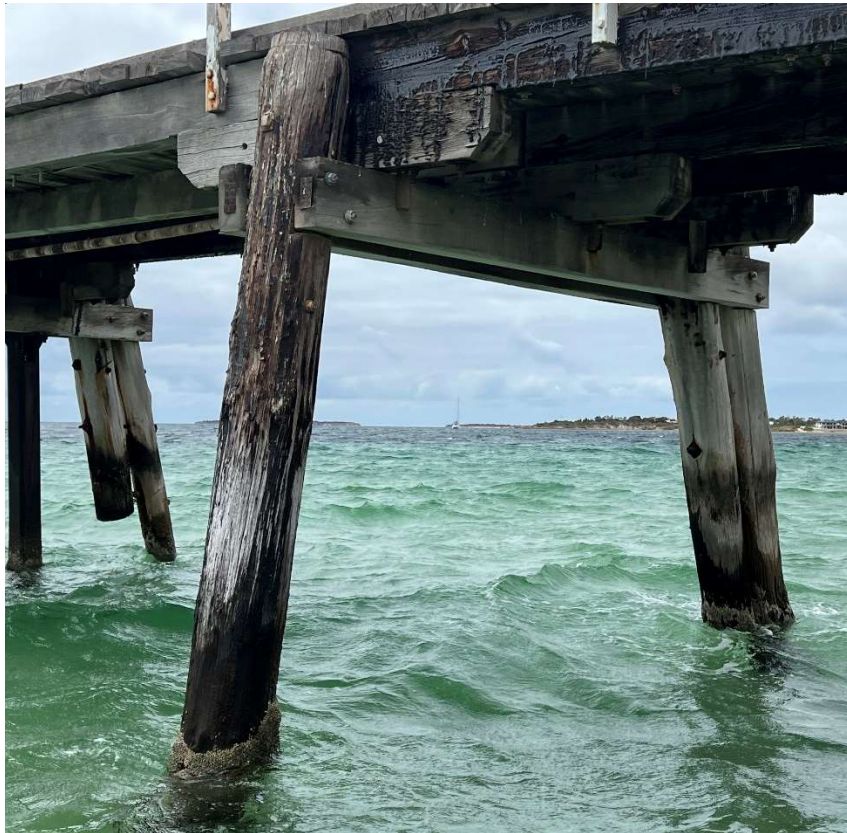
Approximately 50% of the timber piles have already been replaced with steel sister piles. The remainder of the timber piles are in fair-poor condition. The main defects are cracking, splitting and rot above water surface. Below the water surface the piles are undergoing pipe rot and necking usually at the location of the connection of cross bracing. Referring the previous diver's reports, it is pointed out that marine borer attack has happened below the water surface at the seabed region.

- Figure 14 represents a typical condition rating 4 timber pile with moderate pipe rot, splits or cracks.
- Figure 15 represents a typical defect for a condition rating 5 timber pile, notably necking of the pile.

Figure 14: Typical Condition '4' Timber Pile

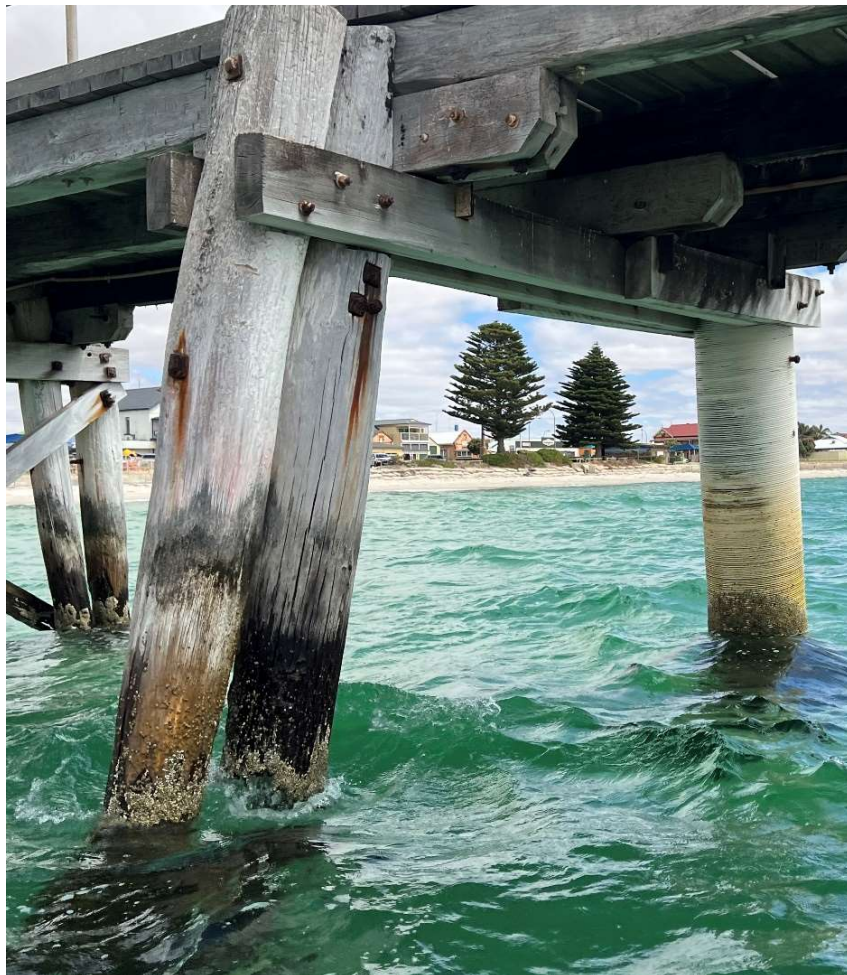
Figure 15: Typical Condition '5' Timber Pile

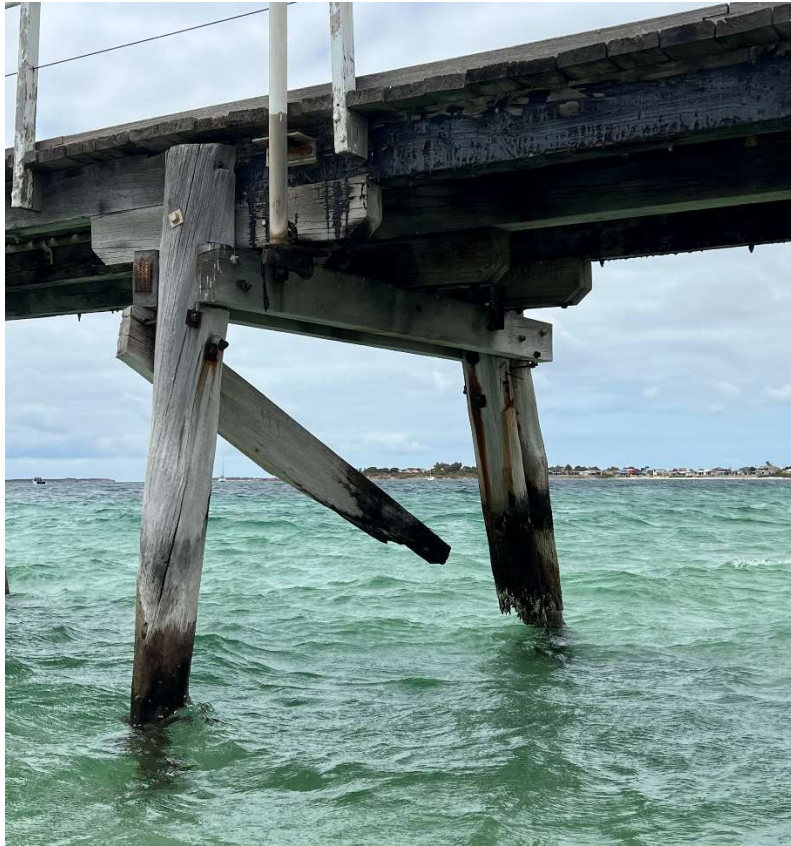
- Figure 16 represents a typical condition rating 6 timber pile, with severe necking at the base in tidal zone.
- Figure 17 represents a condition rating 7 pile, where the pile is missing and redundant piles are visible.

Figure 16: Typical Condition '6' Timber Pile

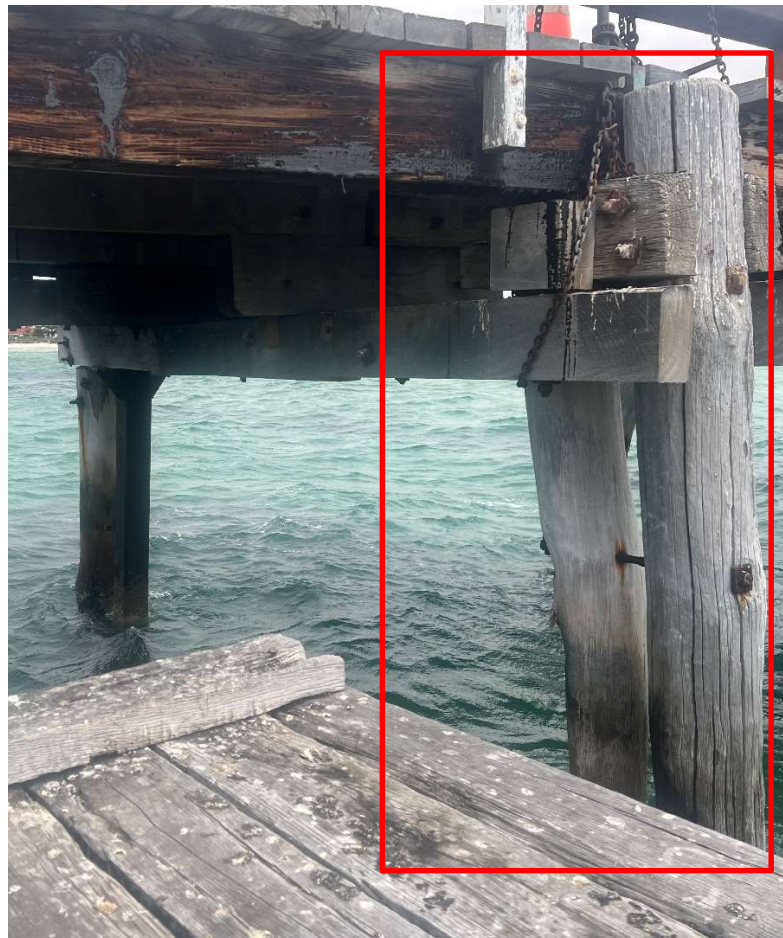
Figure 17: Missing pile at bent 21, redundant piles visible in photo. Condition '7' Timber Pile

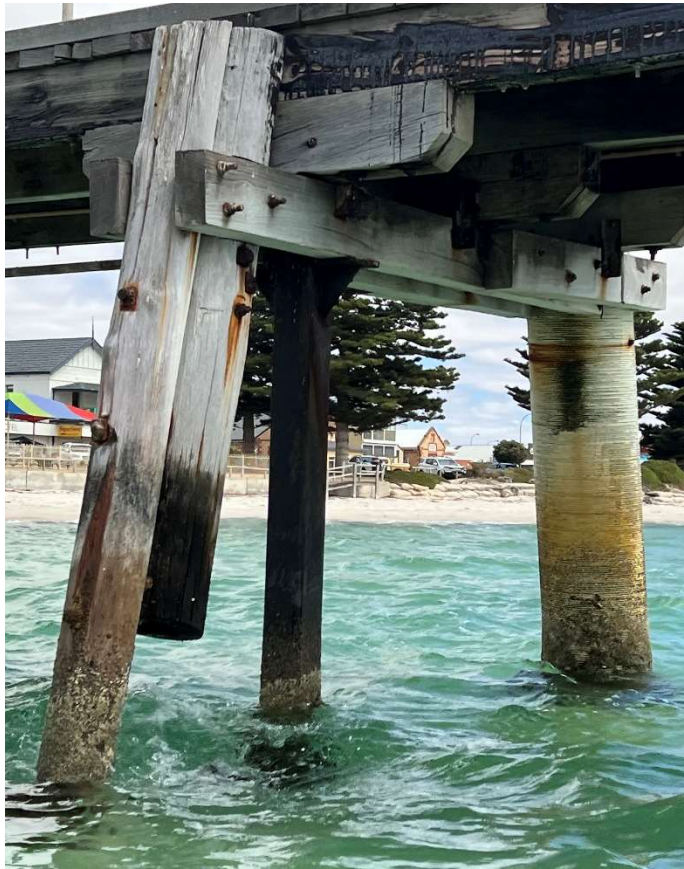
- Figure 18 represents a typical condition rating 4 steel pile with minor protective coating loss.
- Figure 19 represents a typical condition rating 5 steel pile with moderate surface corrosion.

Figure 18 Typical Condition '4' Steel Pile

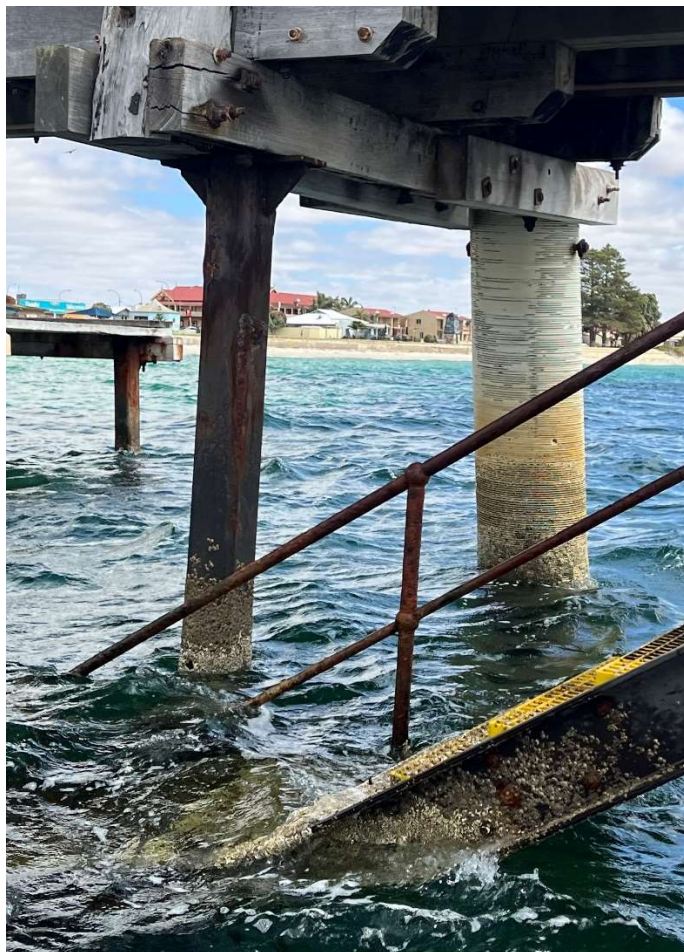
Figure 19 Typical Condition '5' Steel Pile

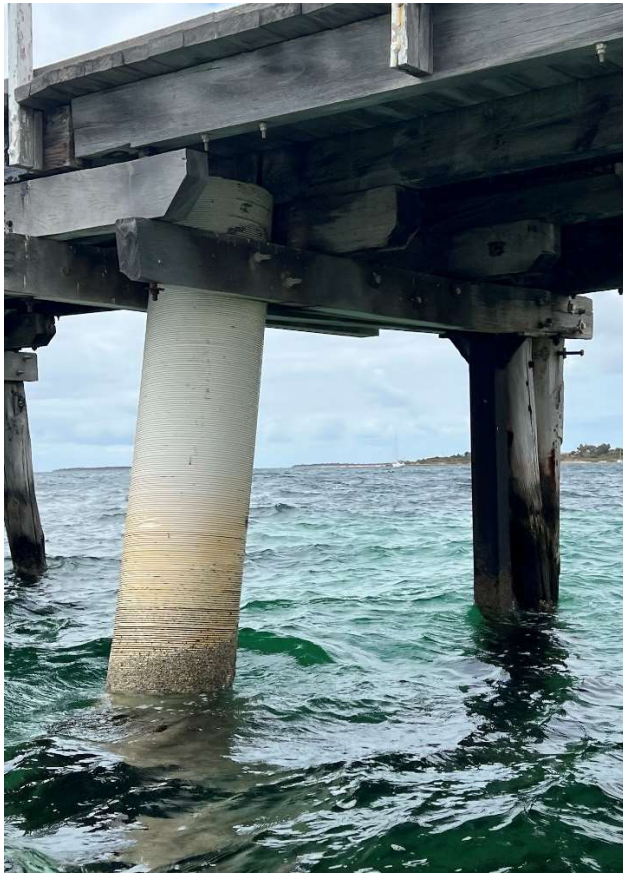
- Figure 20 represents a typical condition rating 4 concrete encased timber pile, with no significant damage visible.
- Figure 21 represents a typical condition rating 5 concrete encased timber pile, where the pile is has visible spalling and separation visible at top of pile.

Figure 20 Typical Condition '4' Concrete Encased Pile

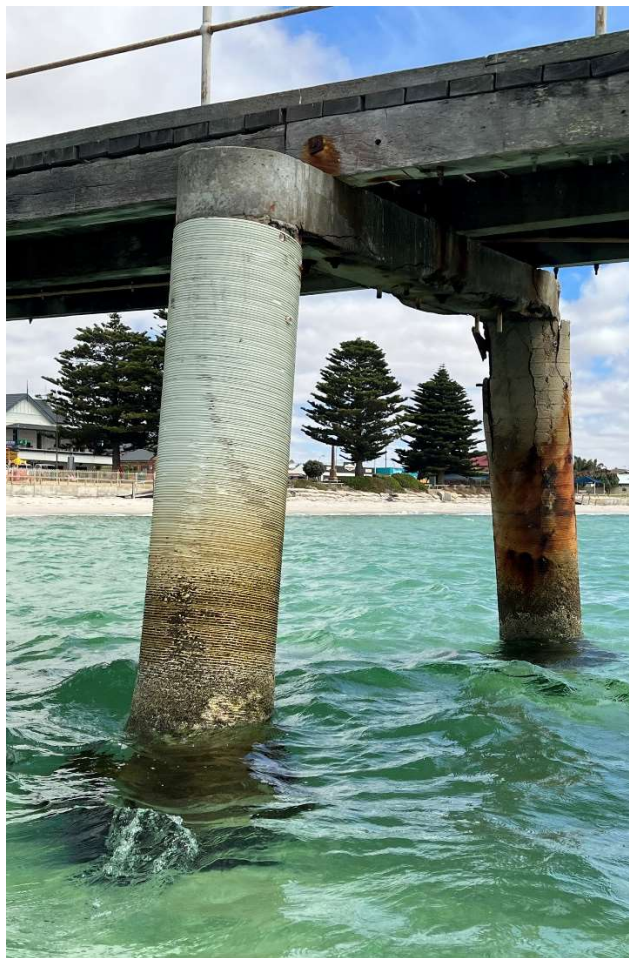
Figure 21 Typical Condition '5' Concrete Encased Timber Pile

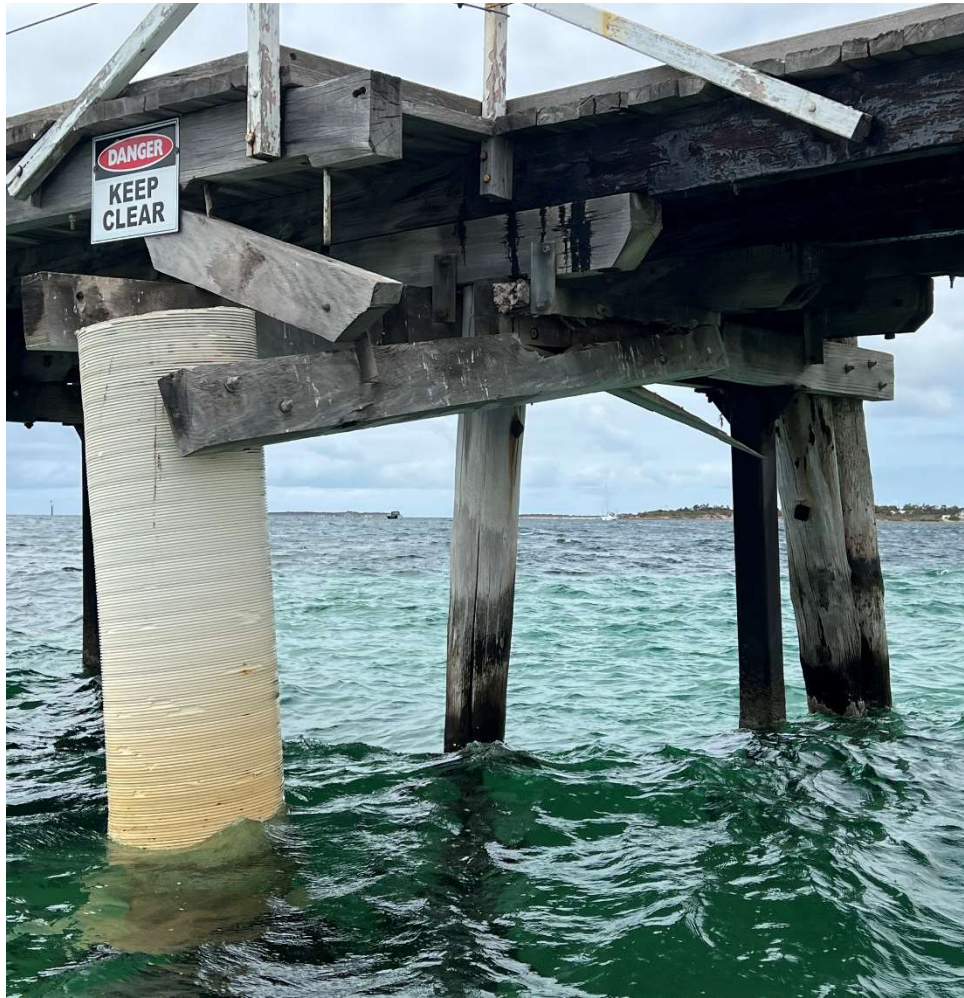
- Figure 22 represents a condition rating 7 pile, where the pile has failed and dropped.

Figure 22 Typical Condition '7' Concrete encased timber pile

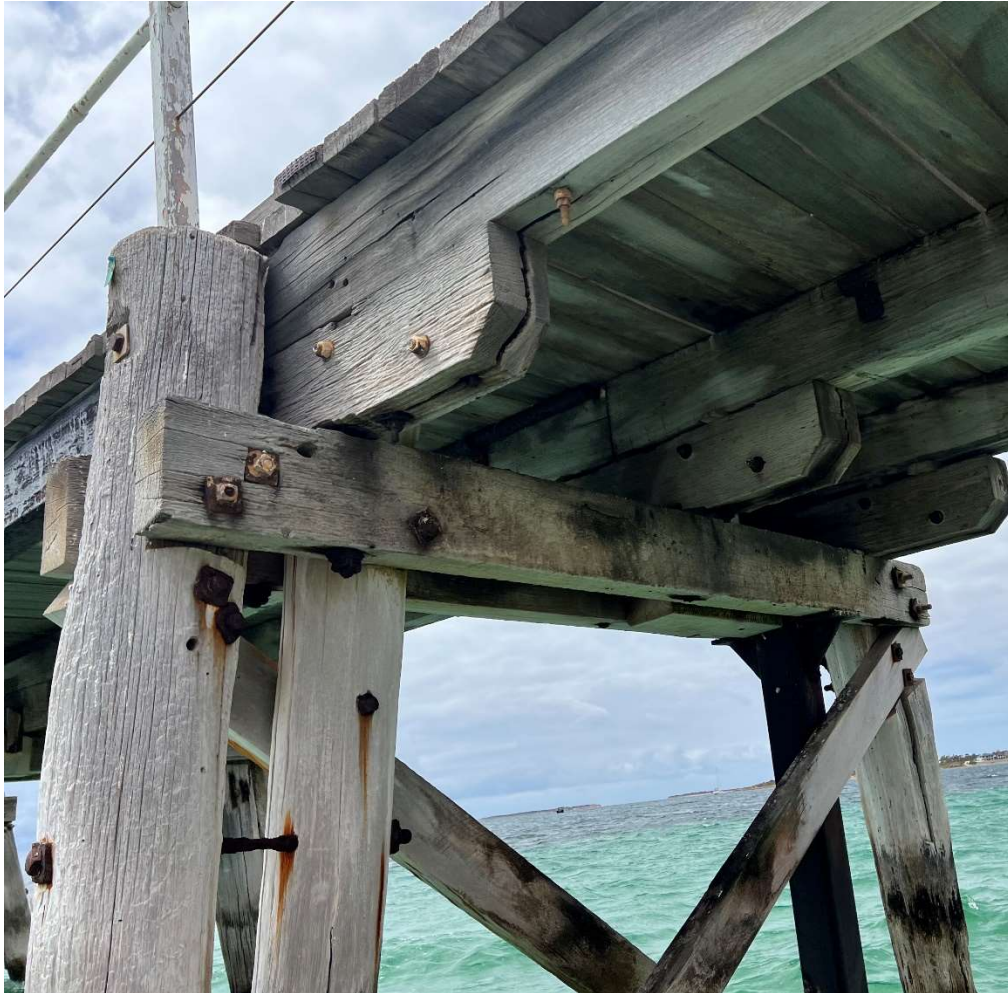
Figure 24: Typical Condition Rating '4' Crosshead

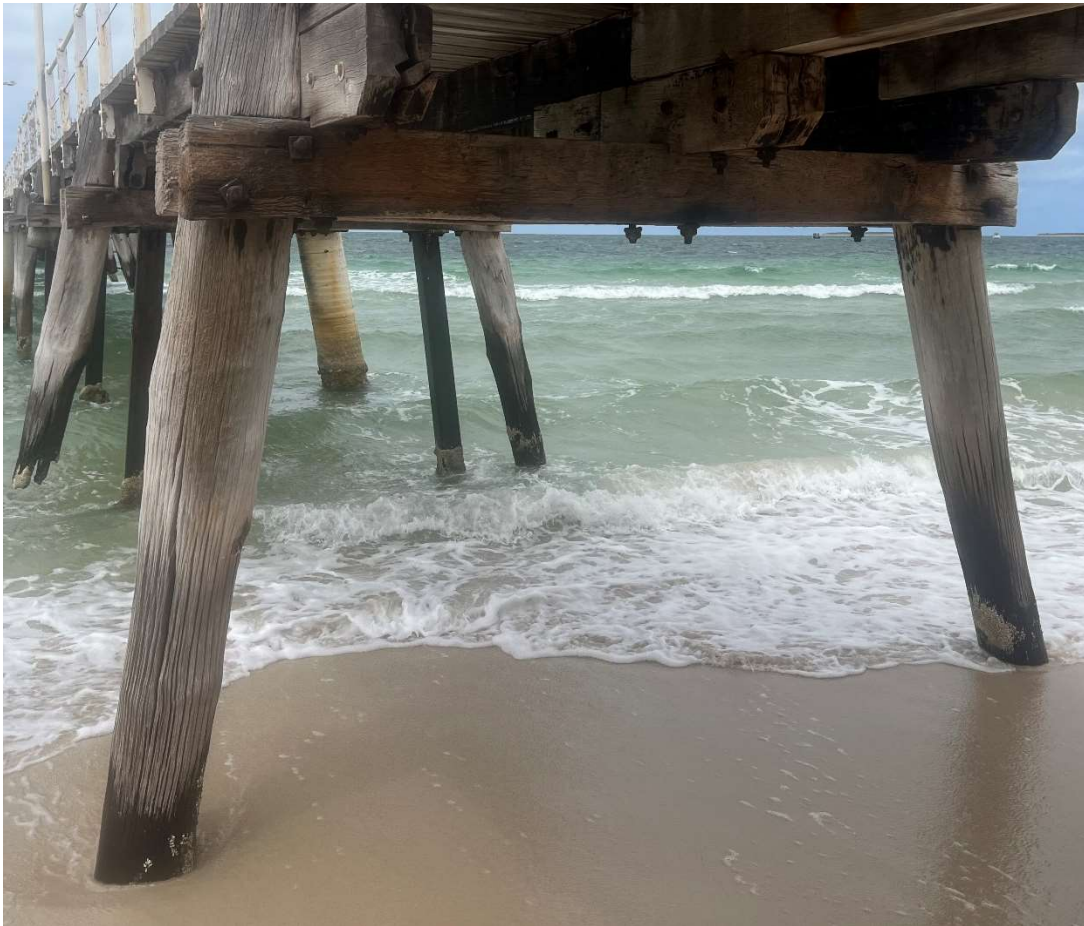
Figure 25: Typical condition '5' Crosshead

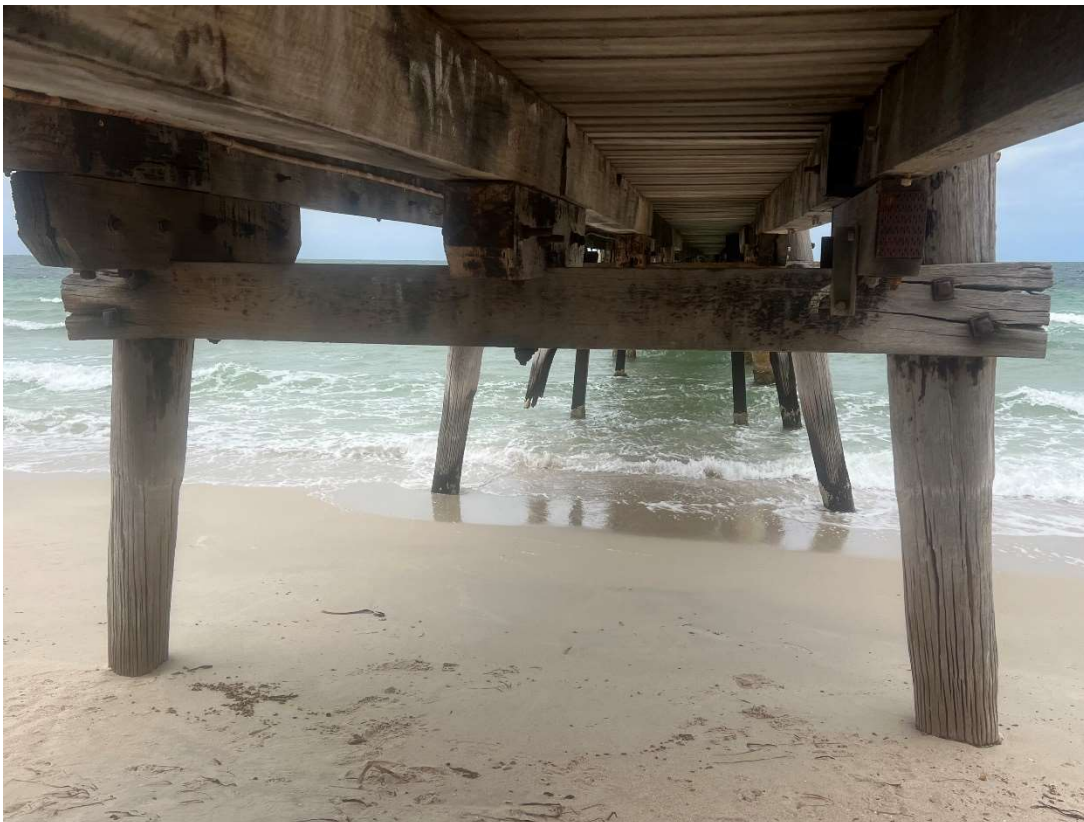
Figure 26: Typical condition '6' Crosshead

- Replace all crossheads that are rating 6 & 7.
- If piles replaced on crosshead with rating 6 & 7, it may not require replacement
- Replace all rating 5 crossheads in 10 years time.

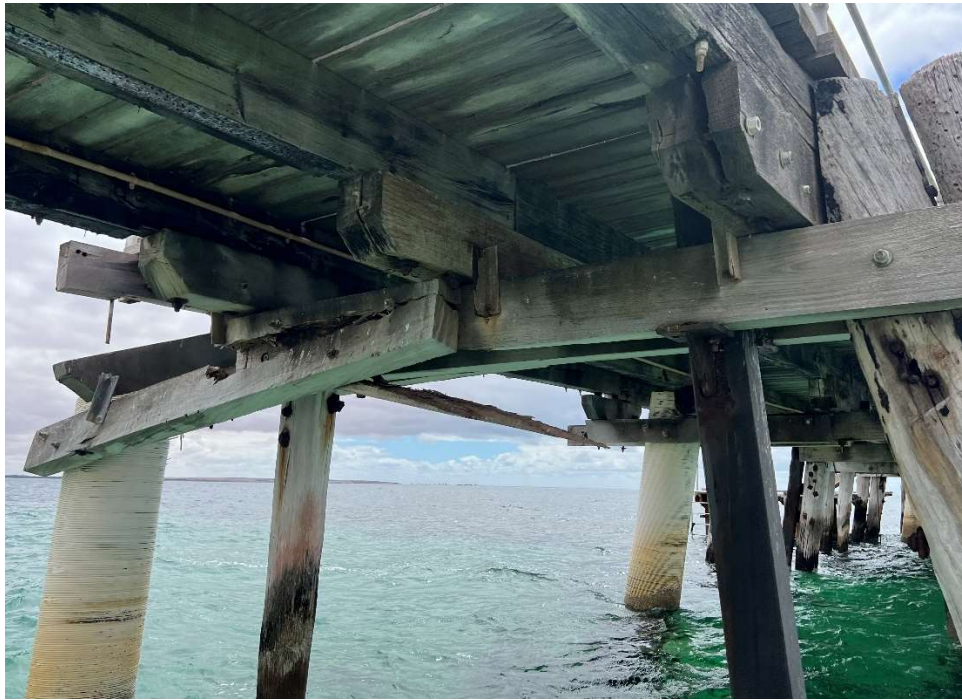
Figure 27 Typical condition '7' Crosshead

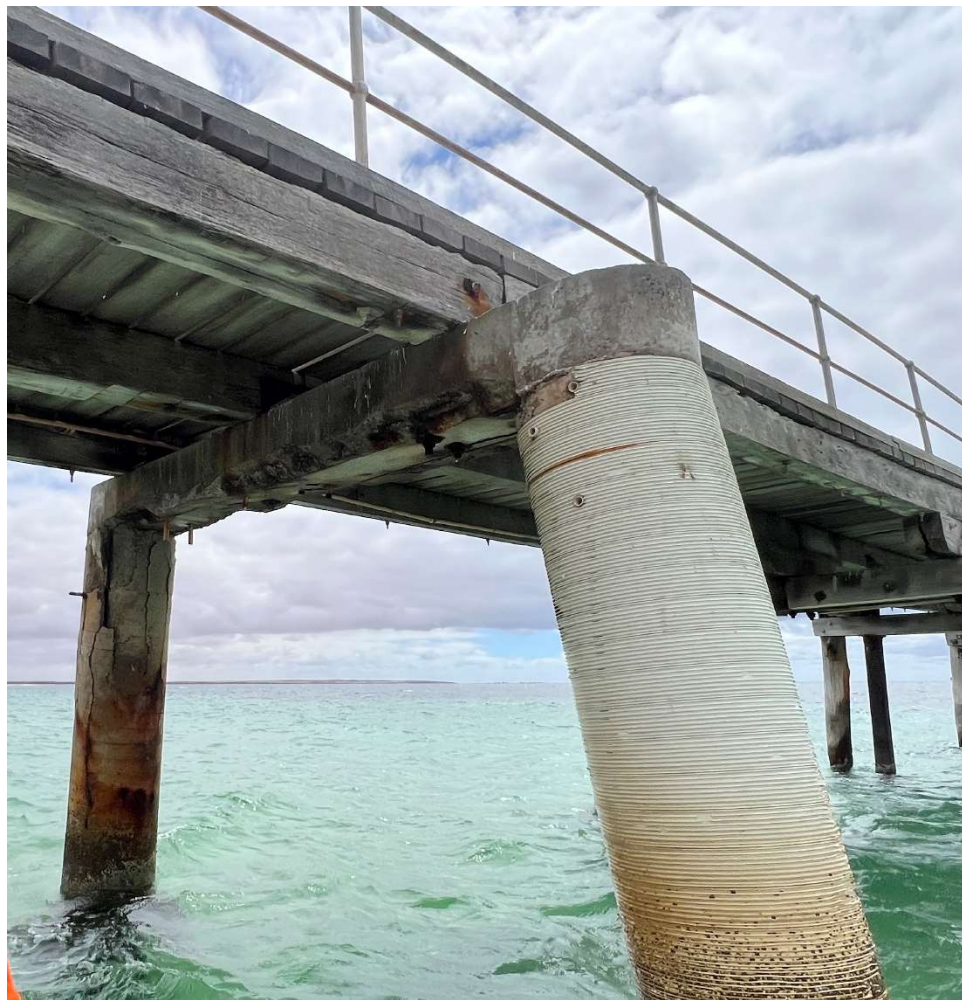
Figure 28 Typical condition '6' concrete crosshead

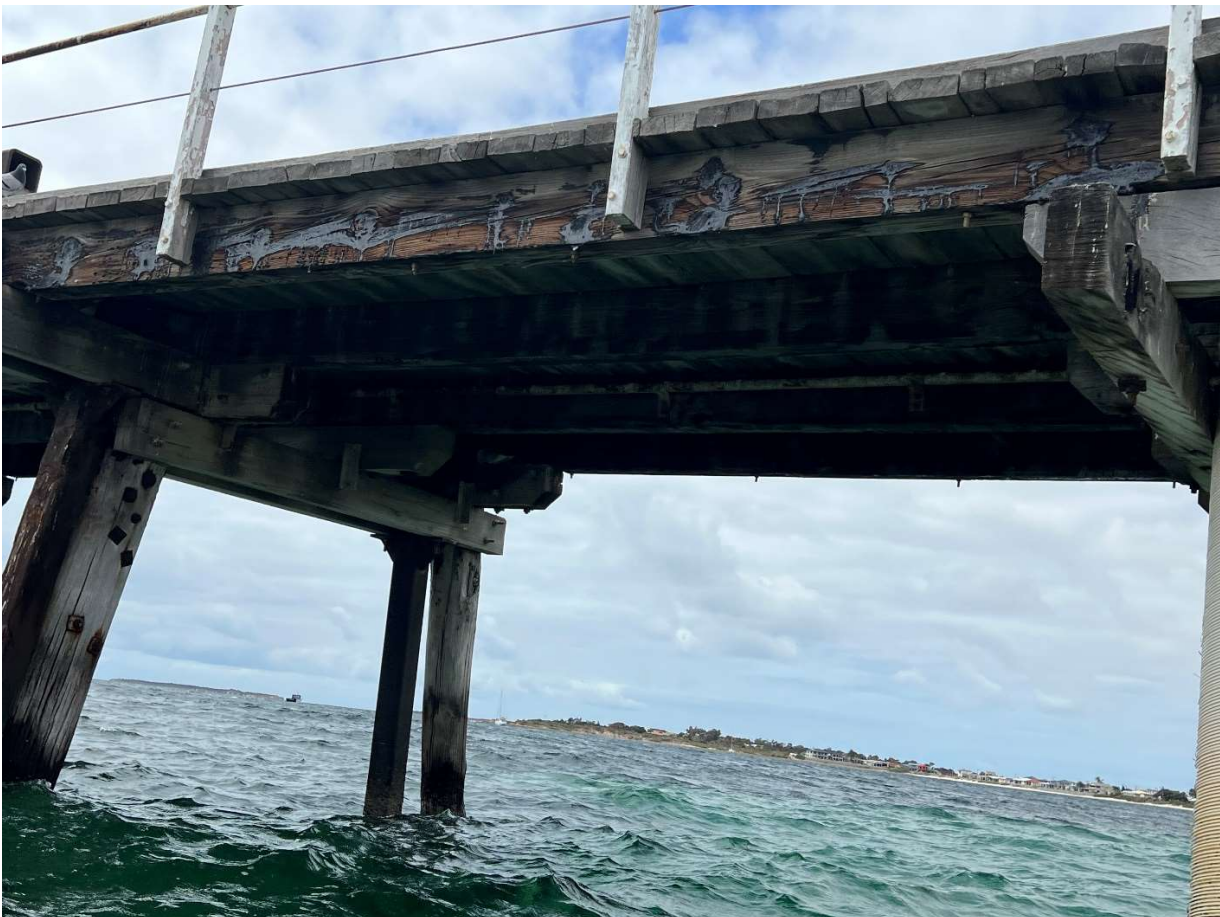
Figure 30: Typical condition '4' girder

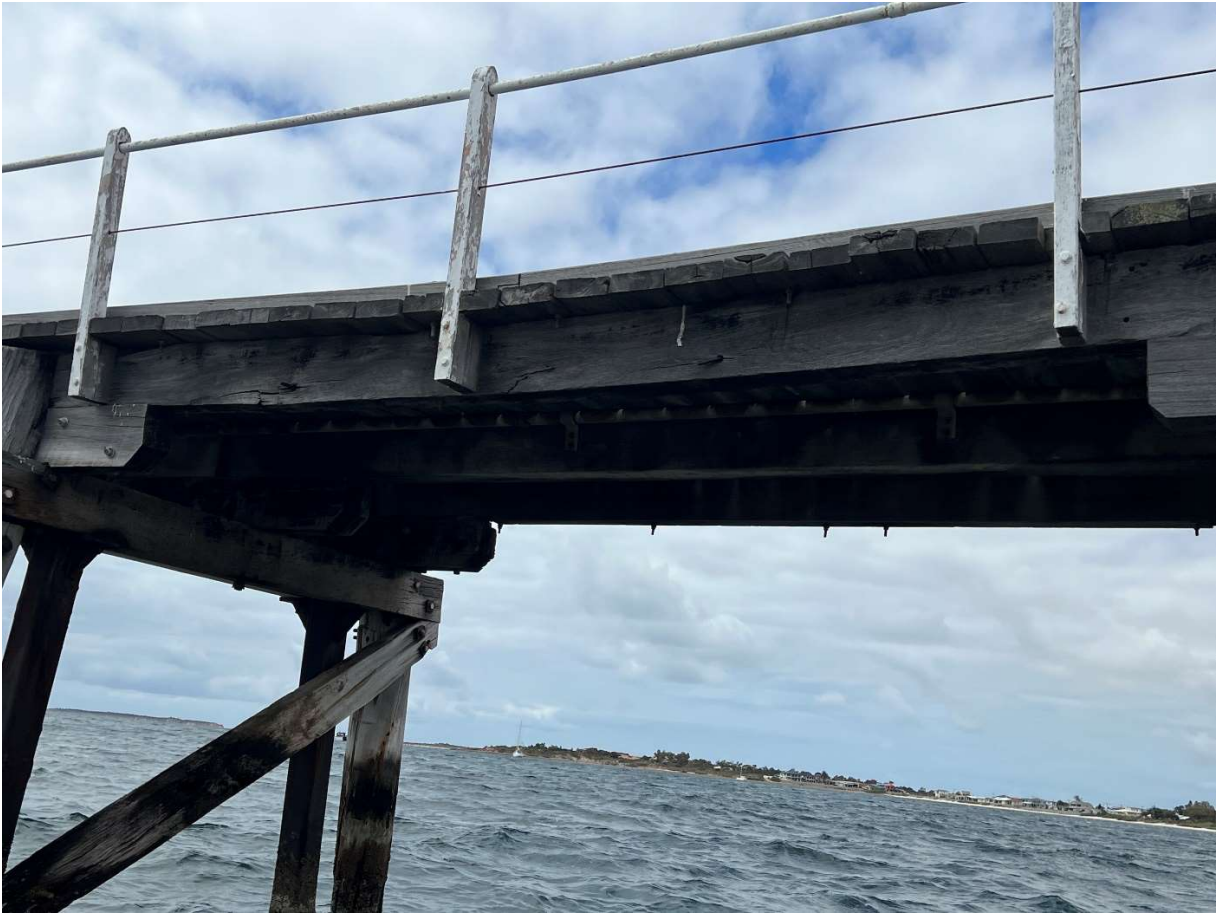
Figure 31: Typical condition '5' girder

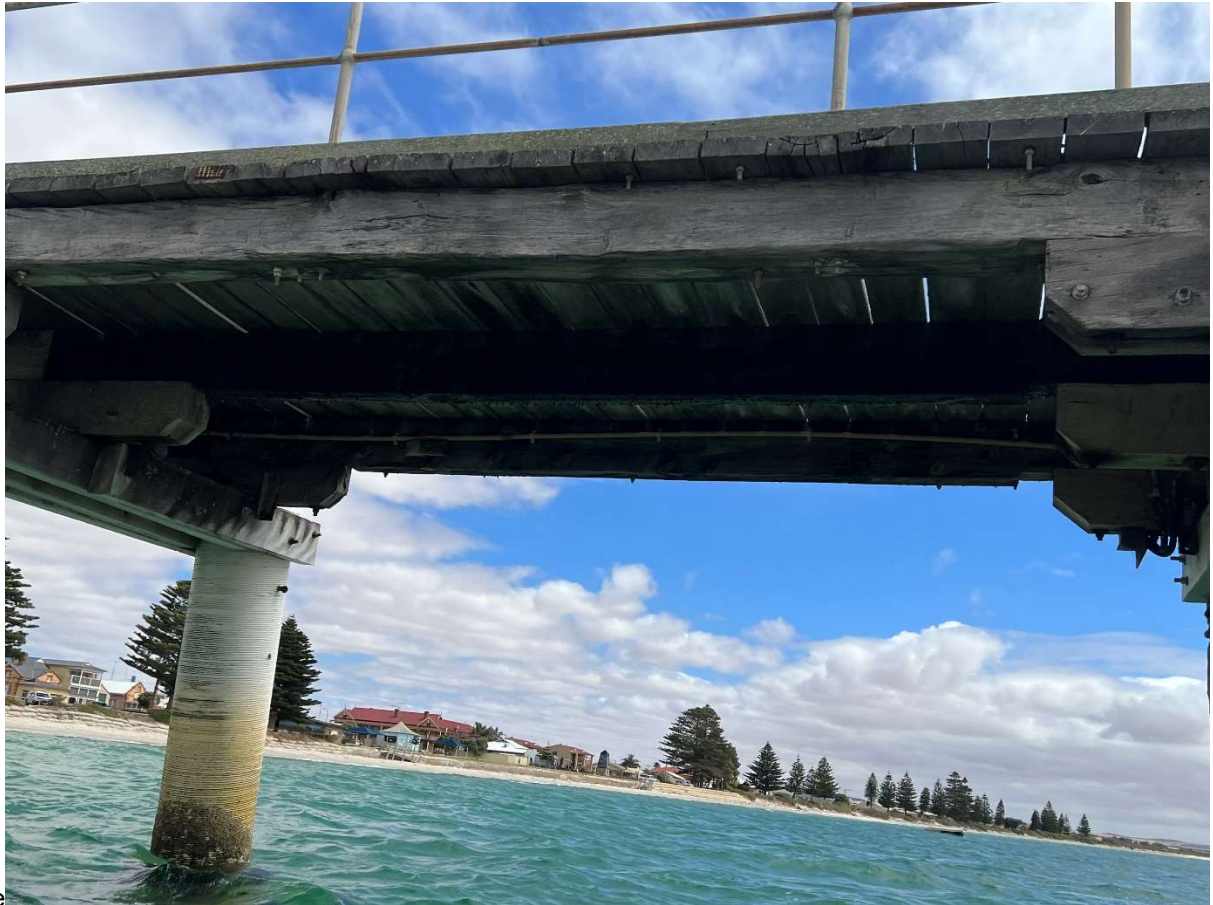
Figure 32 Typical condition '6' girder

- Repair all girders rated 6 & 7.
- Replace all rating 5 girders in 10 years time.

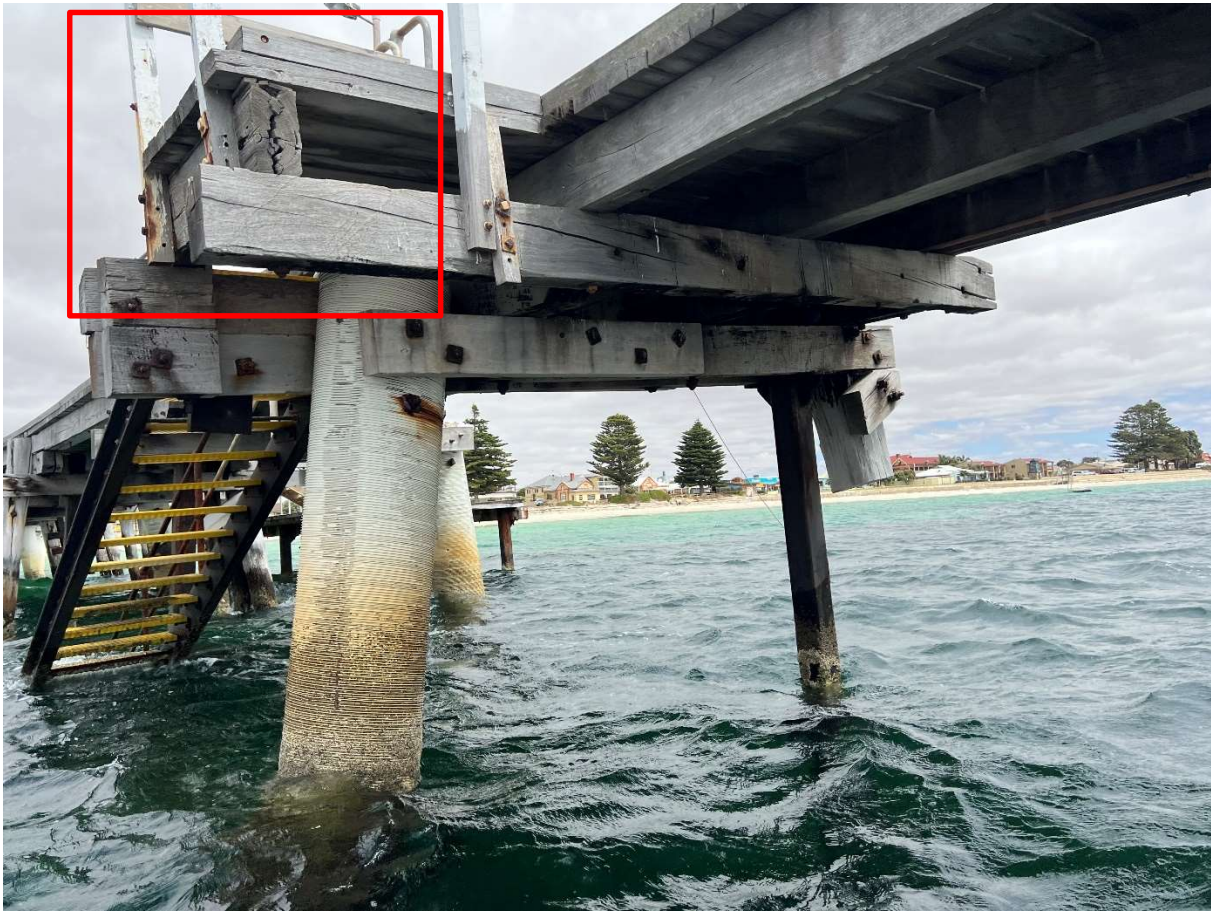
Figure 33 Typical condition '7' girder

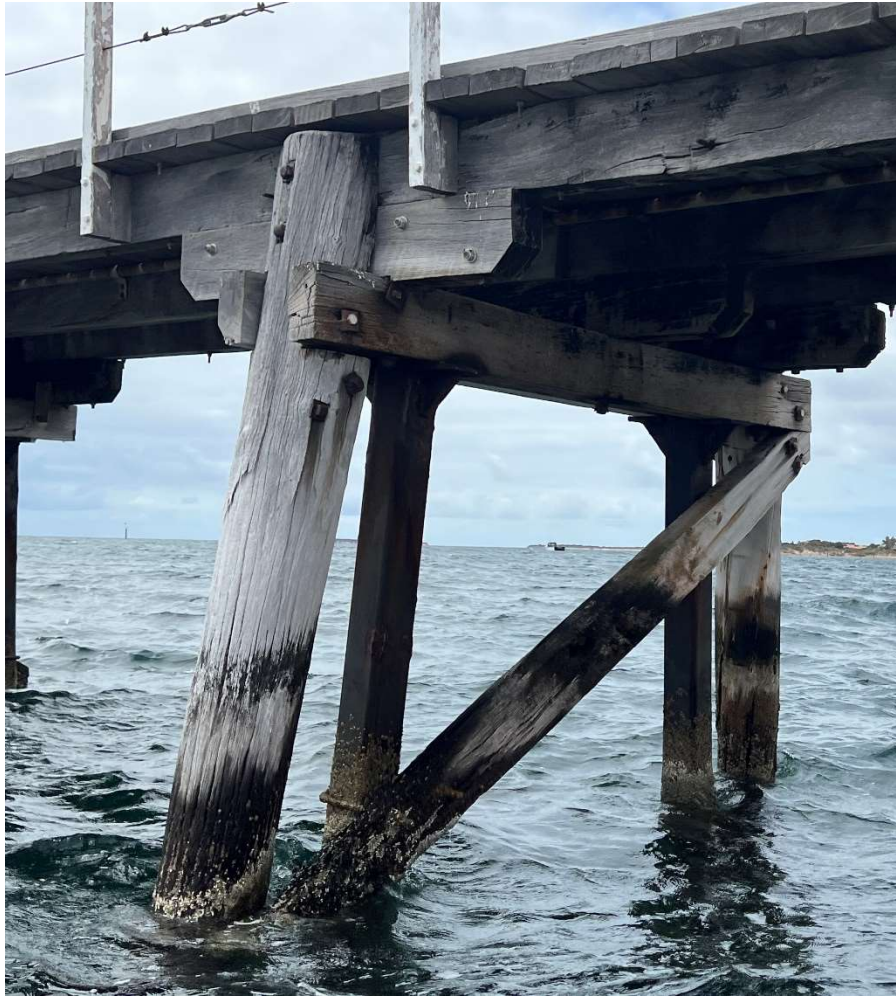
The cross braces were found to be in poor condition throughout the structure. The common defect noted during the inspection was rot to the lower ends of the cross braces at the connection points. This is common throughout jetty structures and cross braces due to the lower ends residing within the tidal zone. These timber sections have undergone rot with section loss evident on some bents around the connection bolts into the timber piles. Many cross braces have already failed. There were instances noted during the inspection where crossbraces were removed during installation of concrete casing to timber piles or while steel piles were installed but they were not replaced or reinstated. There also have been instances where the crossbraces are either connected unconventionally to steel piles or are not connected at all. The steel rod has been welded to the steel piles, which does not provide a good load path for lateral loads. Crossbraces should be reinstated with a clamped bracket as used on recent jetty upgrades throughout South Australia.

Figure 35 Typical Condition '7' crossbrace. Seaside crossbrace missing

- Replace all cross bracing rating 6 & 7.
- Connect bracing back to steel piles with clamp bracket

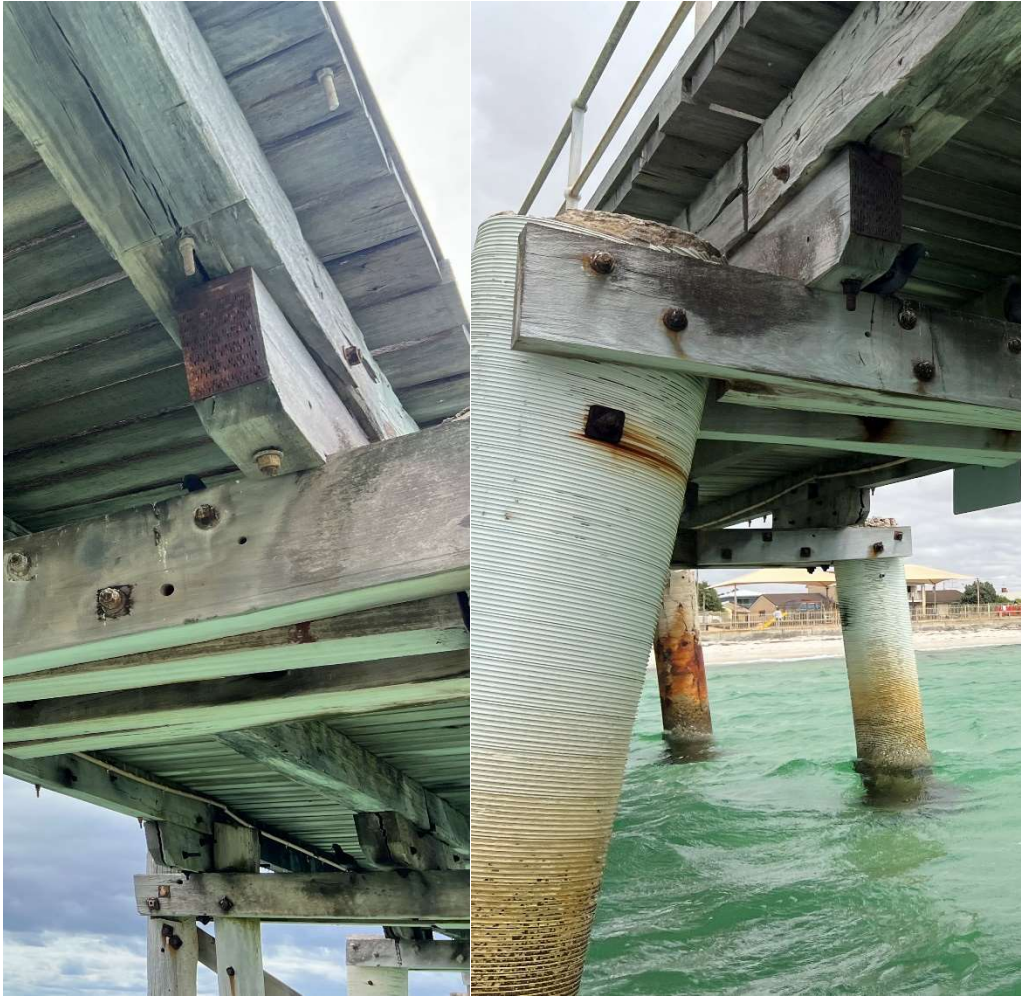
Figure 37 Typical condition '4' Corbel (same corbel-both sides shown)

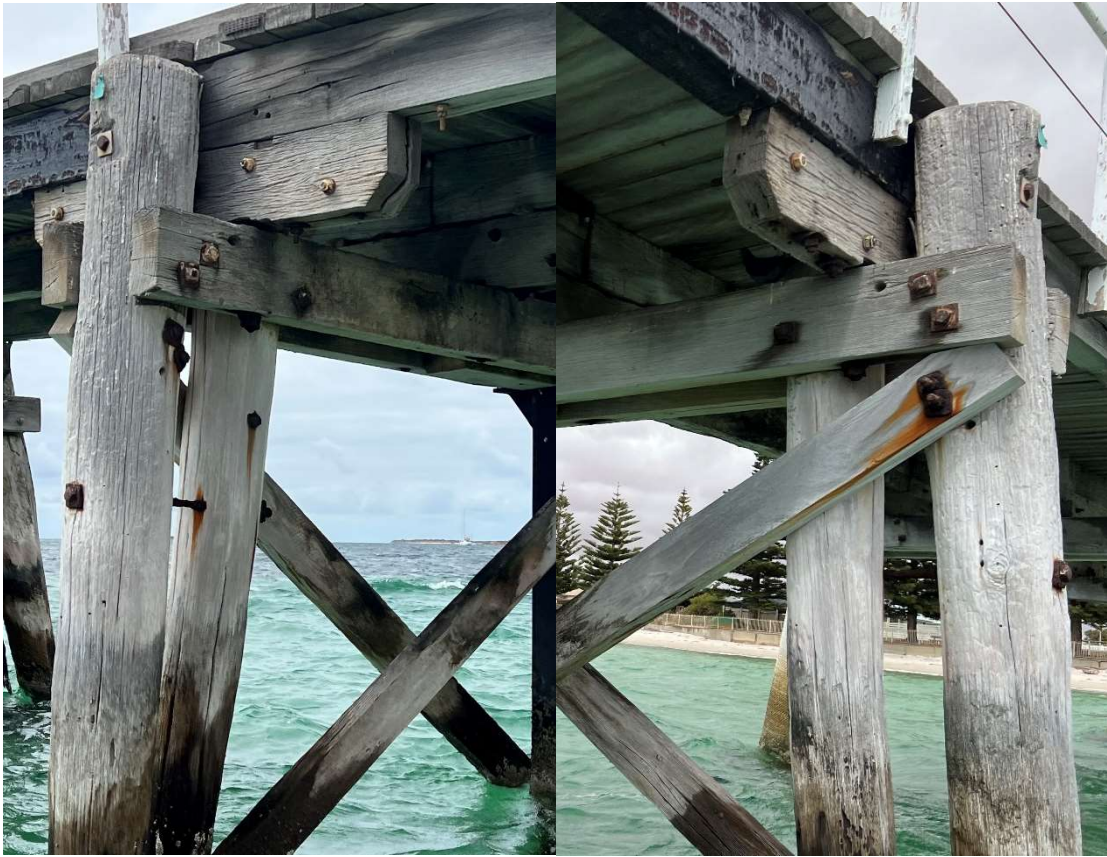
Figure 38 Typical condition '5' Corbel (same corbel-both sides shown)

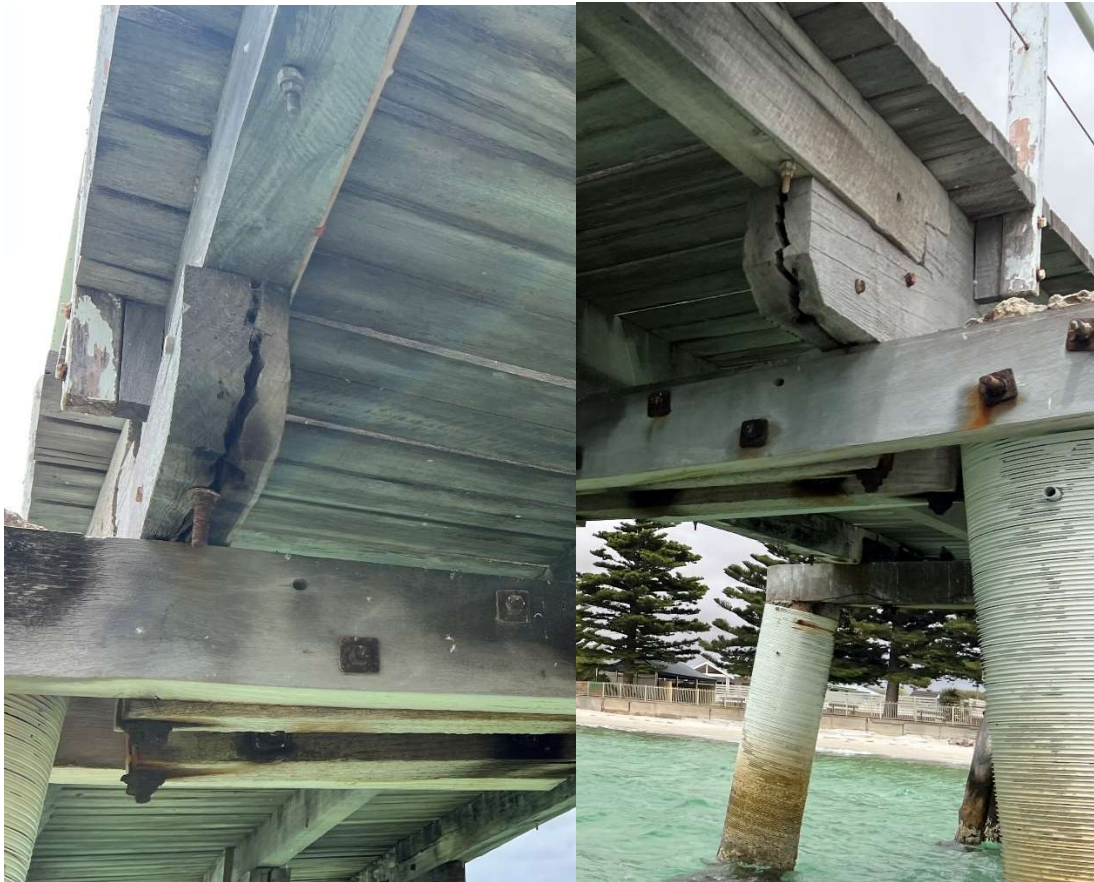
Figure 39 Typical condition '6' Corbel (same corbel-both sides shown)

- Replace rating 6 & 7 Corbels.
- Replace all rating 5 corbels in 10 years time.

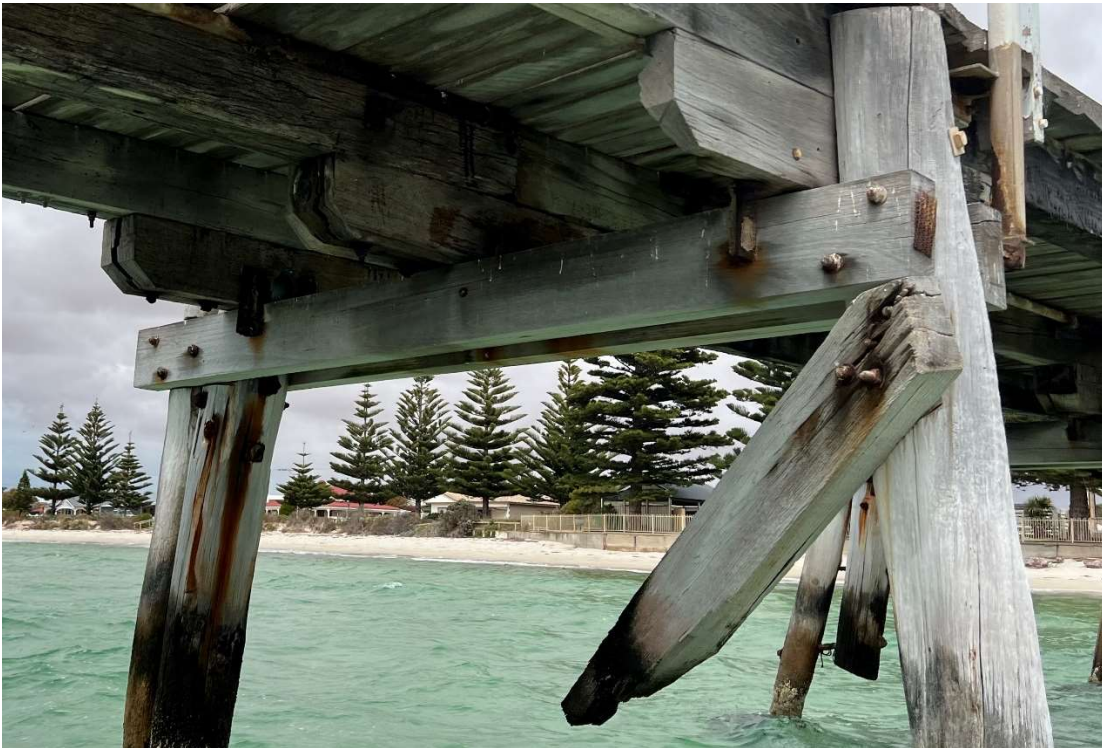
Figure 40 Typical condition '7' corbel
