TUMBY BAY JETTY

WSCAM Assessment INSPECTION REPORT

6 FEBRUARY 2024

Infrastructure Consulting Pty Ltd
Authored by: Keegan Steele
Revision: C

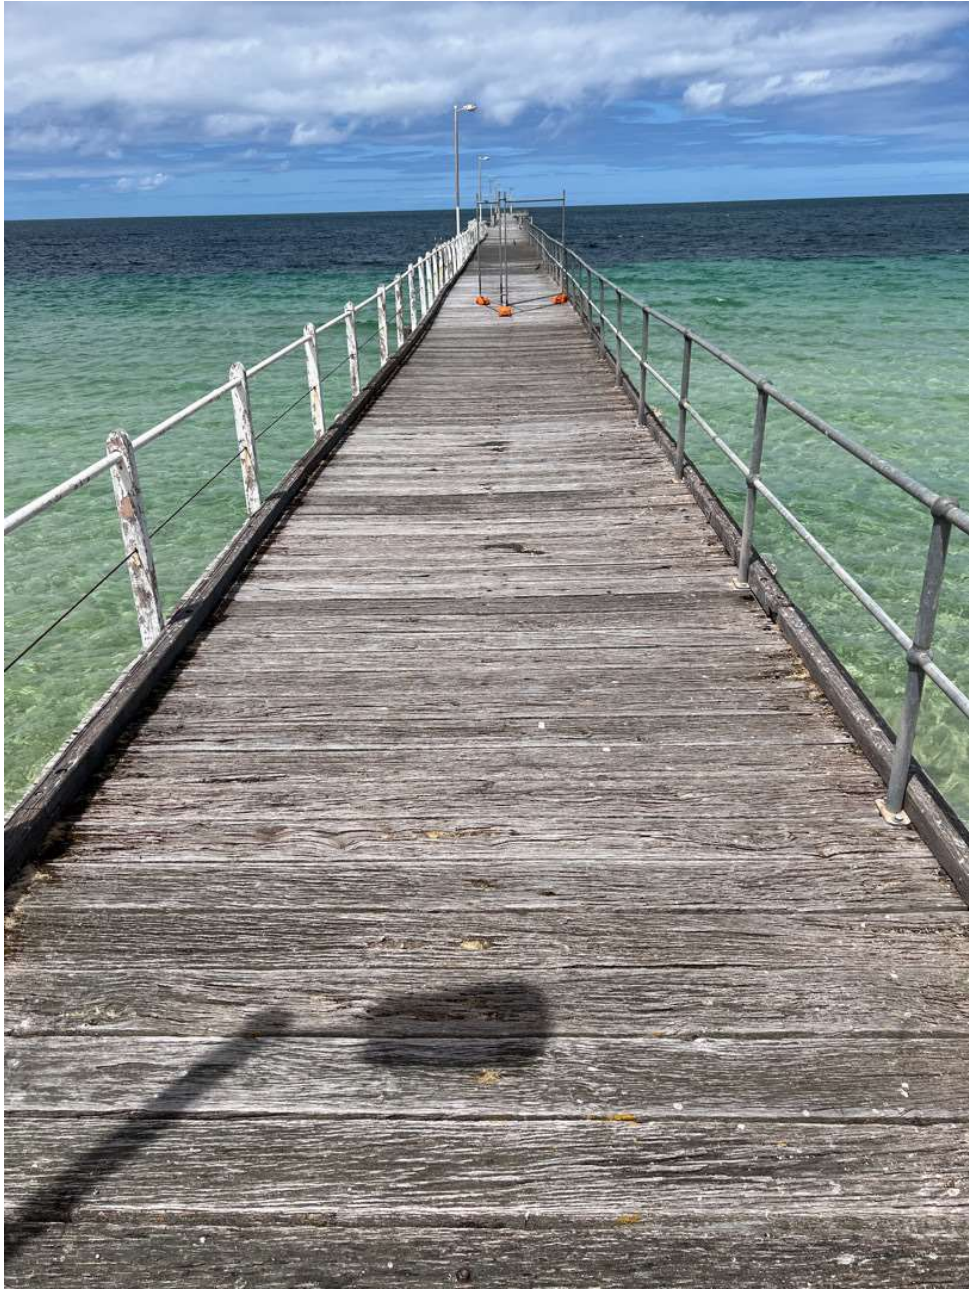
Figure 43 Typical condition '4' decking

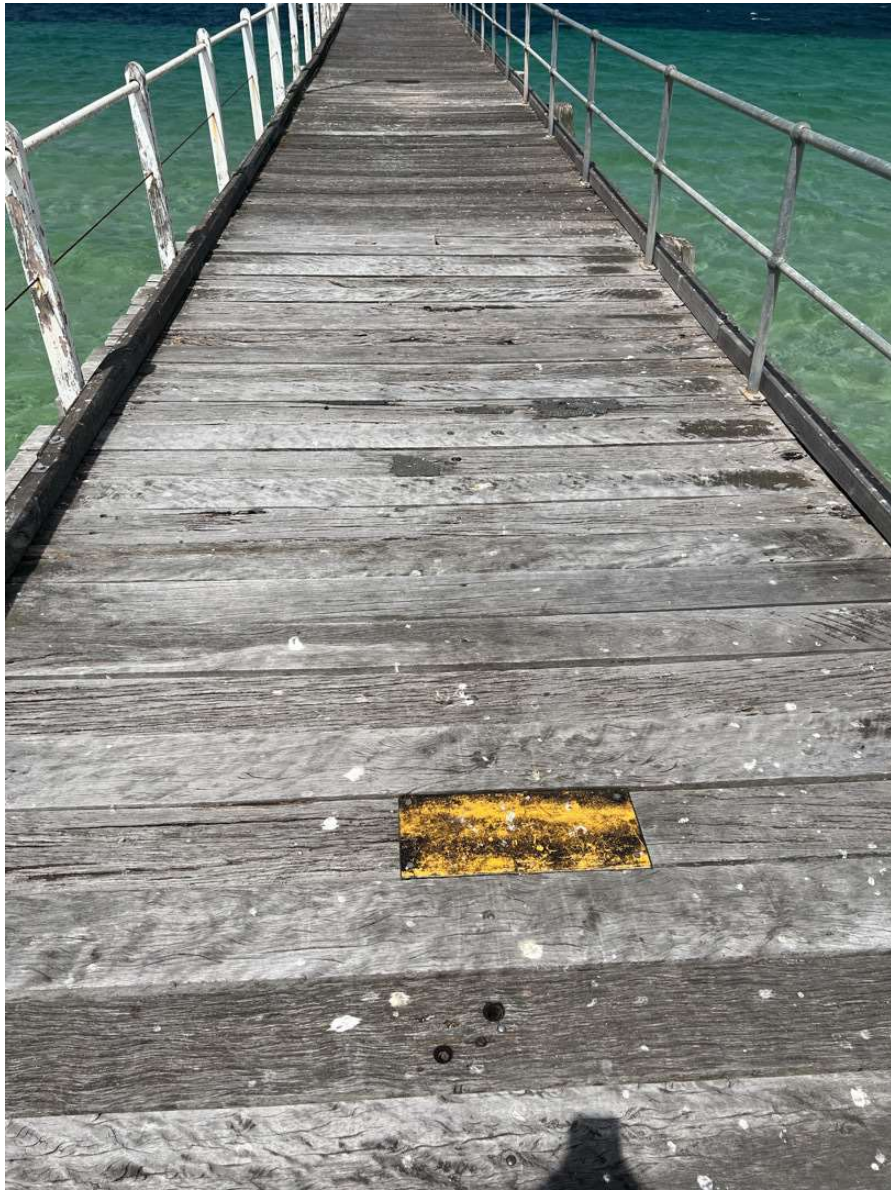
Figure 44 Typical condition '5' decking

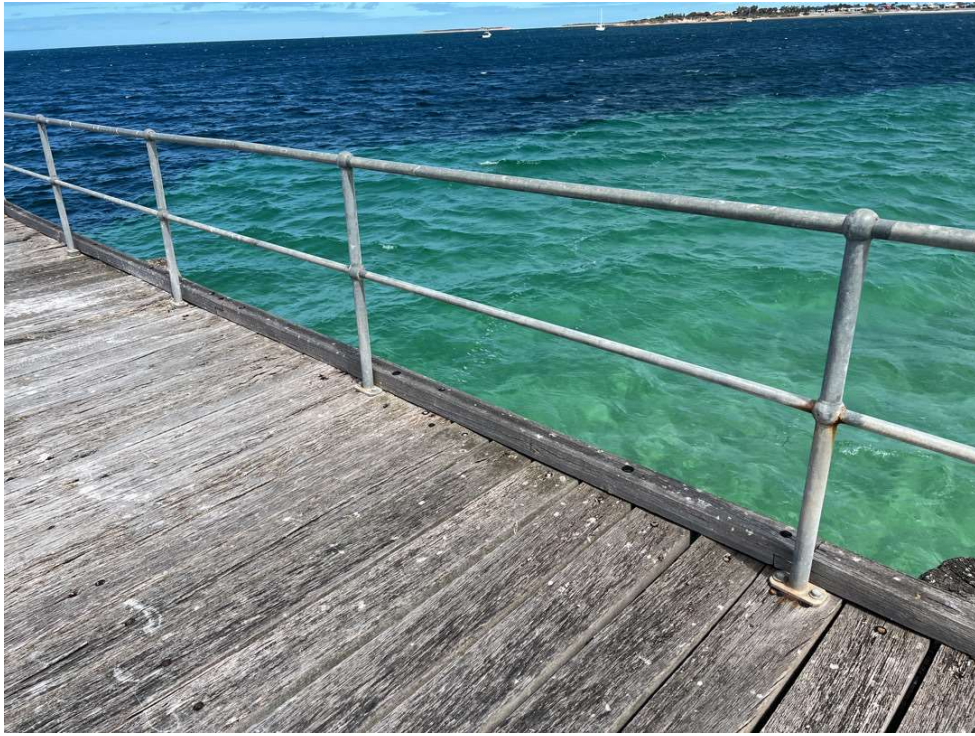
Figure 45: Typical Condition '4' Kerb

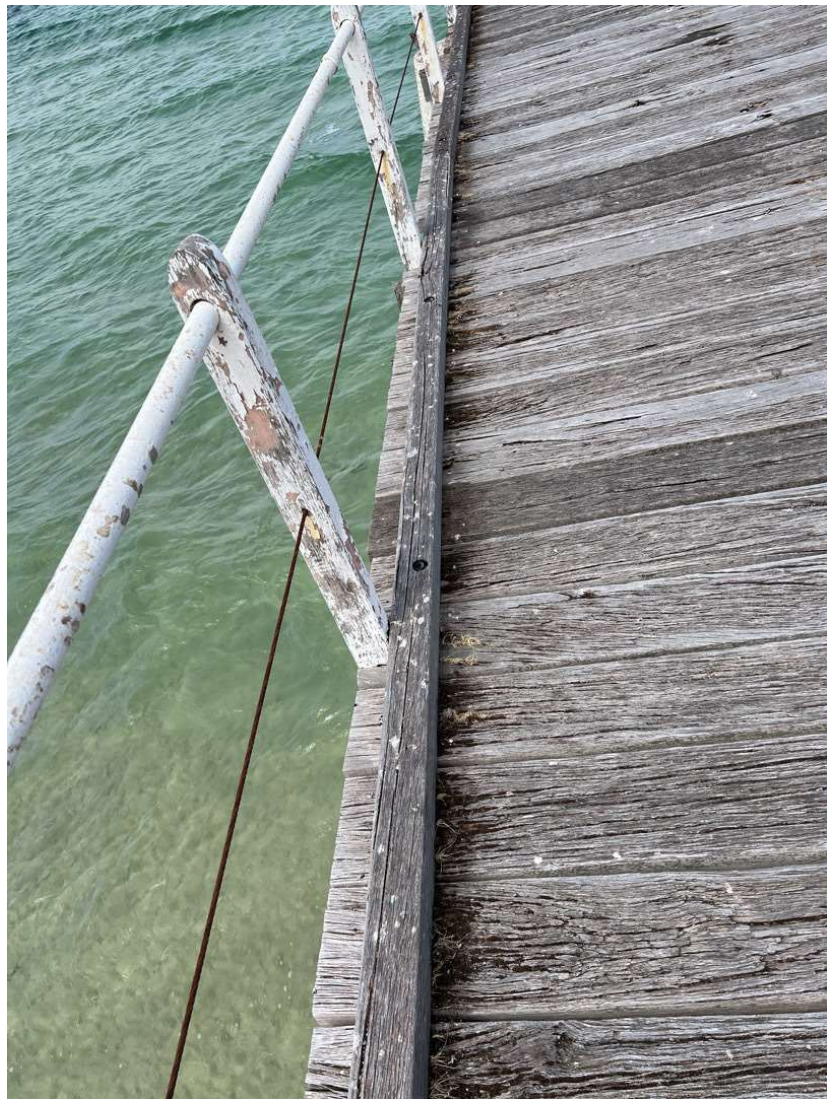
Figure 46: Typical Condition '5' Kerb

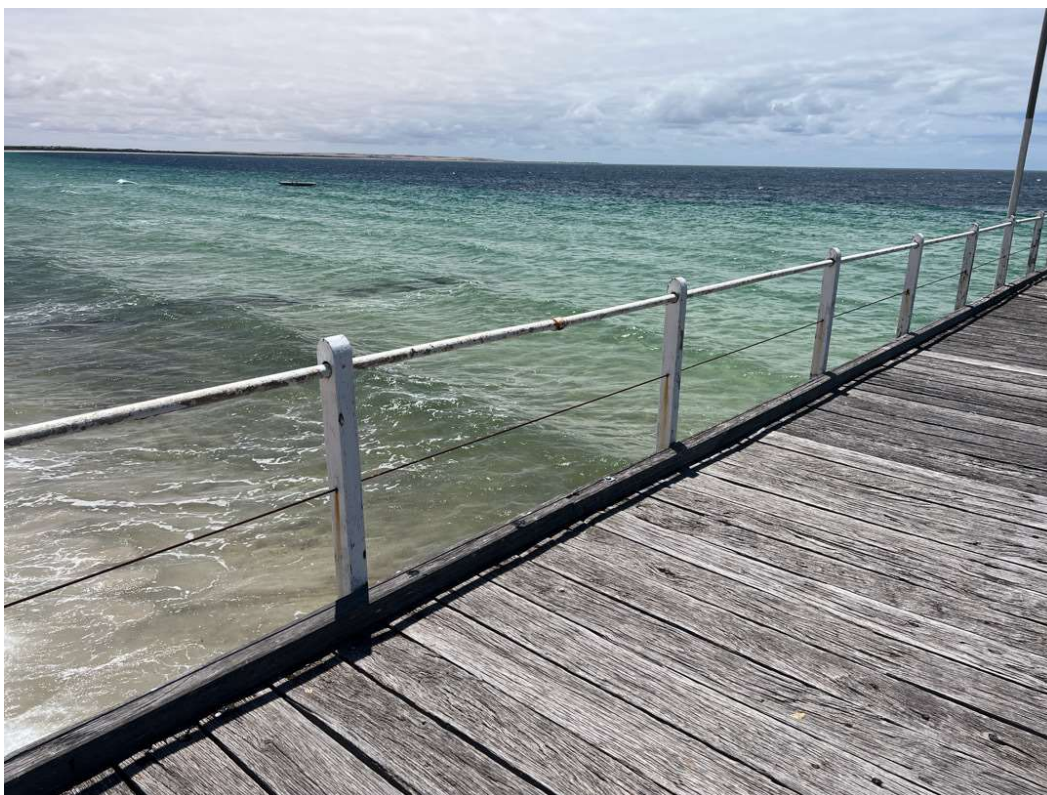
Figure 47: Typical condition '4' of handrail – LHS of the jetty

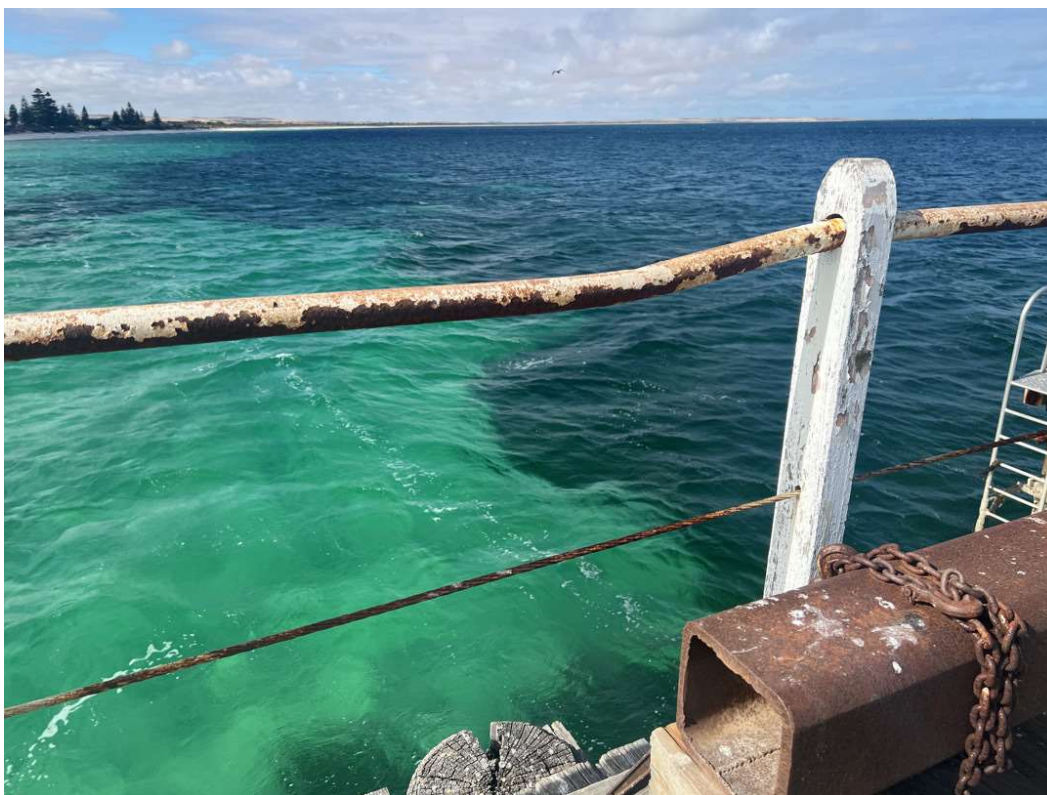
Figure 48 Typical condition '5' of handrail – LHS of the jetty

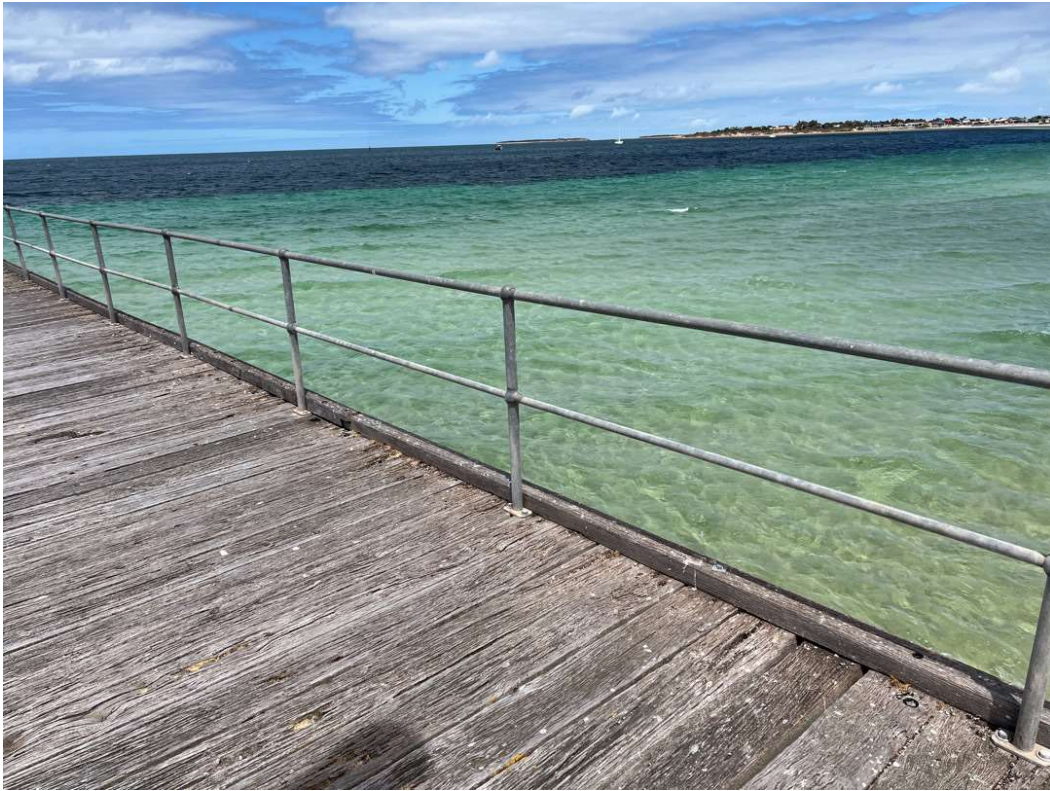
Figure 49: Typical condition '4' of handrail – RHS of the jetty

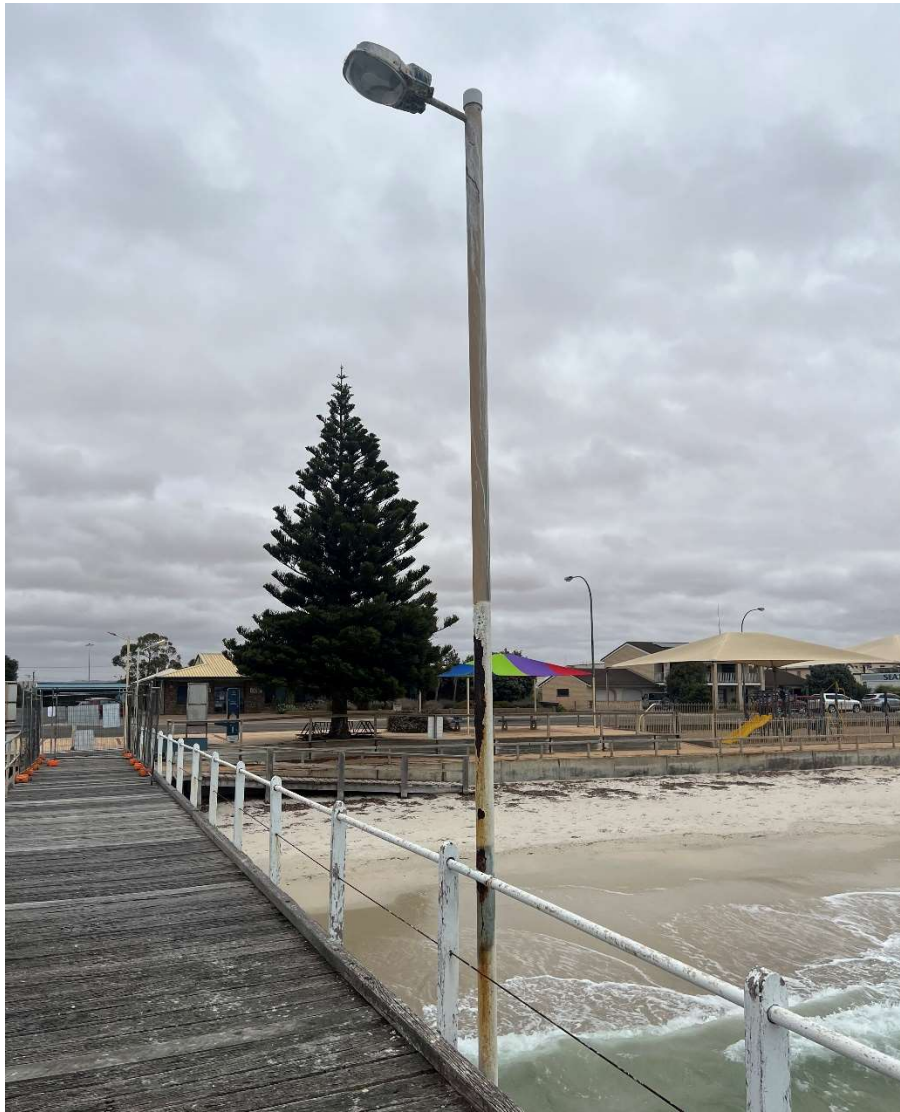
Figure 51 Typical condition '4' Lightpole

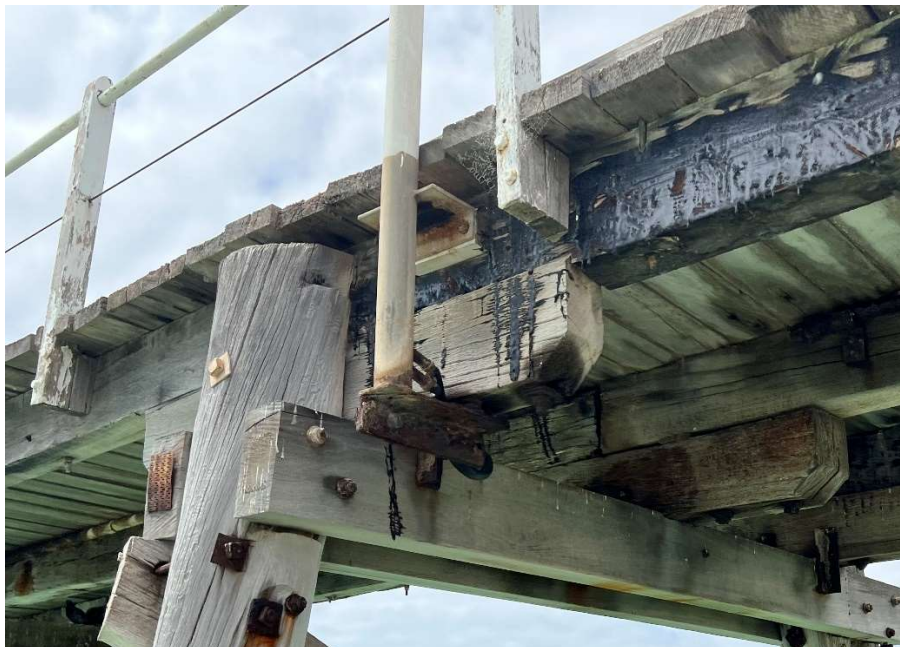
The 6 light poles on the Tumbay Bay Jetty were observed to be in good condition, with one defect noted to the bent 11 lighting connection to the girder which was severely corroded.

Figure 52 Bent 11 Lightpole corroded connection, rated 6

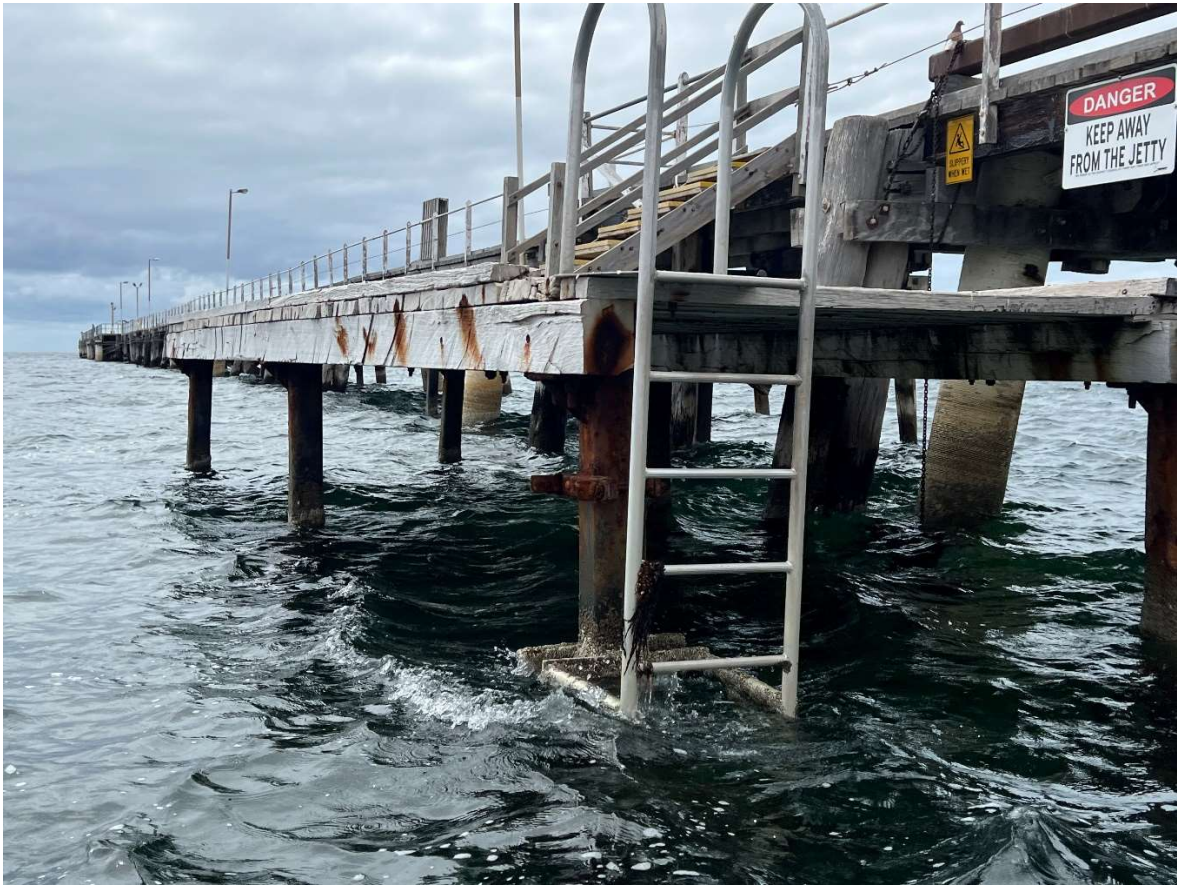
The third ladder is located on the landing serving purpose as a dive ladder and is in a good condition.

Figure 55: Lower Landing Dive Ladder

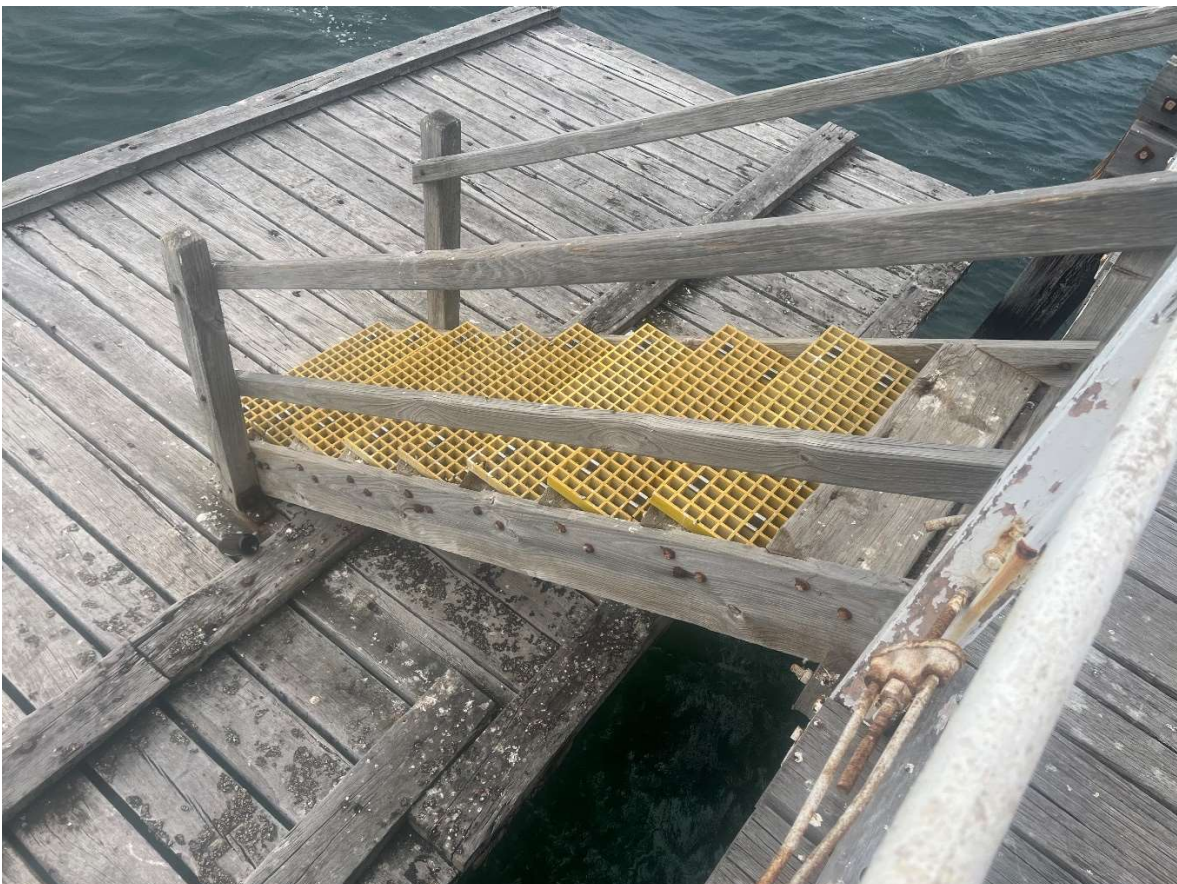
The second ladder is connecting the landing with the jetty and this stair is in a fair condition with no significant damage observed.

Figure 56: Jetty and Lower Landing Stair

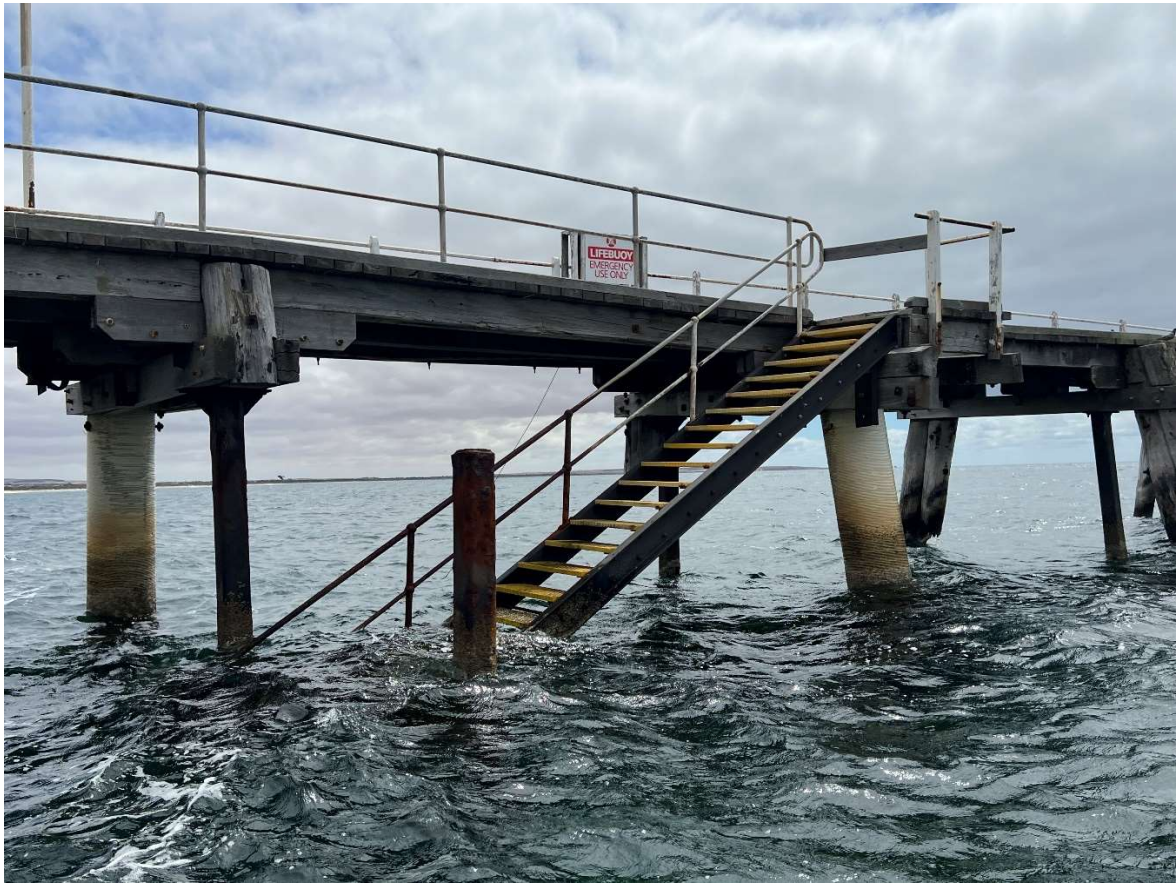
There are three ladders along the jetty between bents 1- 36. One ladder is located between bent 24 and 25. This ladder is in a fair condition and no significant damages were observed.

Figure 57: Jetty Ladder between bent 24 and 25
