The District Council of
Tumby Bay

Jetty Condition Assessment Reports

TUMBY BAY JETTY

Doc No. WGA192080-RP-MA-0002

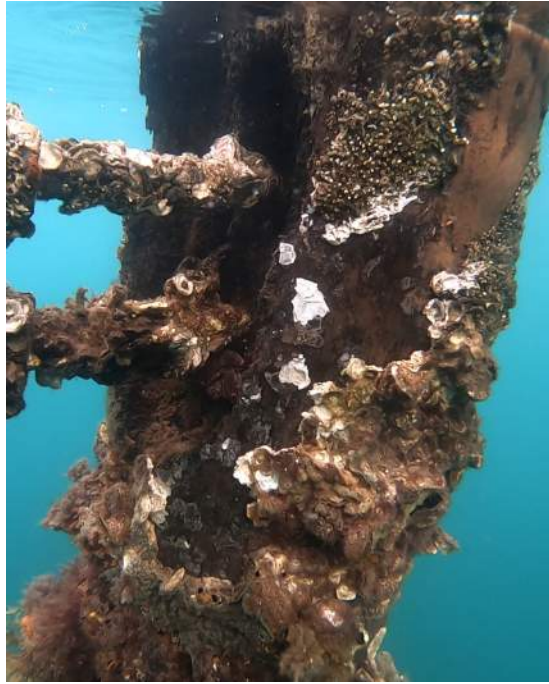
Figure 7 – Typical Condition 5 Timber Pile (Defect: Necking & Damage at cross brace)

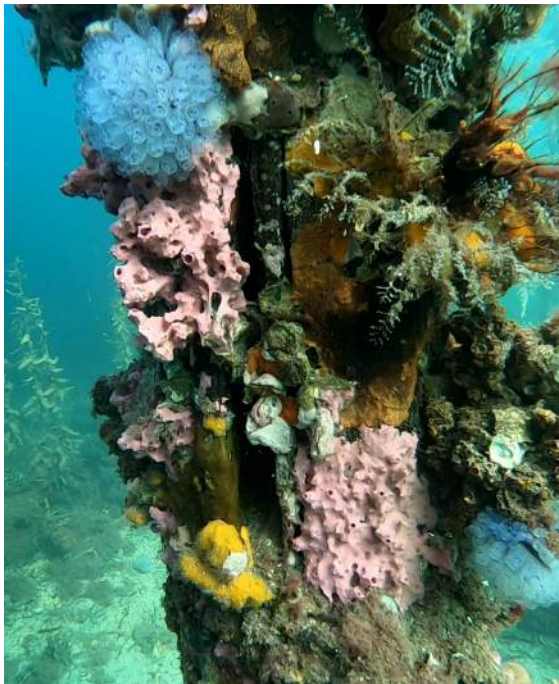
Figure 8 – Typical Condition 6 Timber Pile (Defect: Necking & Splitting)

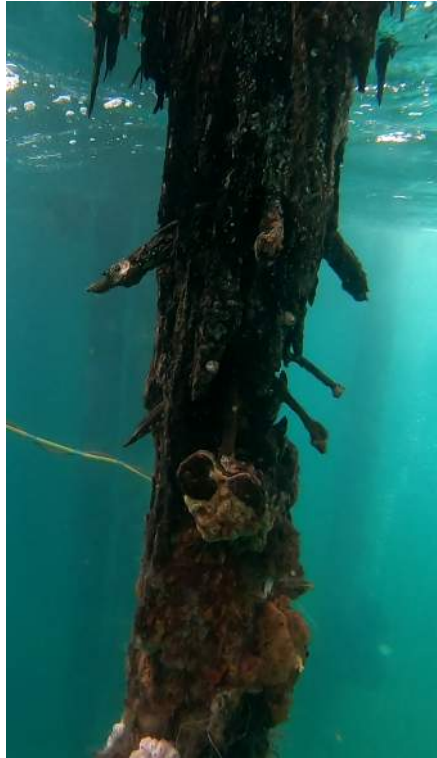
Figure 9– Typical Condition 7 Timber Pile (Defect: Necking & Splitting)

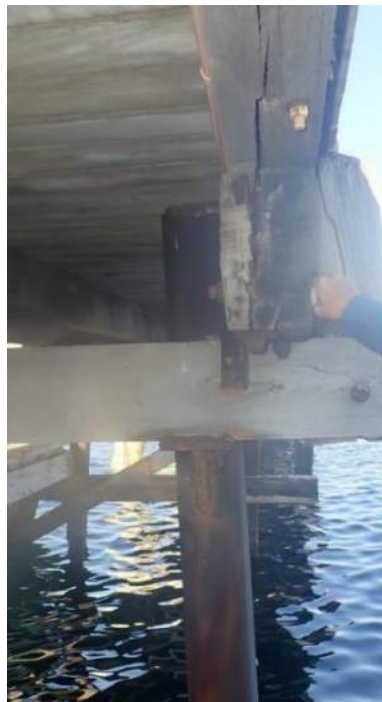
Figure 10 – Typical Condition 4 Steel Pile (Defect: Surface Corrosion)

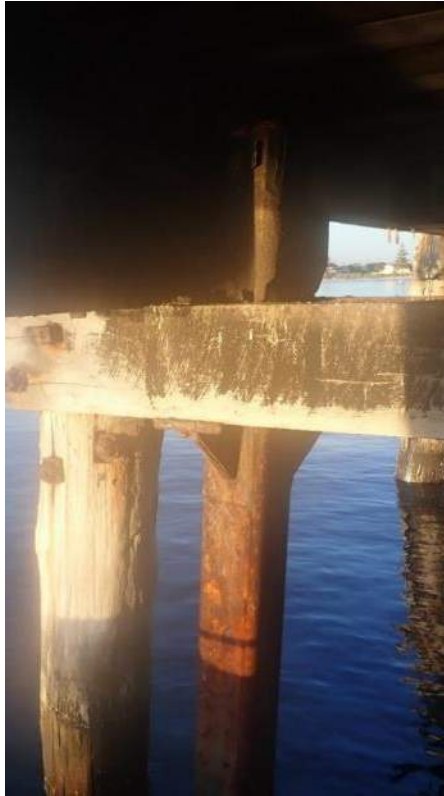
Figure 11 – Typical Condition 5 Steel Pile (Defect: Surface Corrosion & Pitting)

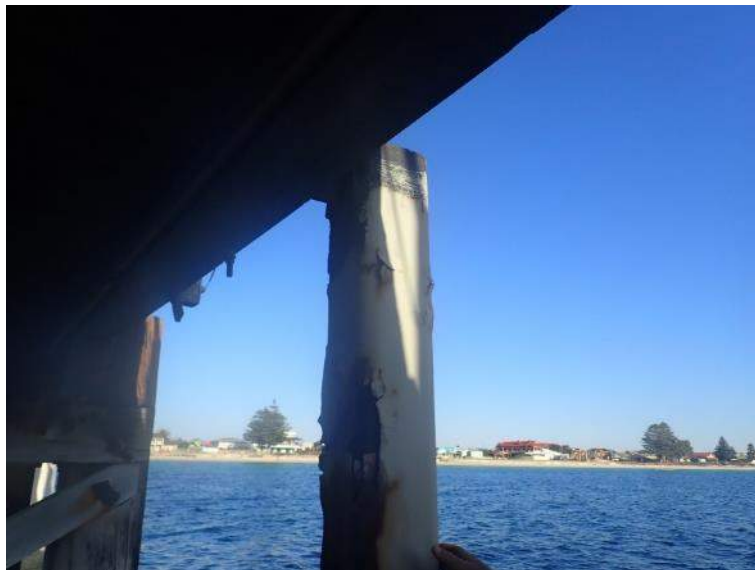
Figure 12 – Typical Condition 6 Steel Pile (Defect: Surface Corrosion, Pitting & Section Loss)

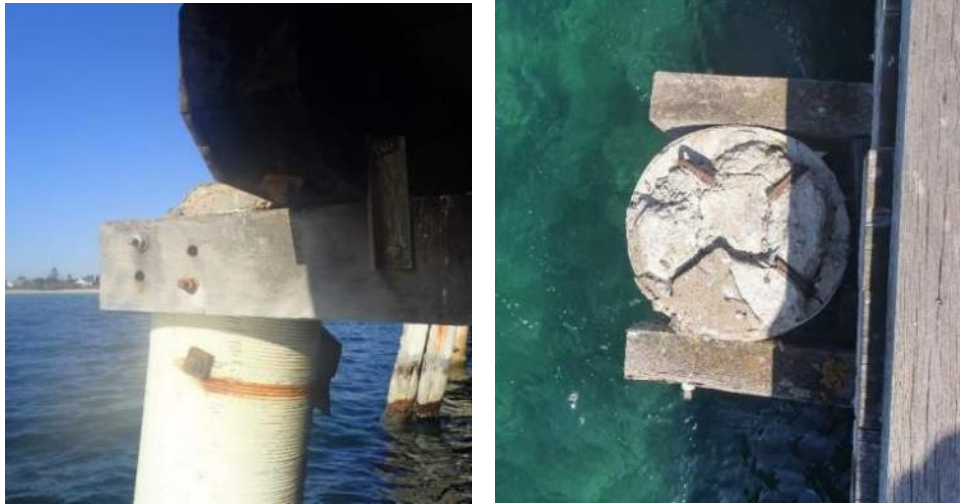
Figure 13 – Typical Condition 5 Concrete Pile (Defect: Minor damage to sleeve, exposed reinforcement and spalled concrete)

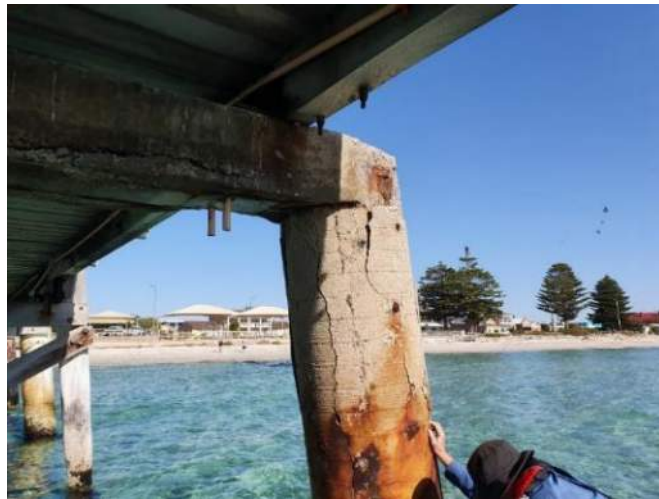
Figure 14 – Typical Condition 6 Concrete Pile (Defect: Missing sleeve, cracking and spalled concrete along pile)

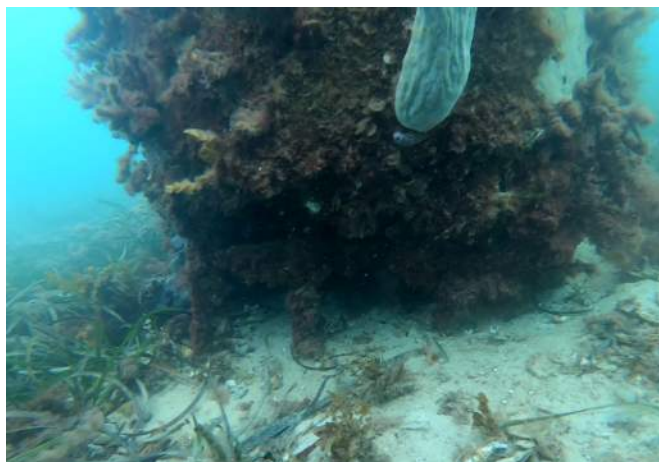
Figure 15 – Typical Condition 7 Concrete Pile (Defect: Missing sleeve, exposed reinforcement and missing concrete at seabed)

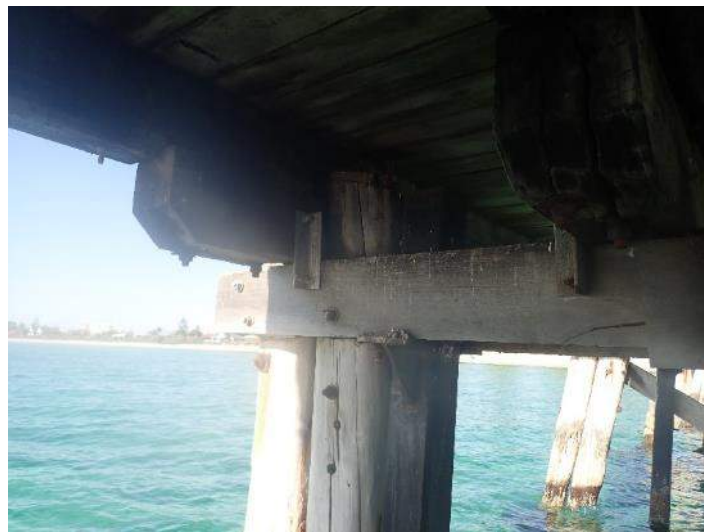
Figure 16 – Typical Condition 4 Timber Crosshead (Defect: Weathering)

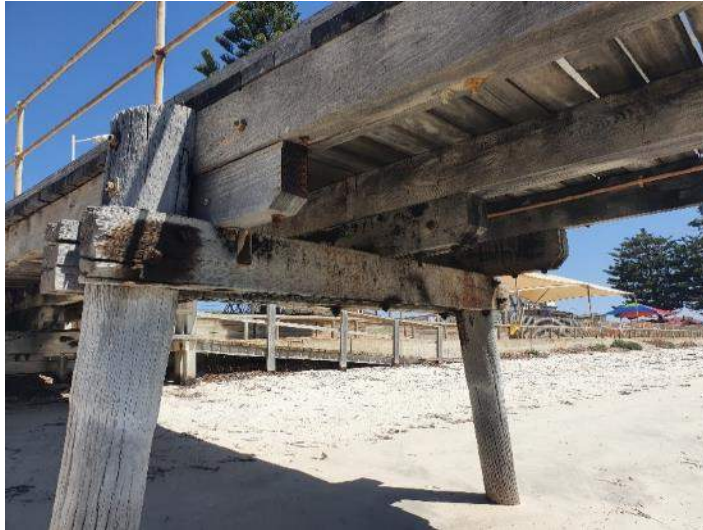
Figure 17 – Typical Condition 5 Timber Crosshead (Defect: Splitting at Ends and Weathering)

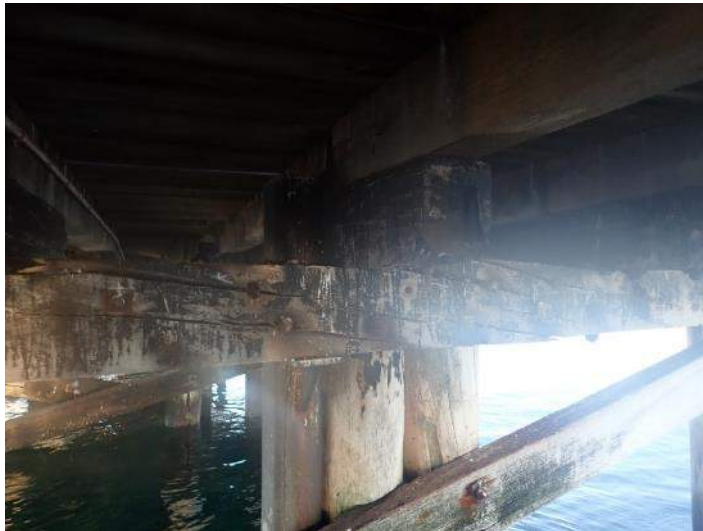
Figure 18 – Typical Condition 6 Timber Crosshead (Defect: Splitting Along Length and Weathering)

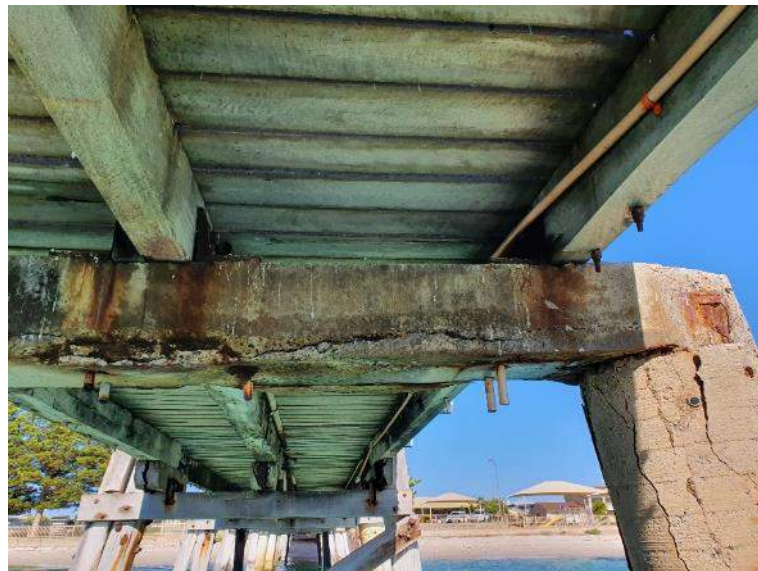
Component		Condition Rating (number of components)						
		1	2	3	4	5	6	7
Concrete Crossheads	No. of Components (1 Total)						1	
							100%	
	Comments	<ul style="list-style-type: none"> Concrete cracking and spalling along underside of member, exposing corroded reinforcement. 						
	Recommended Maintenance	<ul style="list-style-type: none"> Replace condition rating 6 crosshead with timber crosshead to match the rest of the jetty.

Figure 19 – Typical Condition 6 Concrete Crosshead (Defect: Cracking & Spalling)

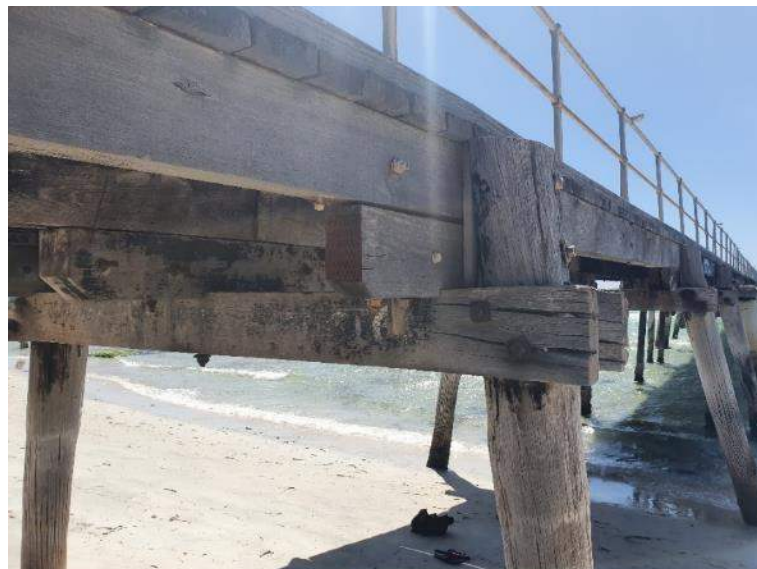
Figure 20 – Typical Condition 3&4 Timber Corbel (Defect: Weathering & Minor Splitting of Member)

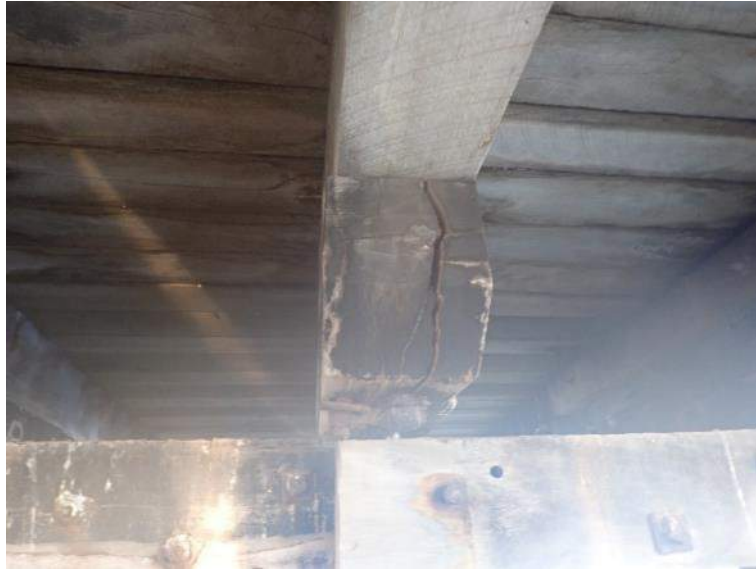
Figure 21 – Typical Condition 5 Timber Corbel (Defect: Weathering & Splitting at End(s) of Member)

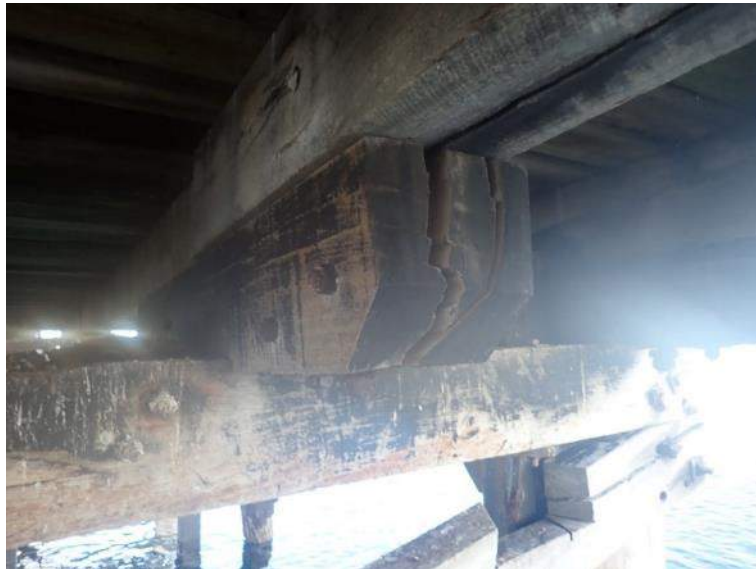
Figure 22 – Typical Condition 6 Timber Corbel (Defect: Weathering & Major Splitting Along Member)

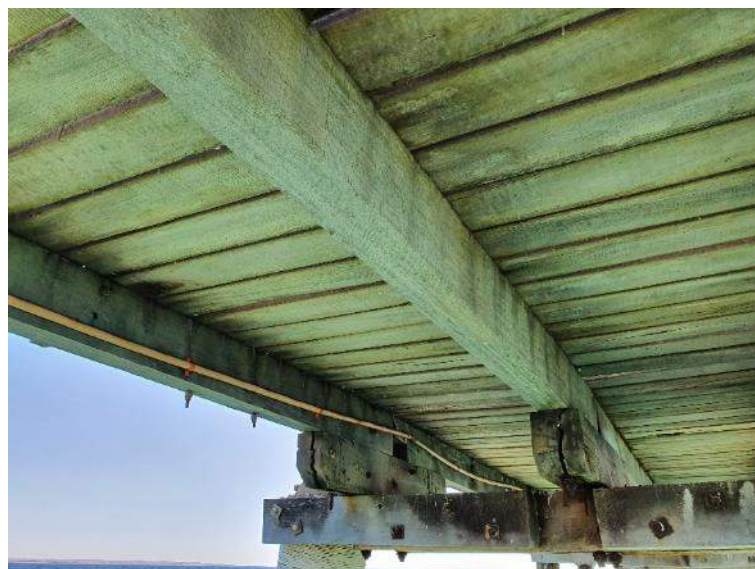
Figure 23 – Typical Condition 3 & 4 Bearer (Defect: Minor Splitting & Weathering)

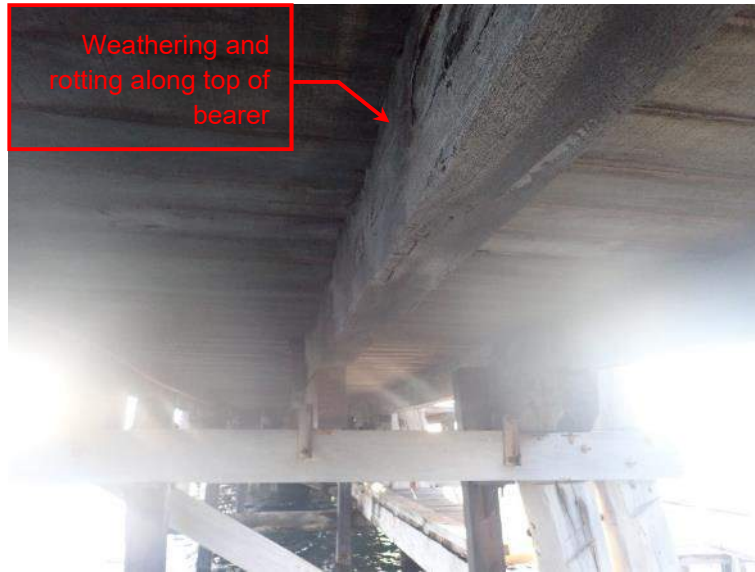
Figure 24 – Typical Condition 5 Bearer (Defect: Splitting and Weathering along Top)

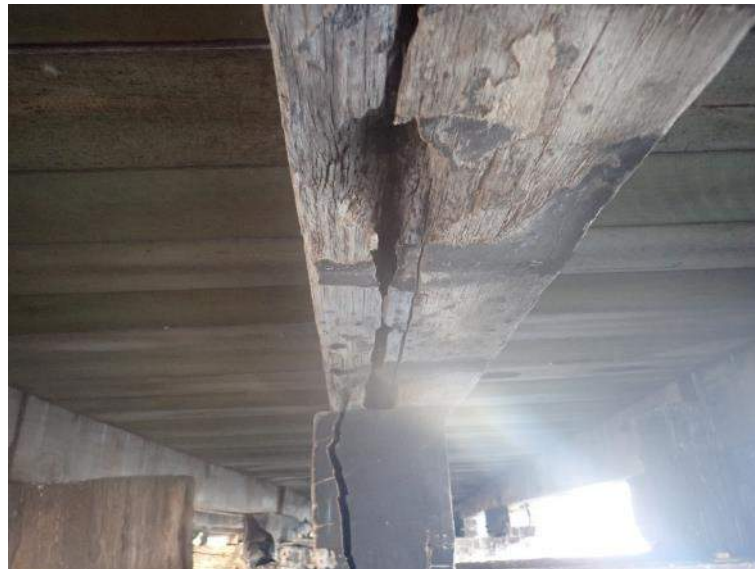
Figure 25 – Typical Condition 6 Bearer (Defect: Major Splitting & Rotting)

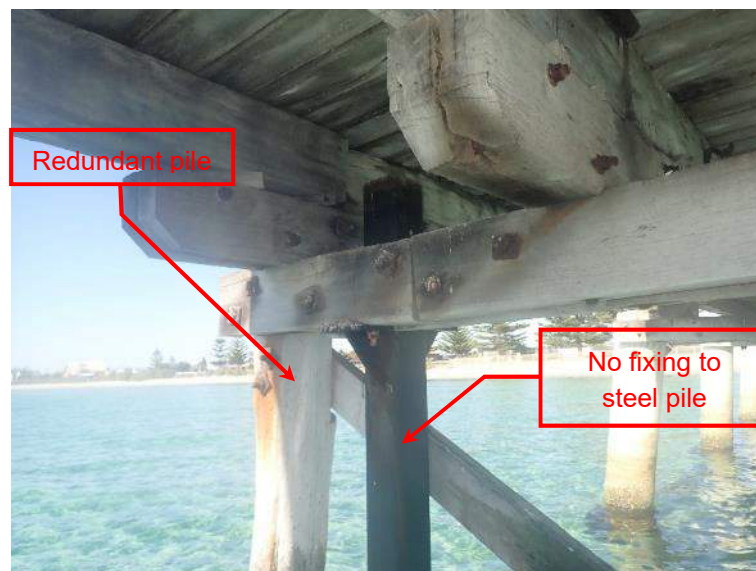
Component		Condition Rating (number of components)						
		1	2	3	4	5	6	7
Cross-Braces	No. of Components (43 Total)				1			42
					2%			98%
	Comments	<ul style="list-style-type: none"> The majority of the bents have either no cross braces or the braces connected to redundant timber piles instead of steel or concrete piles that have been used to supplement/replace degraded timber piles. Where braces have been fixed to a redundant pile were rated a condition 7. Lack of cross braces is more predominate within the first half of the jetty and braces connected to redundant timber piles more predominate in the second half of the jetty. 						
Recommended Maintenance	<ul style="list-style-type: none"> Recommend a structural assessment be conducted to determine if cross-bracing is required. Further information may be required to inform the structural assessment with future works potentially involving repairing / replacing existing and missing cross-bracing.

Figure 26 – Typical Condition 7 Cross Braces (Defect: Connected to Redundant Pile)

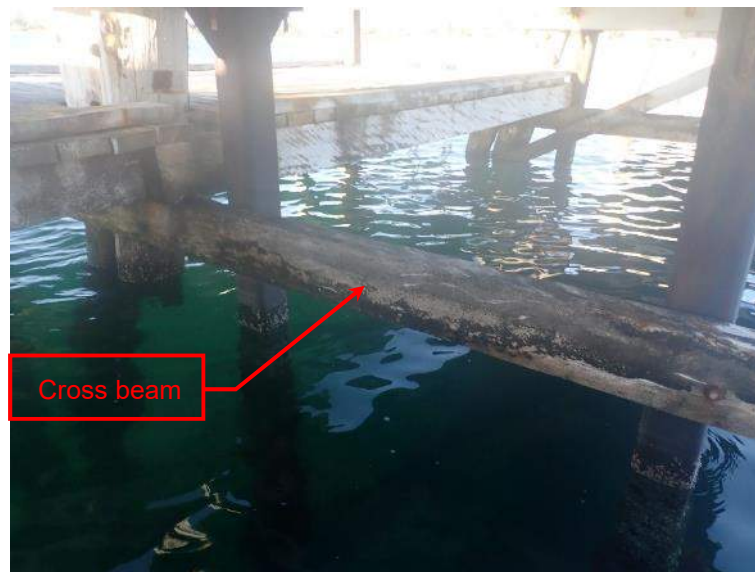
Figure 27 – Typical Condition 4/5 Crossbeam (Defect: Minor Splitting and Weathering)

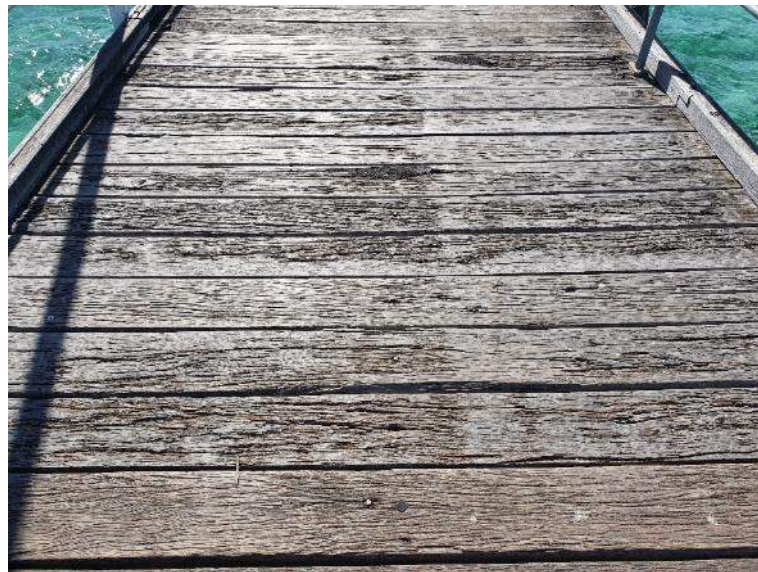
Component		Worst Case Condition Rating (number of components)						
		1	2	3	4	5	6	7
Timber Decking	No. of Components (61 Lengths Total)				2	59		
					3%	97%		
	Comments	<ul style="list-style-type: none"> • Minor splitting and weathering observed. • Local defects (holes, splitting, etc) typically filled with asphalt. • Decking timbers loose and lifted at multiple locations creating tripping hazards. 						
	Recommended Maintenance	<ul style="list-style-type: none"> • Refix/replace lifted and loose timber decking planks. • Monitor condition of timber decking to determine the appropriate timing of decking replacement.

Figure 28 – Typical Condition 4/5 Decking (Defect: Splitting, Weathering & Loose Members)

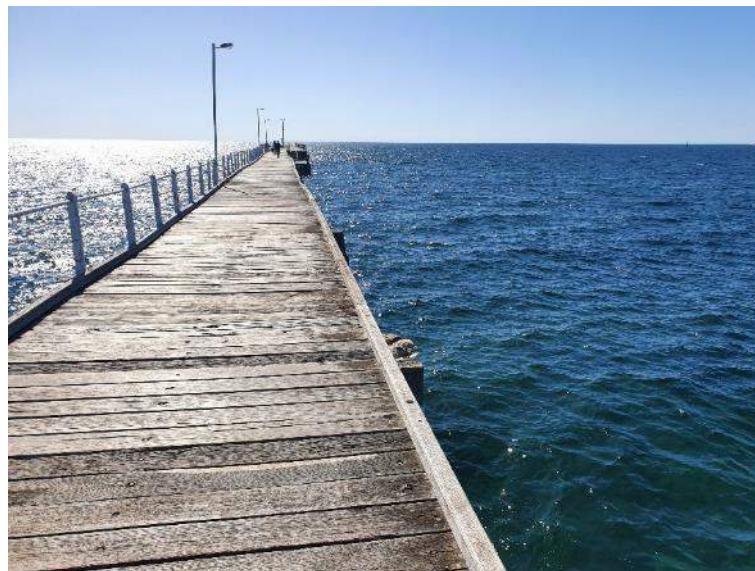
Component		Worst Case Condition Rating (number of components)						
		1	2	3	4	5	6	7
Timber Kerbing	No. of Components (61 Lengths Total)			9	52			
				15%	85%			
	Comments	<ul style="list-style-type: none"> Minor splitting and weathering observed. 						
	Recommended Maintenance	<ul style="list-style-type: none"> Monitor condition of timber kerbing to determine the appropriate timing of kerbing replacement. No immediate replacement works required.

Figure 29 – Typical Condition 3 & 4 Timber Kerbing (Defect: Weathering)

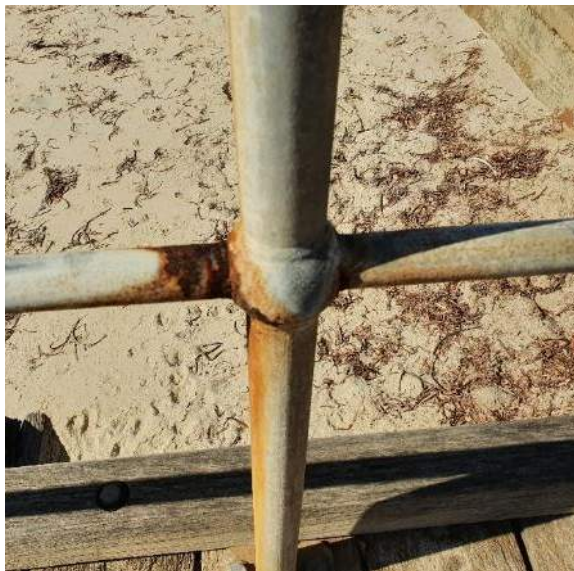
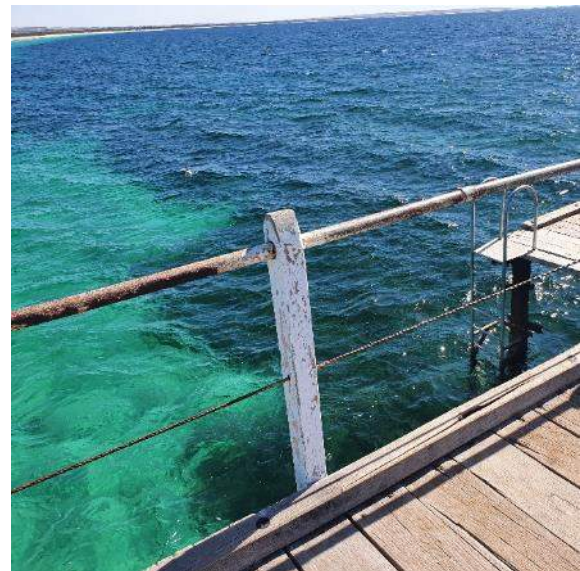
Component		Worst Case Condition Rating (number of components)						
		1	2	3	4	5	6	7
Handrailing	No. of Components (105 Lengths Total)			14	62	29		
				13%	59%	28%		
	Comments	<ul style="list-style-type: none"> • Minor surface corrosion observed on steel elements. • LHS (facing out to sea) handrail typically has timber stanchions, steel handrail and steel cable mid-rail. RHS handrail typically Monowills style system with no handrailing between bent 26 and 41. • Timber stanchions typically fixed to bearers and Monowills to decking. Loose fixings of stanchions causing large deflections, typically towards the end of the jetty. Condition rating 5 typically have loose stanchions. 						
	Recommended Maintenance	<ul style="list-style-type: none"> • Refix loose stanchions of condition rating 5 handrailing. • Monitor condition of handrailing to determine the appropriate timing of handrailing replacement.

Figure 30 – Typical Condition 4 Handrailing (Defect: Surface Corrosion)

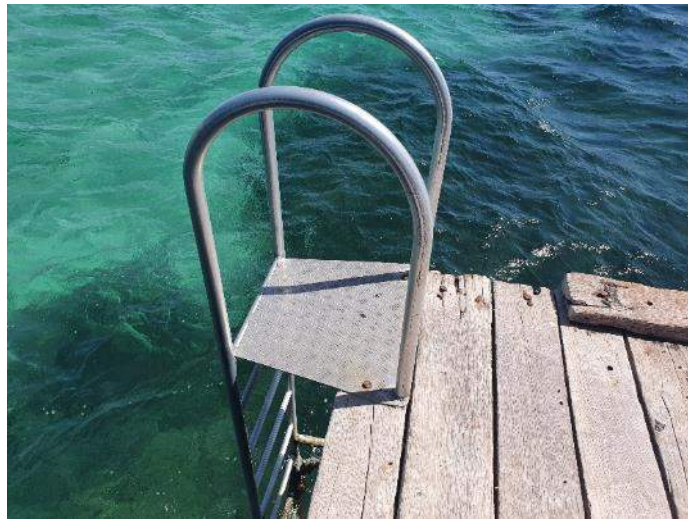
Figure 31 – Typical Condition 3 & 4 Access Ladder (Defect: Corrosion of Fixings)

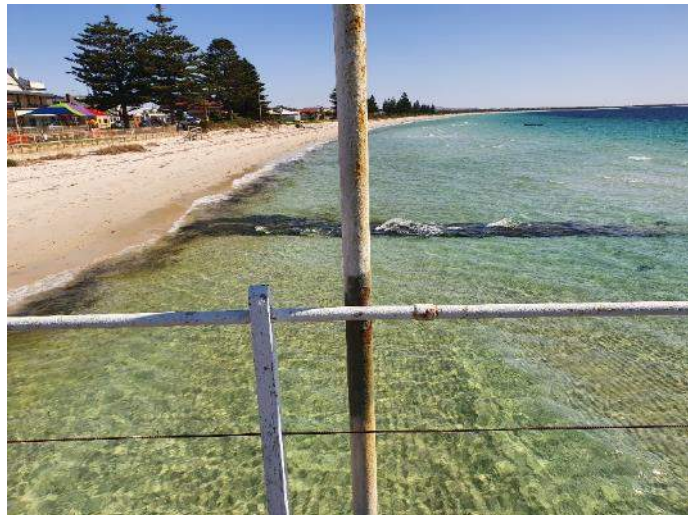
Figure 32 – Typical Condition 4 Light (Defect: Surface Corrosion)

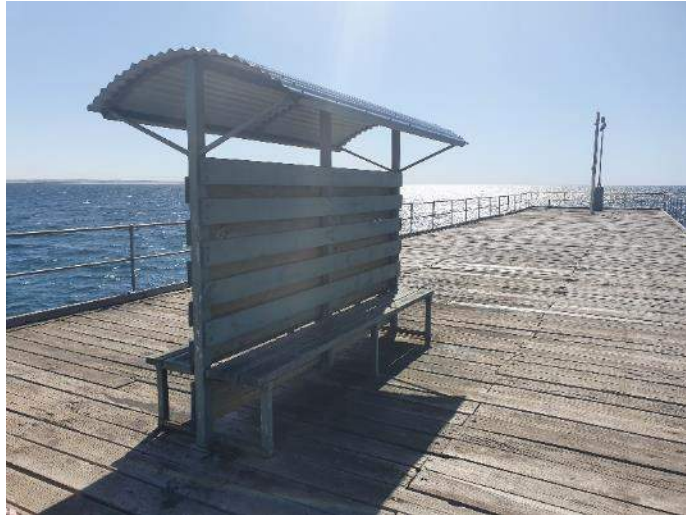
Figure 33 – Typical Condition 4 Shelter (Defect: Surface Corrosion & Weathering)

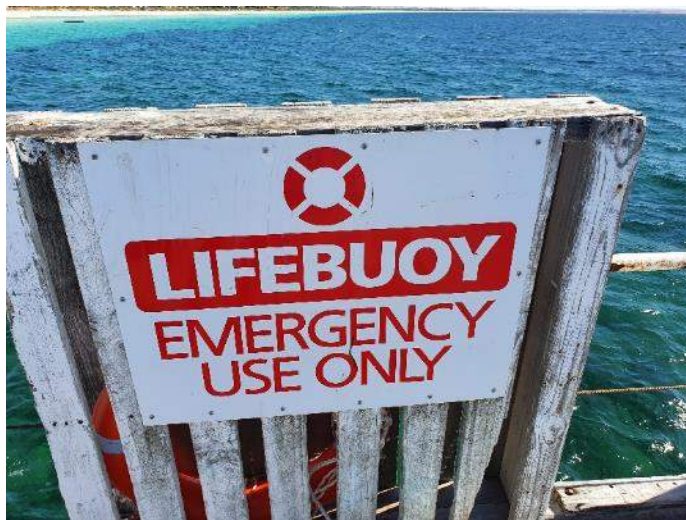
Figure 34 – Typical Condition 4 Sign (Defect: Weathering)

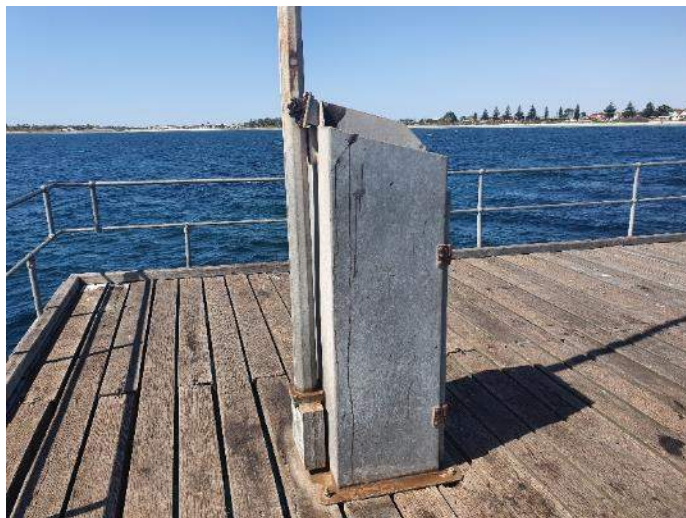
Figure 35 – Typical Condition 4 Navigation Beacon (Defect: Surface Corrosion)

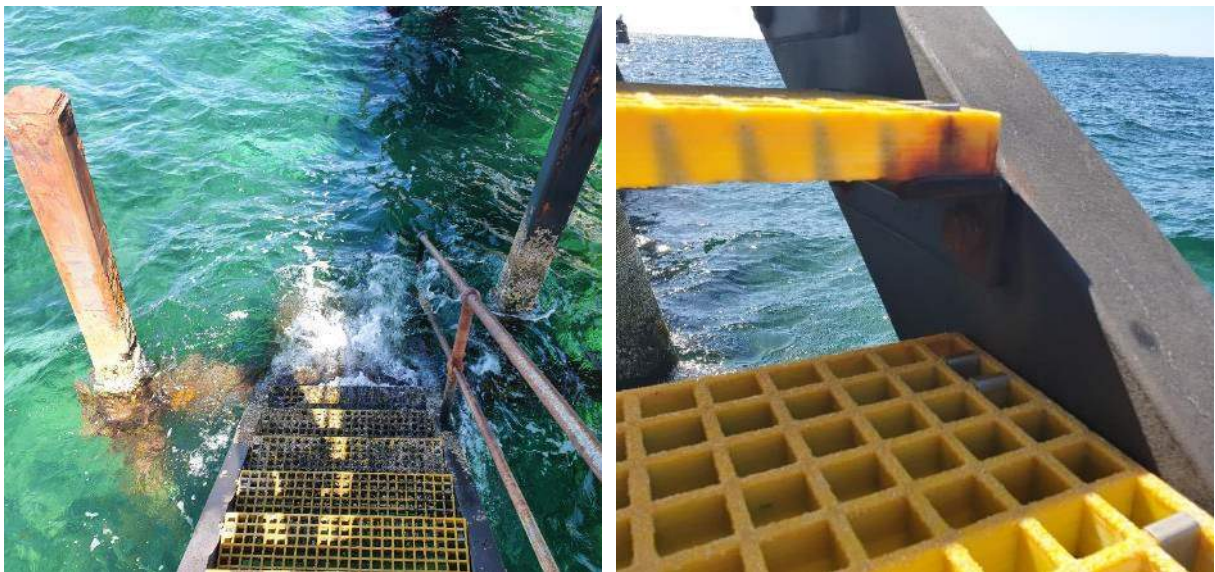
Component		Condition Rating (number of components)						
		1	2	3	4	5	6	7
Access Stairs	No. of Elements (5 Total)			2	1	2		
				40%	20%	40%		
	Comments	<ul style="list-style-type: none"> • Jetty has one access stair located at bent 24/bay 23. Treads and stringers a condition rating 3, beam a condition rating 4 and handrail and pile a condition rating 5. • Handrail and pile have both surface corrosion in the tidal zone with the pile also having delamination of steel at the pile cap. • Minor defects of FRP treads and surface corrosion of the connections to the stringers. 						
	Recommended Maintenance	<ul style="list-style-type: none"> • Replace condition 5 handrails and grit blast / repaint pile prior to excessive steel thickness loss (greater than 4.0mm). • Monitor condition 3 and 4 elements.

Figure 36 – Typical Access Stair Defects (Defect: Corrosion)

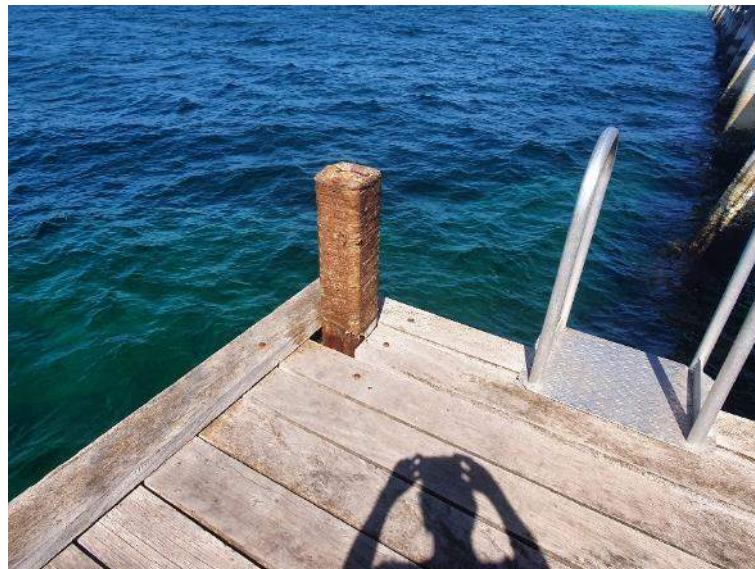
Component		Condition Rating (number of components)						
		1	2	3	4	5	6	7
Steel Landing Piles	No. of Components (5 Total)					8		
						100%		
	Comments	<ul style="list-style-type: none"> Corrosion of steel piles is typically concentrated at the crosshead support brackets, around the weld of the pile cap and in the spray zone. Pile caps of landing at bent 41-42 are wrapped in Denso tape with some delamination from the piles. Piles in landing 21-23 unwrapped. 						
	Recommended Maintenance	<ul style="list-style-type: none"> Monitor condition ra5 and grit blast / repaint prior to excessive steel thickness loss (greater than 4.0mm).

Figure 37 – Typical Condition 5 Steel Landing Pile (Defect: Surface Corrosion)

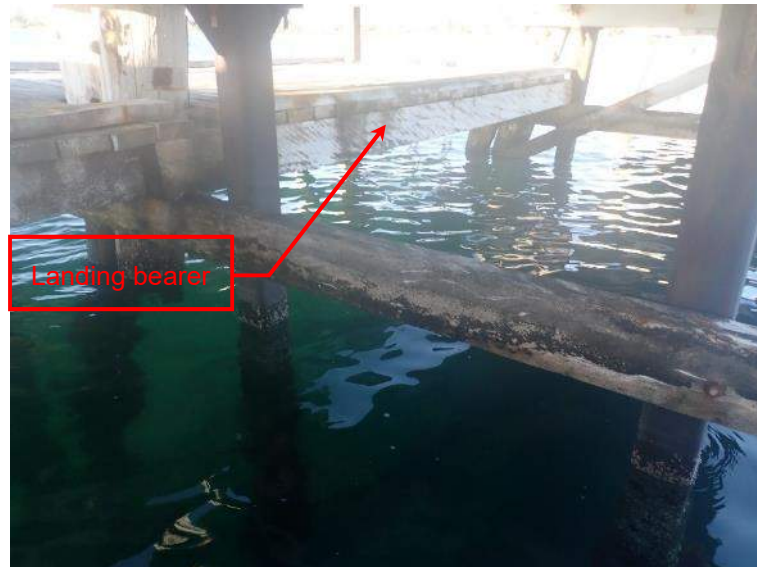
Component		Condition Rating (number of components)						
		1	2	3	4	5	6	7
Landing Bearers	No. of Components (10 Total)				6	4		
					60%	40%		
	Comments	<ul style="list-style-type: none"> Most common defect for bearers is weathering and minor splitting. 						
	Recommended Maintenance	<ul style="list-style-type: none"> Monitor condition rating 5 and below landing bearers to determine if weather and splitting defects are worsening over time.

Figure 38 – Typical Condition 4 & 5 Landing Bearer, In Rear Ground (Defect: Splitting & Weathering)

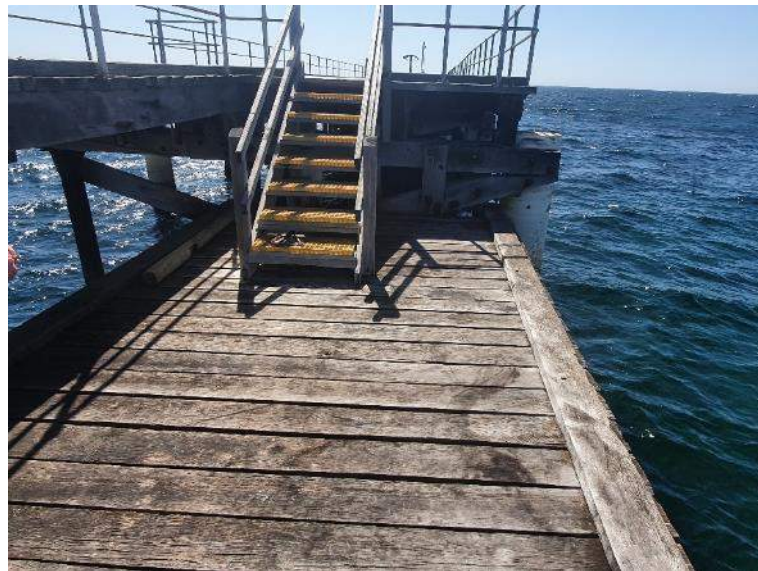
Component		Worst Case Condition Rating (number of components)						
		1	2	3	4	5	6	7
Landing Timber Decking	No. of Components (4 Lengths Total)				4			
					100%			
	Comments	<ul style="list-style-type: none"> Minor splitting and weathering observed. 						
	Recommended Maintenance	<ul style="list-style-type: none"> Monitor condition of landing timber decking to determine the appropriate timing of decking replacement. No immediate replacement works required.

Figure 39 – Typical Condition 4 Decking (Defect: Splitting & Weathering)

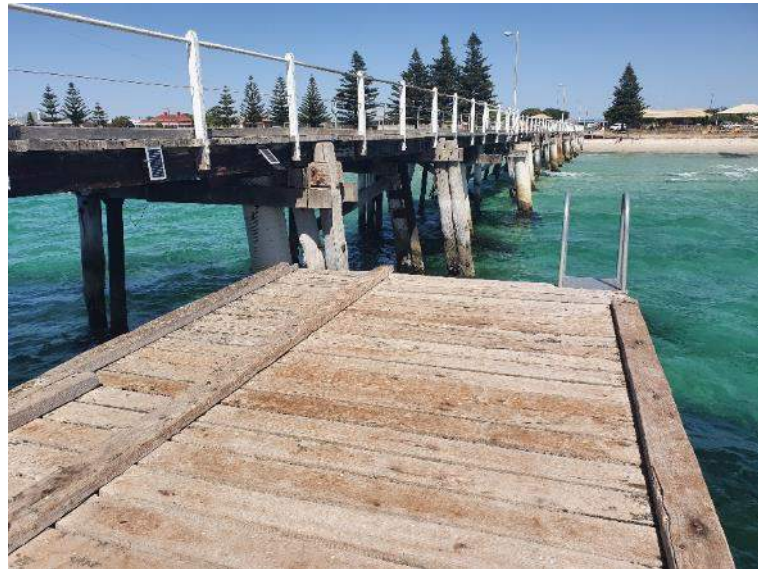
Component		Worst Case Condition Rating (number of components)						
		1	2	3	4	5	6	7
Landing Timber Kerbing	No. of Components (61 Lengths Total)				2	2		
					50%	50%		
	Comments	<ul style="list-style-type: none"> Minor splitting and weathering observed. 						
	Recommended Maintenance	<ul style="list-style-type: none"> Monitor condition of timber kerbing to determine the appropriate timing of kerbing replacement. No immediate replacement works required.

Figure 40 – Typical Condition 4 & 5 Timber Kerbing (Defect: Splitting & Weathering)

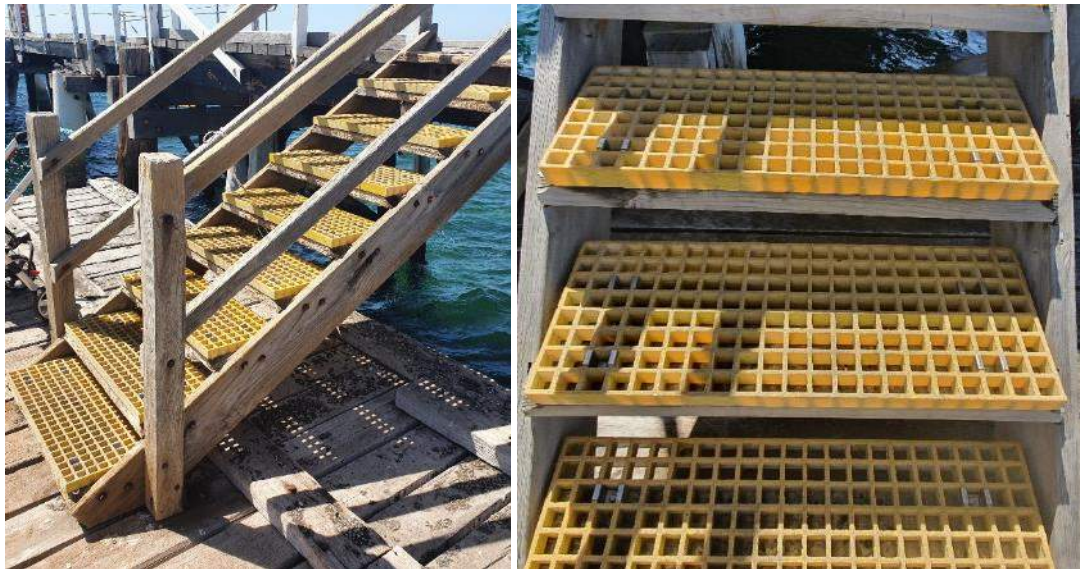
Component		Condition Rating (number of components)						
		1	2	3	4	5	6	7
Landing Stairs	No. of Elements (5 Total)			2	4			
				33%	67%			
	Comments	<ul style="list-style-type: none"> The jetty has two landing stairs, one per landing. Treads a condition rating of 3 and handrail and stringers a condition rating of 4. Handrails and stringer are timber and typically showing signs of weathering Minor defects of FRP treads and surface corrosion of the connections to the stringers. 						
	Recommended Maintenance	<ul style="list-style-type: none"> Replace condition 5 handrails and grit blast / repaint pile prior to excessive steel thickness loss (greater than 4.0mm). Monitor condition of stairs to determine the appropriate timing of element replacement. No immediate replacement works required.

Figure 41 – Typical Landing Stair Defects (Defect: Weathering)

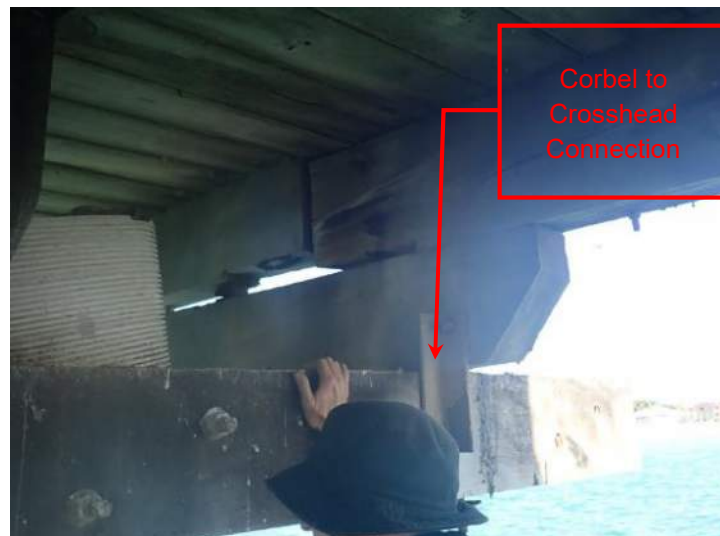
Figure 42 – Typical Bearer to Crosshead Connection

- At a few locations, the corbels do not have a vertical hold-down fixing directly into the crosshead or the connection is ineffective due to splitting around fixing. Where this occurs an angle bracket with a single bolt through the side of each member is used, refer to Figure 42. This connection is susceptible to rollover and prying of the bolt when subjected to large lateral and longitudinal forces during a storm event and is not recommended. Instead the steel angle should run full height of the corbel and crosshead and have multiple bolts per member.

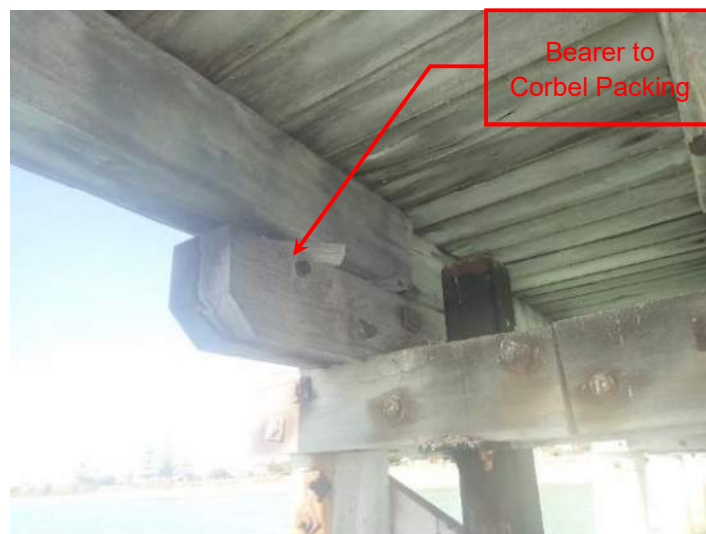
Figure 43 – Typical Bearer and Corbel Timber Packing

- Timber packing has been installed between the corbels and bearers at numerous locations along the jetty. The packing is non-uniform and causes the bearers to be supported on a small, uneven areas (refer to Figure 43). This has the potential to cause the bearers to roll during storm events and also exposes the thread of the bolts in the connection which exacerbates corrosion.

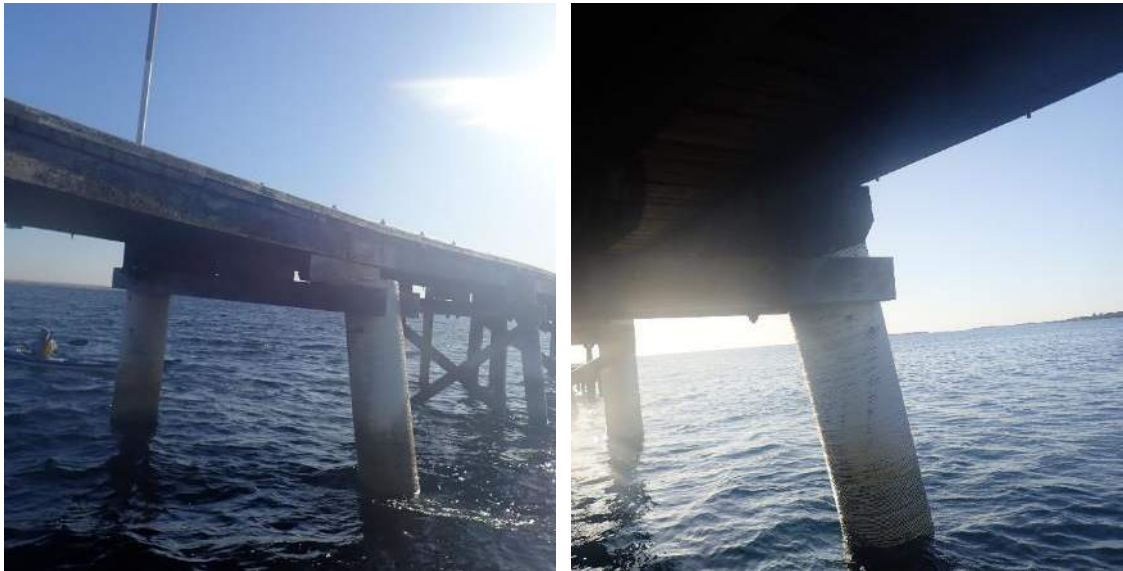
Figure 44 – Raking of Concrete Piles

- Concrete piles along the RHS of the jetty within the central bents (bents 25-40) rake outwards varying amounts, refer to Figure 44. The raking piles correlate with undulating decking as well as bearers that are out of square and not parallel between bays. It appears that sections of the jetty have subsided and deflected towards the north. From the above waterline inspection, it appears that this could be caused by insufficient geotechnical capacity of the piles, lateral stability/strength or overall structural capacity in the area. Further investigation from the underwater shows that the raking has been caused by in impact, most likely by a vessel. As per the condition rating in the report a new steel pile is to be driven adjacent to concrete pile and the above bay and bent of timber members realigned.
