Tumby Bay Jetty Options Investigations

District Council of Tumby Bay

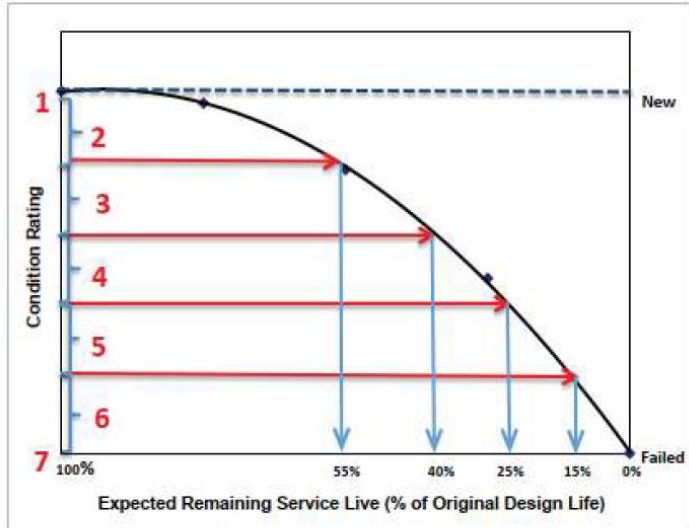
Figure 9: Indicative Design Life Curve (WSCAM 2022)
