<b>COMPANY NAME</b>	District Council of Tumby Bay
<b>ATTENTION</b>	Damian Windsor
<b>SUBJECT</b>	Tumby Bay Jetty Storm Damage

### 1. INTRODUCTION

This memorandum is to summarise the inspection of the storm damage and high-level assessment of the Tumby Bay jetty that was completed by Wallbridge Gilbert Aztec (WGA) for the District Council of Tumby Bay (Council). From this inspection, the risks associated with the current condition of the structure and required remedial works are to be conveyed to Council to inform the ongoing use of the jetty.

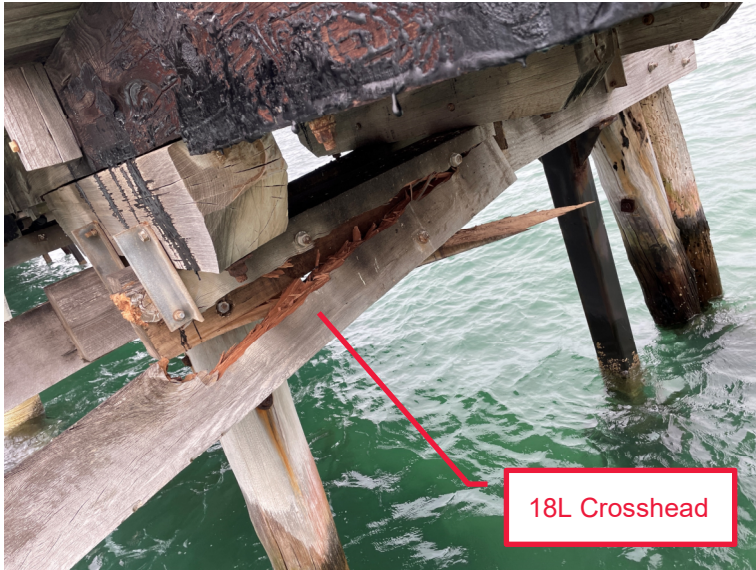
COMPONENT	LOCATION <sup>[1]</sup>	PREVIOUS CONDITION RATING <sup>[2]</sup>	NEW CONDITION RATING	COMMENTS
<b>Crosshead</b>	18L	4	7	<ul style="list-style-type: none"> <li>Northern member of spliced crosshead significantly split, rotated and broken along full length.</li> <li>Southern member split and broken around bolts.</li> <li>Damage of crosshead due to failure of 18A pile.</li> <li>Corbel 18A also dropped and detached due to movement of crosshead.</li> <li>Refer to Figure 1 and Figure 2.</li> </ul>
<b>Crosshead</b>	18S	5	6	<ul style="list-style-type: none"> <li>Splitting of member at northern end due to failure of 18A pile.</li> <li>Bolts connected to 18A pile sheared off.</li> <li>Refer to Figure 3.</li> </ul>
<b>Pile</b>	18A	4	7	<ul style="list-style-type: none"> <li>Pile failed, dropped and rotated.</li> <li>Failure appears to have occurred below waterline, most likely at the base of the pile.</li> <li>Refer to Figure 4 and Figure 5</li> </ul>

**Figure 1: Bent 18L Crosshead Splitting and Failure**

- Concrete Encased Piles: Install new 200x16 steel SHS (or equal approved) sister pile.
- Concrete Crosshead: Install new twin 300mm deep x 150mm wide crosshead.
- Timber Components: Like-for-like replacement.

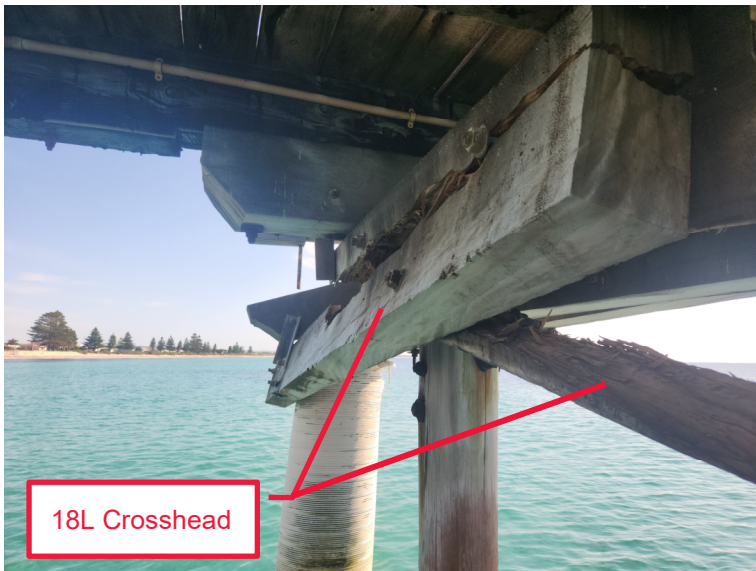
**Figure 2: Bent 18L Crosshead Splitting, Rotation and Failure**

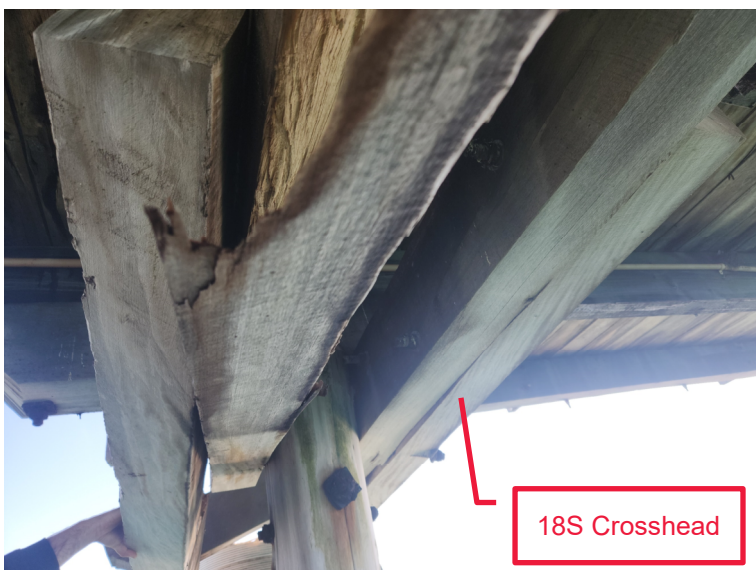
**Figure 3: Bent 18S Crosshead Splitting**

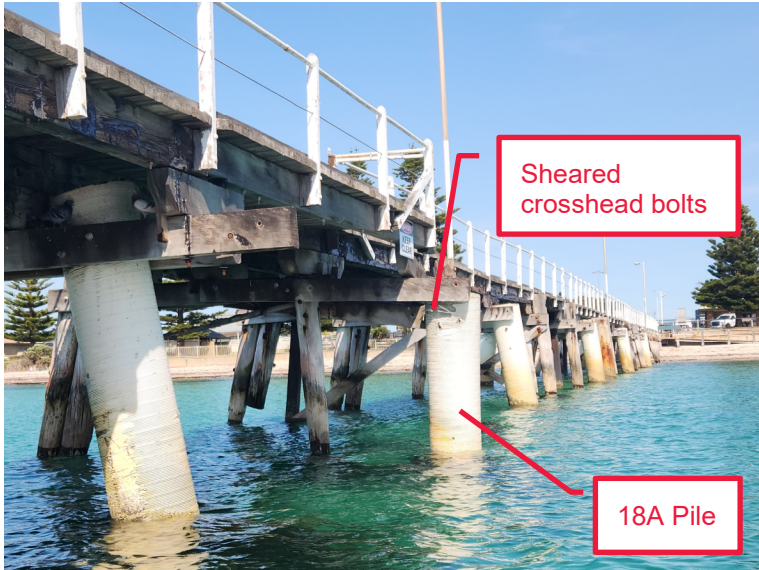
**Figure 4: Bent 18A Pile Failure and Dropping**

It appears that the failure of the concrete encased piles (and connected structural members) outlined in Table 1 is likely due to shear failure of the concrete piles at their base. From what has previously been observed from the diver's inspection, the concrete and sleeves terminate above seabed which has resulted in the encased timber pile being exposed in this zone, allowing it to further deteriorate and eventually fail. The concrete filled sleeves also have the detrimental effect of increasing the tributary area of the pile and in turn the wave and current force imparted on the pile.

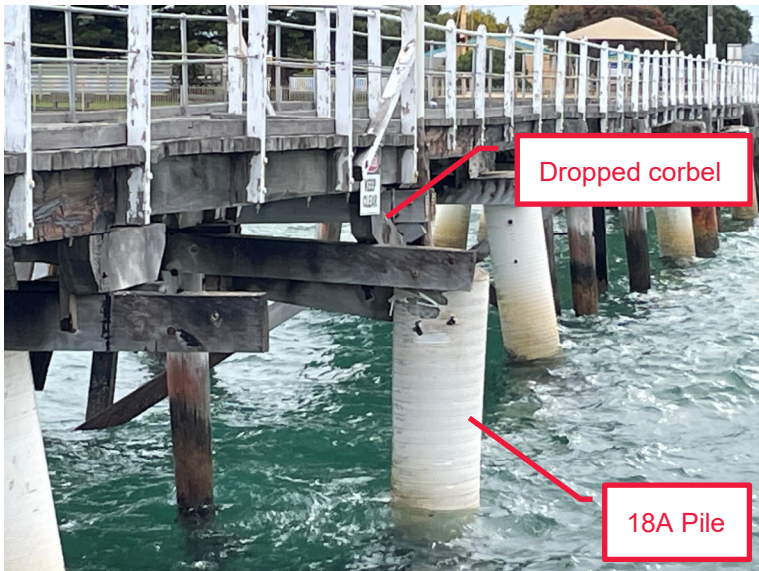
**Figure 5: Bent 18A Pile Failure and Dropping**

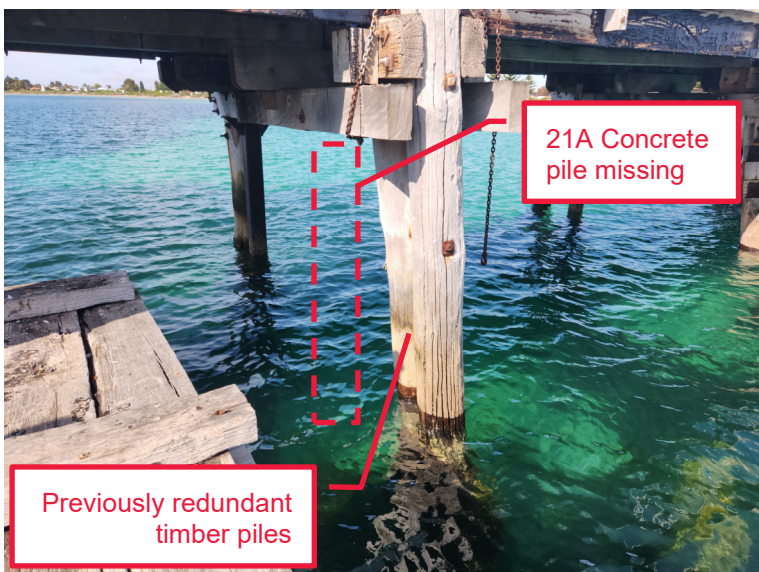
<b>Pile</b>	21A	4	7	<ul style="list-style-type: none"> <li>According to Council, pile previously failed at seabed and was hanging from crosshead. Pile was demolished due to safety concerns.</li> <li>Area is currently unsupported due to only redundant timber piles in area.</li> <li>Refer to Figure 6.</li> </ul>
<b>Pile</b>	25B	4	7	<ul style="list-style-type: none"> <li>Pile failed, dropped and rotated. Failure appears to have occurred below waterline, most likely at the base of the pile.</li> <li>Failure of the pile has caused the connected stairs to drop and rotate.</li> <li>Refer to Figure 7 and Figure 8</li> </ul>

**Figure 6: Bent 21A Pile Missing and Redundant Timber Pile**

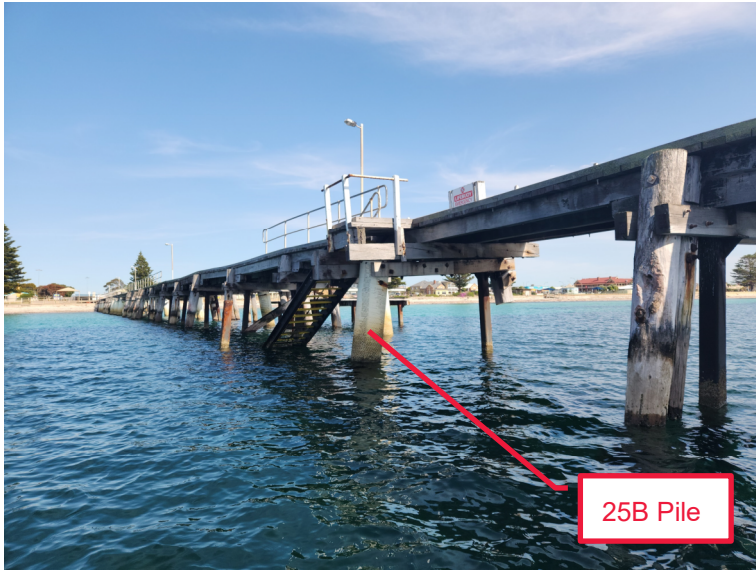
**Figure 7: Bent 25B Pile Failure**

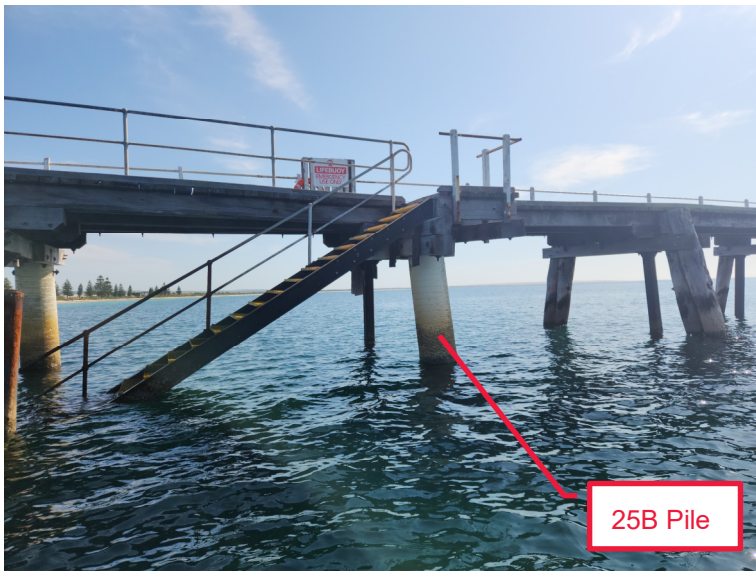
**Figure 8: Bent 25B Pile Failure and Rotation**
