Tumby Bay Foreshore Protection Consultancy Services

Final Concept Design Report

Client: District Council of Tumby Bay

28-Feb-2014

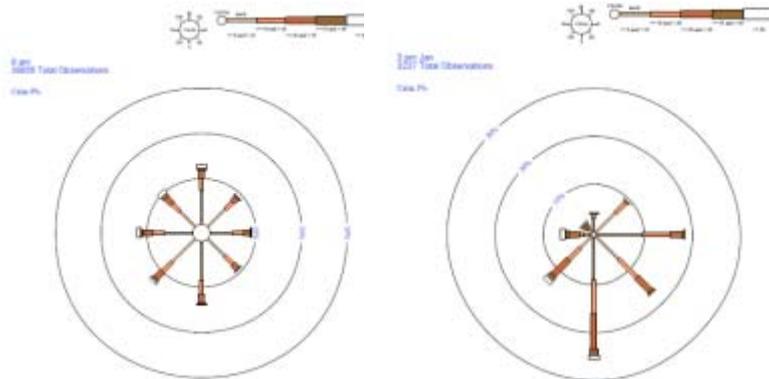
Figure 3 Annual wind roses at North Shields (Port Lincoln). Left panel shows winds (9 am) and the right panel shows winds at 3 pm (Source: Bureau of Meteorology).

The annual wind distribution patterns at a location (North Shields) closest to the study site are shown in Figure 2 where the 9 am winds blow from virtually all directions but the east, south-east to south-west winds are dominant at 3 pm.

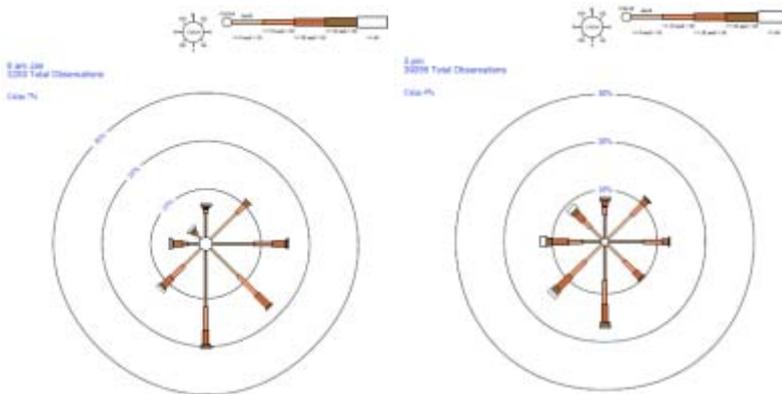
Figure 4 Summer wind roses at North Shields (Port Lincoln). Left panel shows winds (9 am) and the right panel shows winds at 3 pm (Source: Bureau of Meteorology).

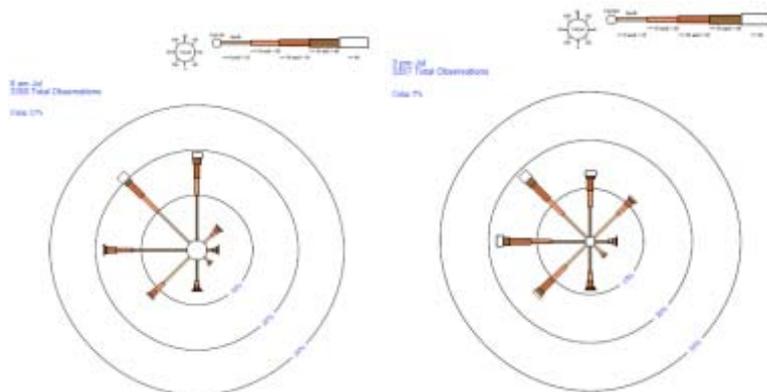
Figure 5 Winter wind roses at North Shields (Port Lincoln). Left panel shows winds (9 am) and the right panel shows winds at 3 pm (Source: Bureau of Meteorology).

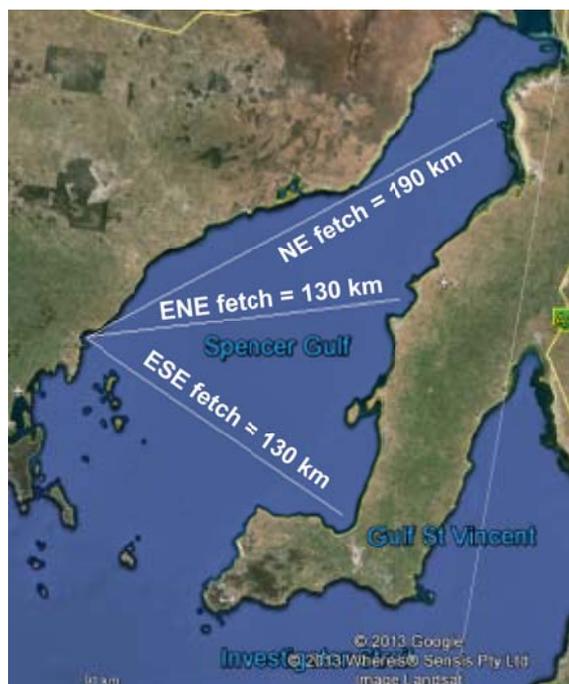
Figure 6 Available fetches at the study site

Whilst swell and wind waves from the Southern Ocean may not have a significant impact on Tumby Bay, the study site will experience large waves generated by strong winds in the Spencer Gulf. The study site is exposed to large fetches of up to 190 km from the northeast and about 130 km from the east and east-south-east as shown in Figure 6.

Using the fetches shown in Figure 6, and the extreme winds from the Australian Standard AS1172.2 wind code, the wind-waves generated by 50, 100, and 500 year ARI winds were calculated. The simple wind-growth functions (SPM, 1984) were employed to compute the wind-waves. The 3-s gust from AS1172.2 was converted to a mean-hourly wind speed required for wave generation. Directional factors (0.8 for NE and ENE) were applied to the wind speed. An average water depth across the fetch length was assumed. Table 1 presents the results of the wind-wave analysis.

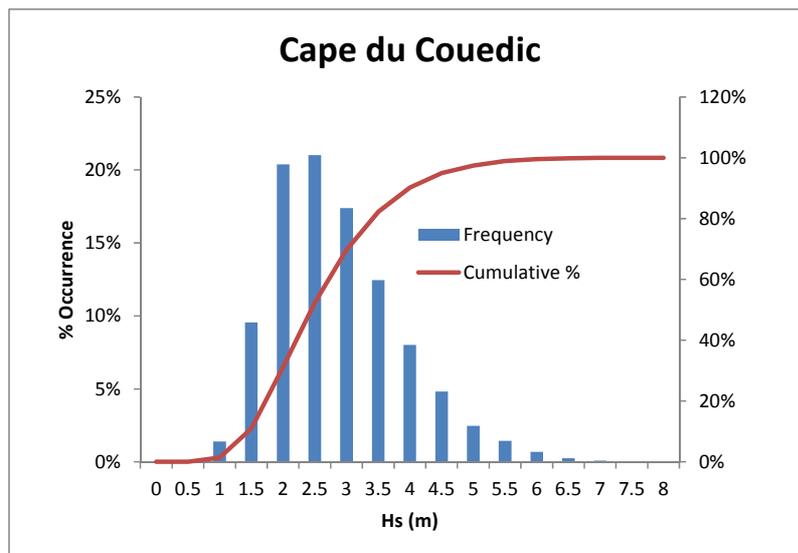
Figure 7 Histogram of wave height distribution at Cape du Couedic (Kangaroo Island).

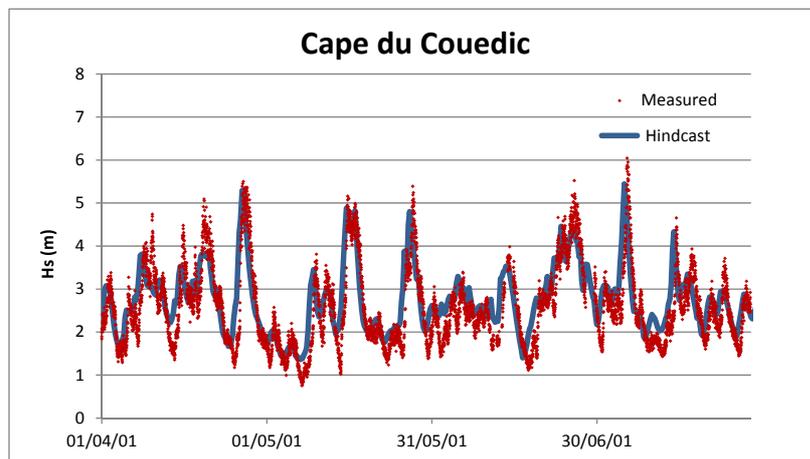
Figure 8 Recorded data (red) and hindcast (global model) at Cape du Couedic (Kangaroo Island).

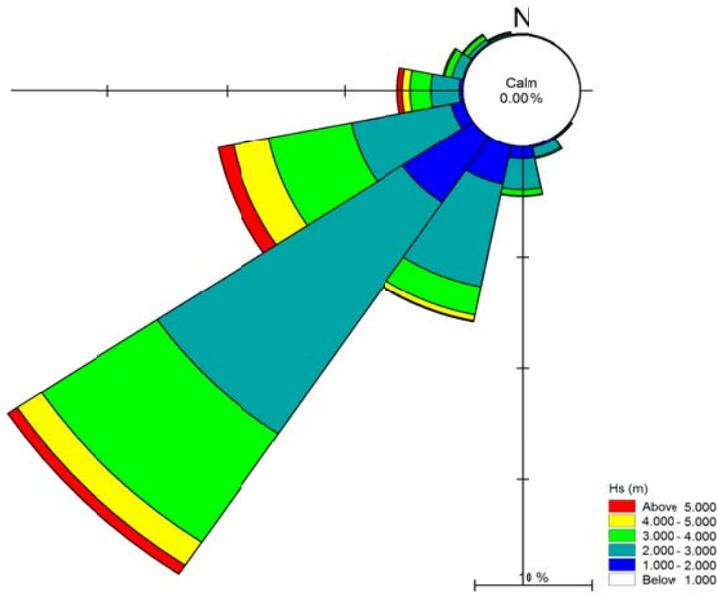
Figure 9 Wave rose using global hindcast data at Cape du Couedic (Kangaroo Island).

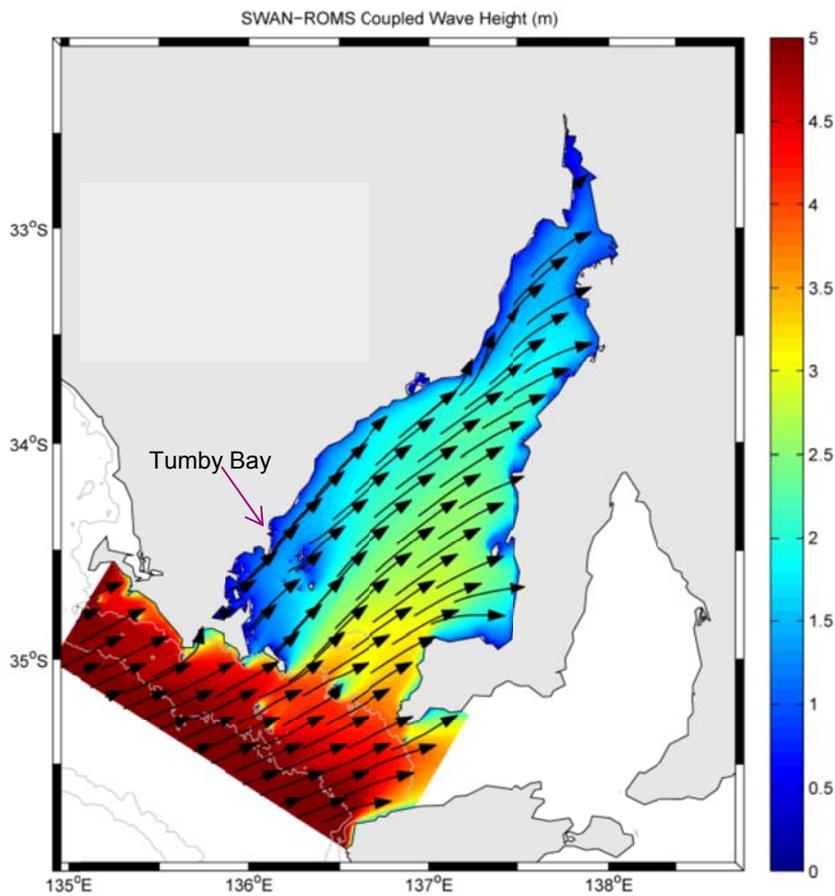
Figure 10 Wave model of Spencer Gulf

A wave model developed by Middleton et al (2012) shows that a southwest significant wave height of 5 m at the mouth will reduce to less than 1 m as it reaches Tumby Bay (Figure 10).

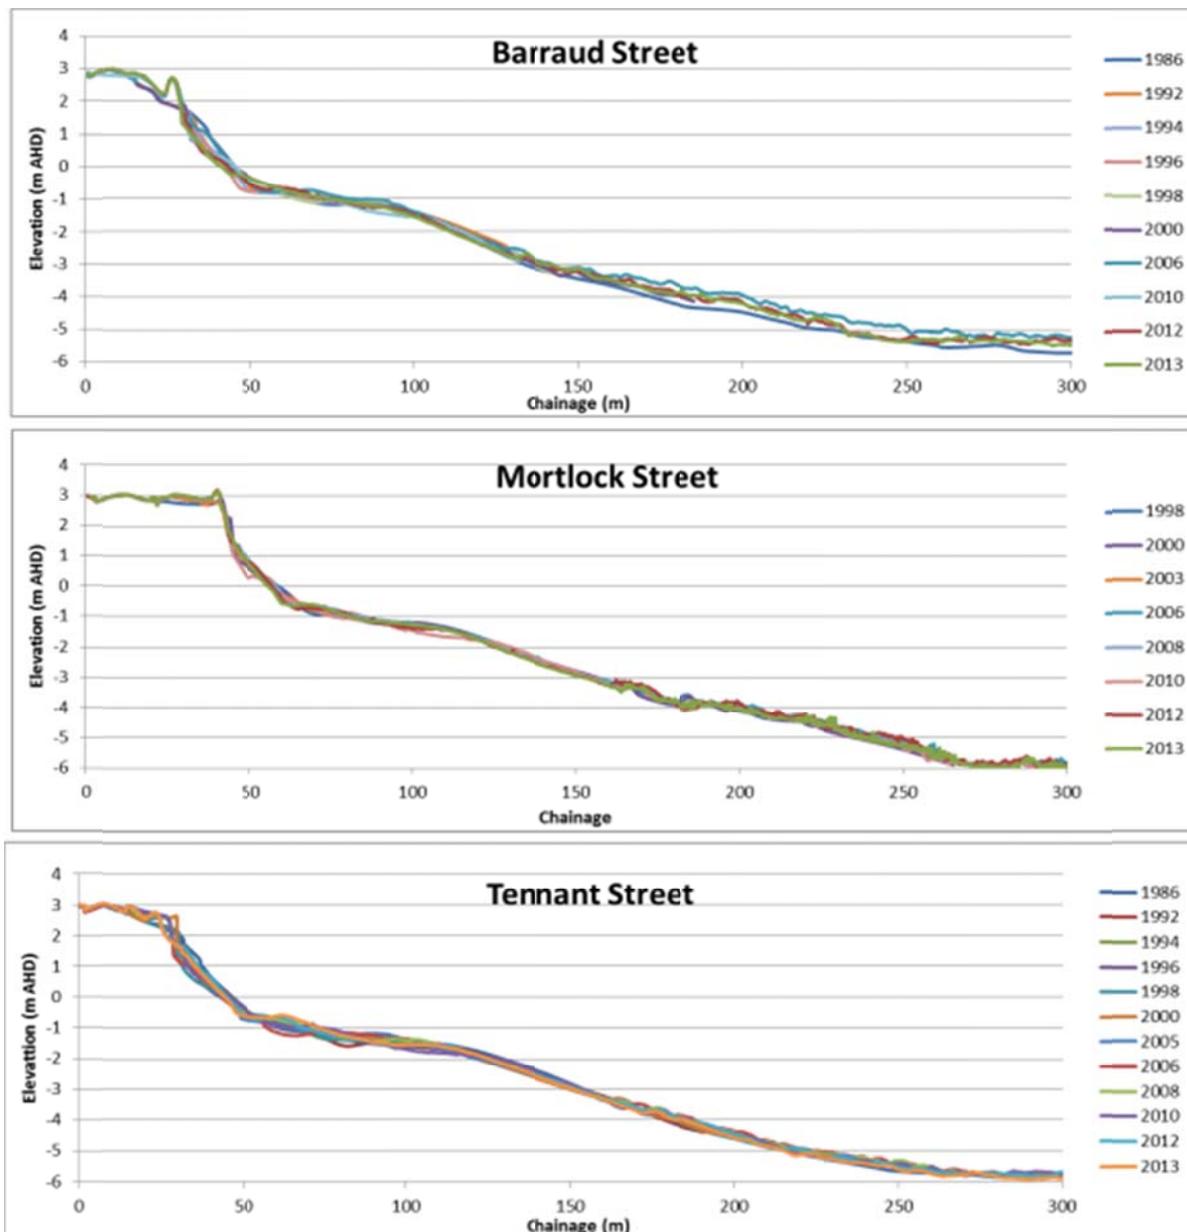
Figure 11 Measured beach profiles at Barraud Street (upper), Mortlock Street (middle), and Tennant Street (lower).

There was considerable loss of sand from the upper beach at Barraud Street between 2006 and 2013 as shown in Figure 11 (top panel). The changes at Mortlock Street (110 m north of the Jetty) are less dramatic than those at Barraud Street. The measured beach profiles (Figure 11, middle panel) show that the dune and upper beach face eroded between 2000 and 2006 but since then has accumulated some sand. There have been several changes in beach profile at Tennant Street (450 m north of the Jetty) indicating the movement of sand across and along the beach. The profile shows that the berm progressively receded by 5 m between 2000 and 2013. All three profiles generally show little sand movement below -4 m AHD.

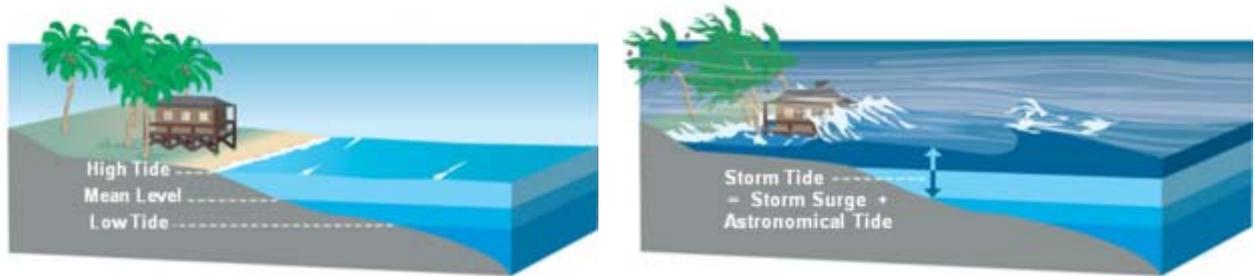
Figure 12 Illustration of how storm surges, astronomical tides and sea level rise influence coastal water levels.

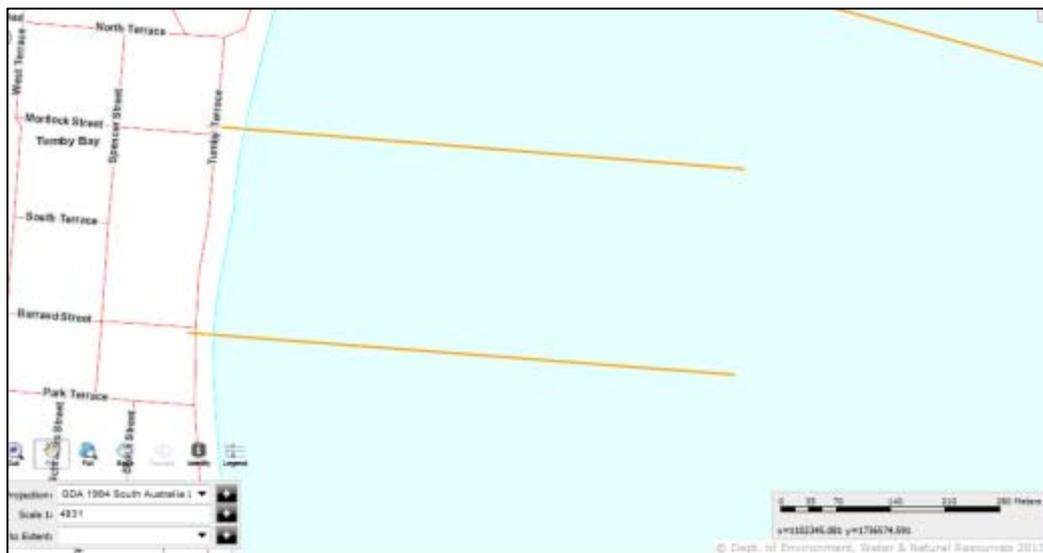
Figure 14 Map showing location of coastal profiles

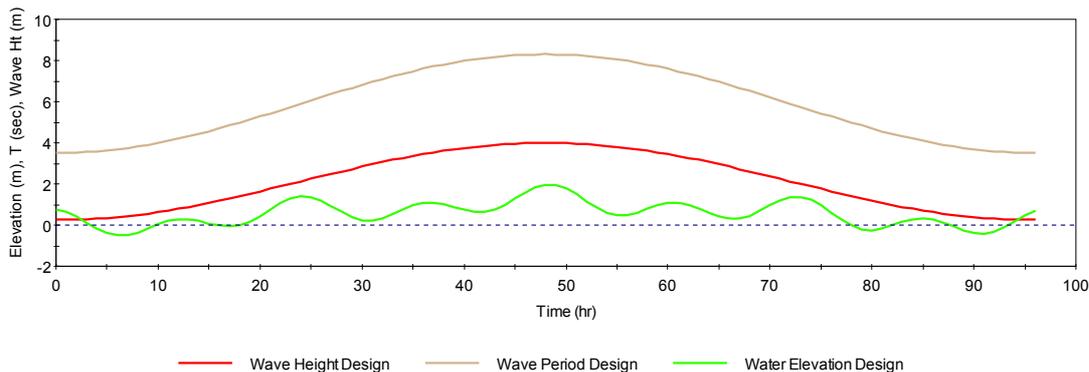
**Figure 15 Synthetic 100 year ARI design storm**

A synthetic design storm representing a 100 year ARI storm was developed. A storm duration of 96 hours was assumed in which the wave height and wave period increase in a sinusoidal progression up to the peak storm design value after 48 hours and then reduce to non-storm conditions in the following 48 hours. The peak design wave and water level conditions for the 100 year ARI storm event from Table 1 and Table 5 respectively were adopted. The design water level was composed of a spring tide superimposed with a design storm surge such that the maximum water level was the same as the 100 year ARI water level of 1.95 m AHD. The wave set-up and run-up was not included since the model computes these parameters.

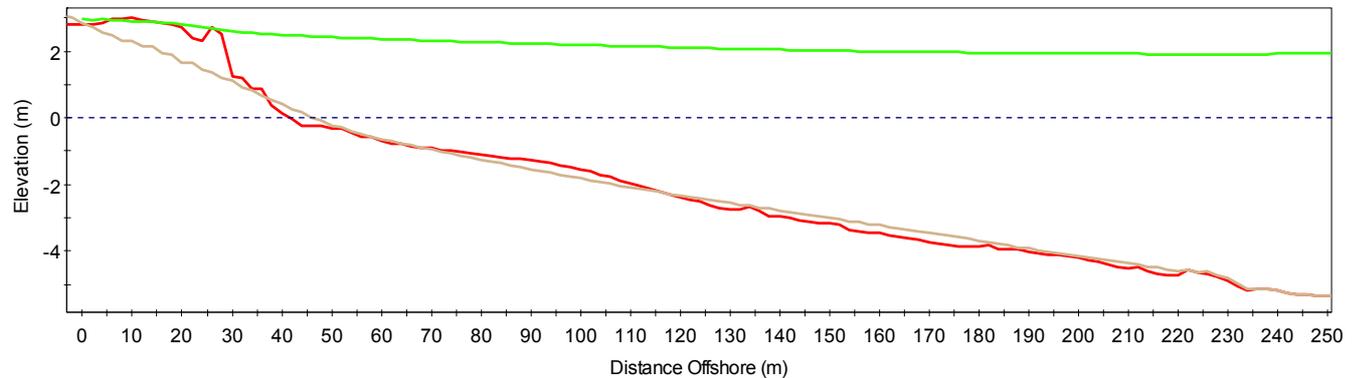
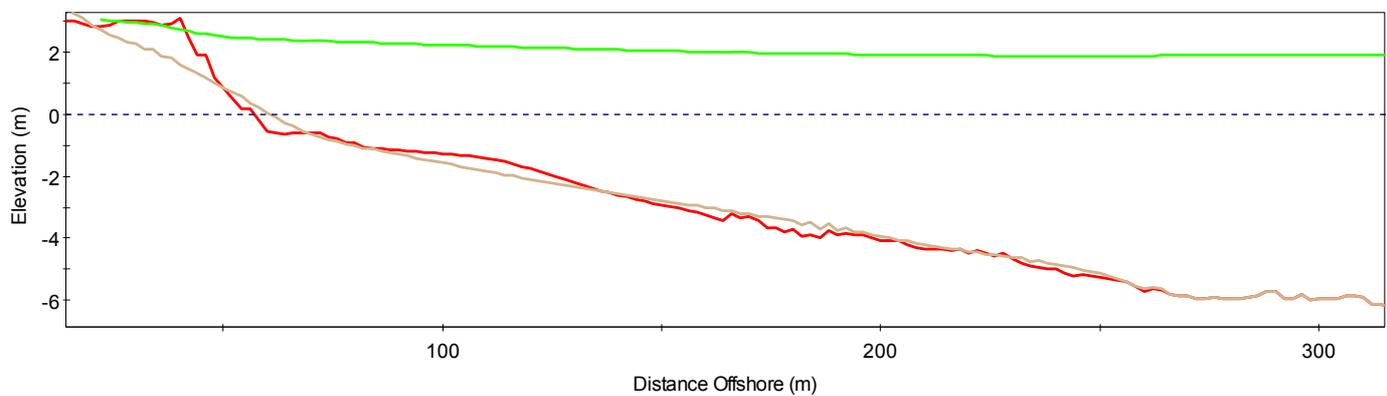
— Initial Profile: P1-Barraud, Design - 96 hr — Final Profile: P1-Barraud, Design - 96 hr — Max Water Elev+Setup: P1-Barraud, Design - 96 hr

— Initial Profile: P2-Mortlock, Design - 96 hr — Final Profile: P2-Mortlock, Design - 96 hr — Max Water Elev+Setup: P2-Mortlock, Design - 96 hr

Figure 16 Beach response due to 100 year ARI storm without protection from sea wall. Upper panel is profile at Barraud Street, and lower panel shows profile at Mortlock Street.

The maximum water surface elevations (including wave set-up) and the beach recession in response to the 96-hour 100 year ARI storm are presented in Table 7 and Figure 16 and Figure 17 for the above two scenarios. The model predicts that the beach at the Barraud Street location may recede by up to 21 m if there is no seawall or if an existing sea wall affords no protection due to overtopping or damage. The beach recession is predicted to reduce to 6 m (Table 7) at this location if there is a seawall, which does not fail.

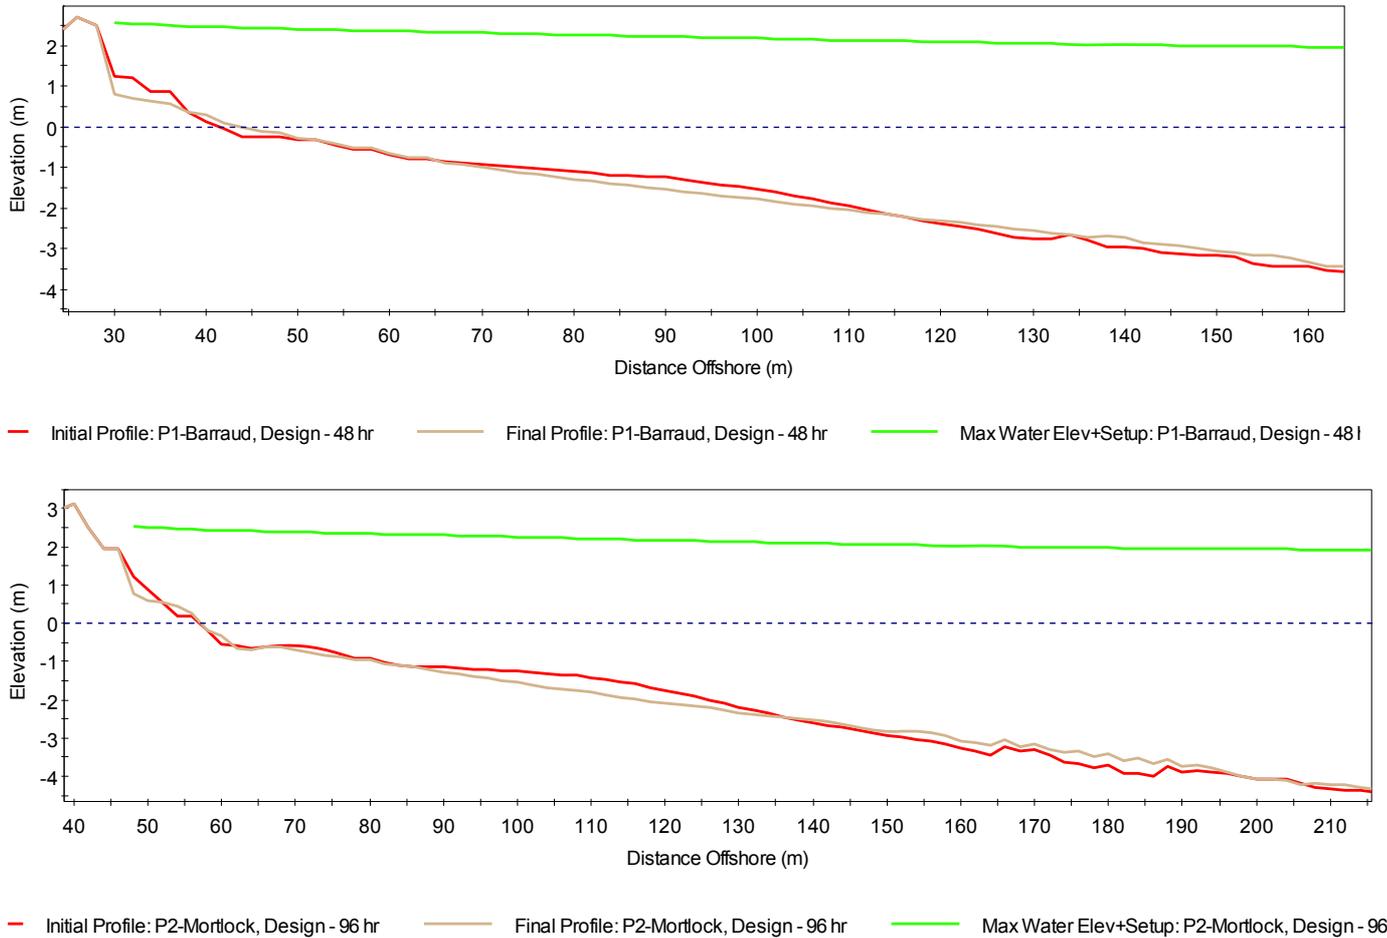
Figure 17 Beach response due to 100 year ARI storm with protection from sea wall. Upper panel is profile at Barraud Street, and lower panel shows profile at Mortlock Street.

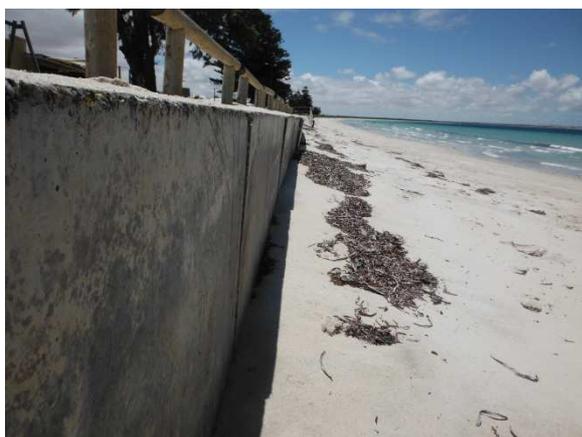
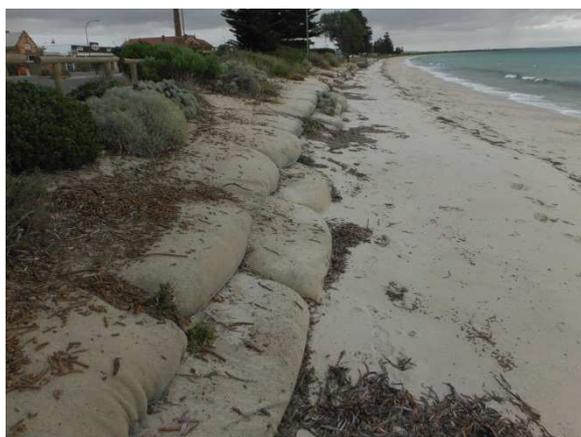
The 'ElcoRock' wall system is present where sections of the concrete panel seawall have failed and required remediation. The remaining concrete panel seawall is in poor condition with rotation of approximately 10° from vertical at some locations (Photograph 1A). Significant spalling and cracking of the concrete wall was also observed.

Photograph 1A and 1B: The existing concrete seawall is in poor condition (left), and ElcoRock wall (right).

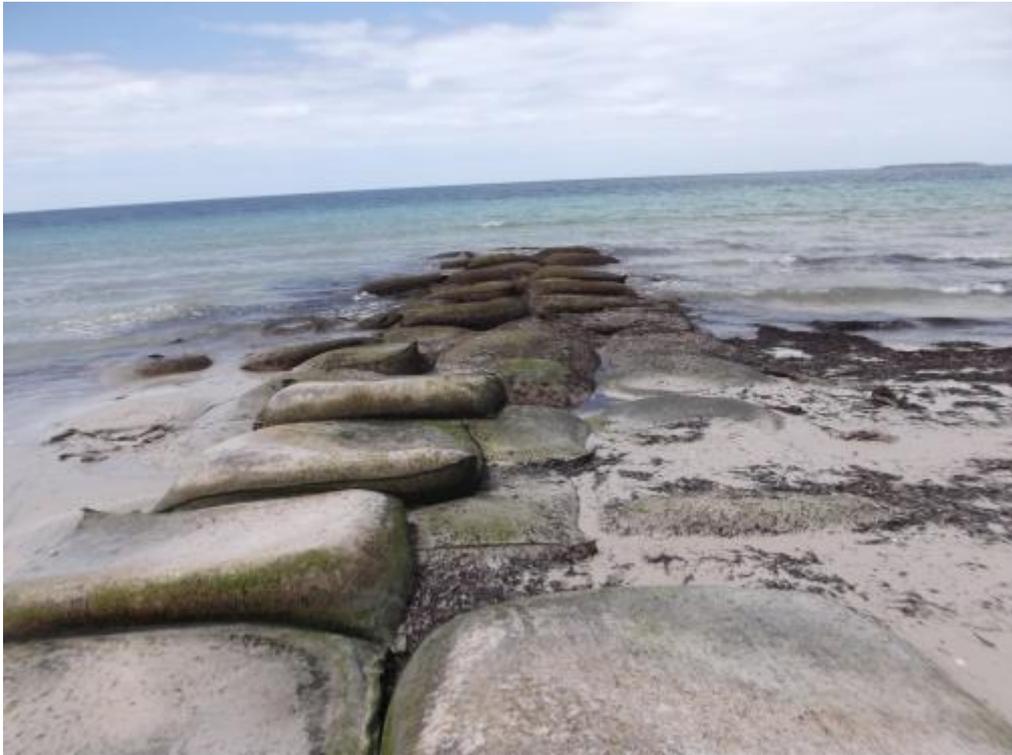
Figure 18 Existing Sand Groyne at north end of beach

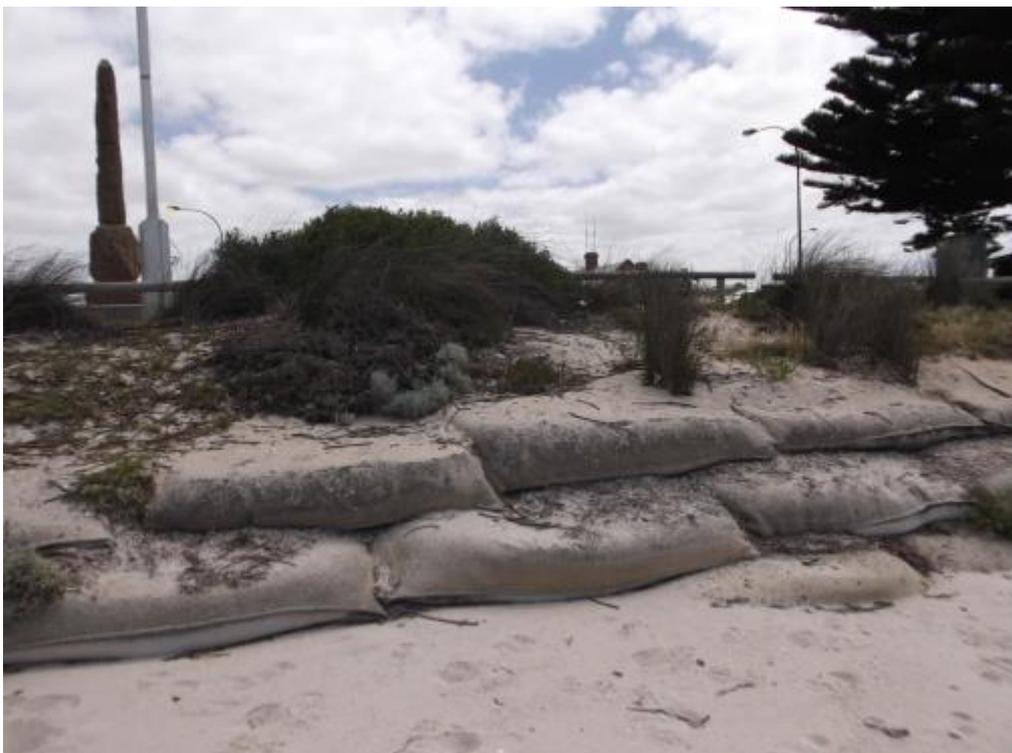
Figure 19 Existing Elcorock Sea Wall Showing Revegetation

- The 'Elcorock' sand bag revetment wall adjacent to the playground was in good condition showing little signs of erosion and appears to have provided reasonable performance for its eight years of service.

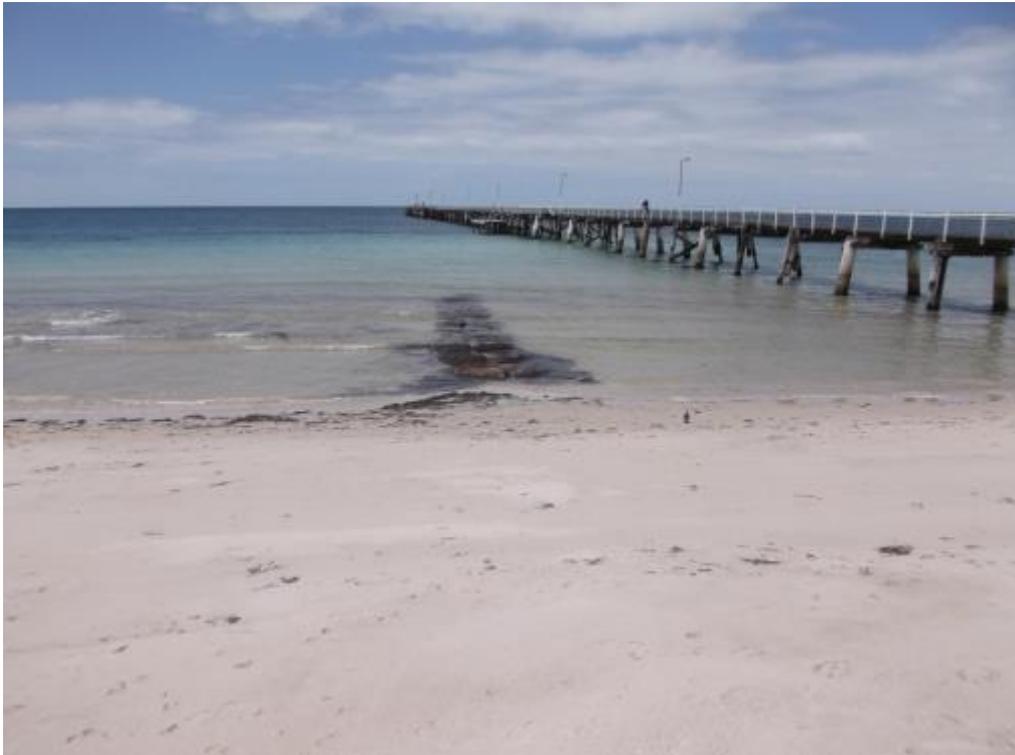
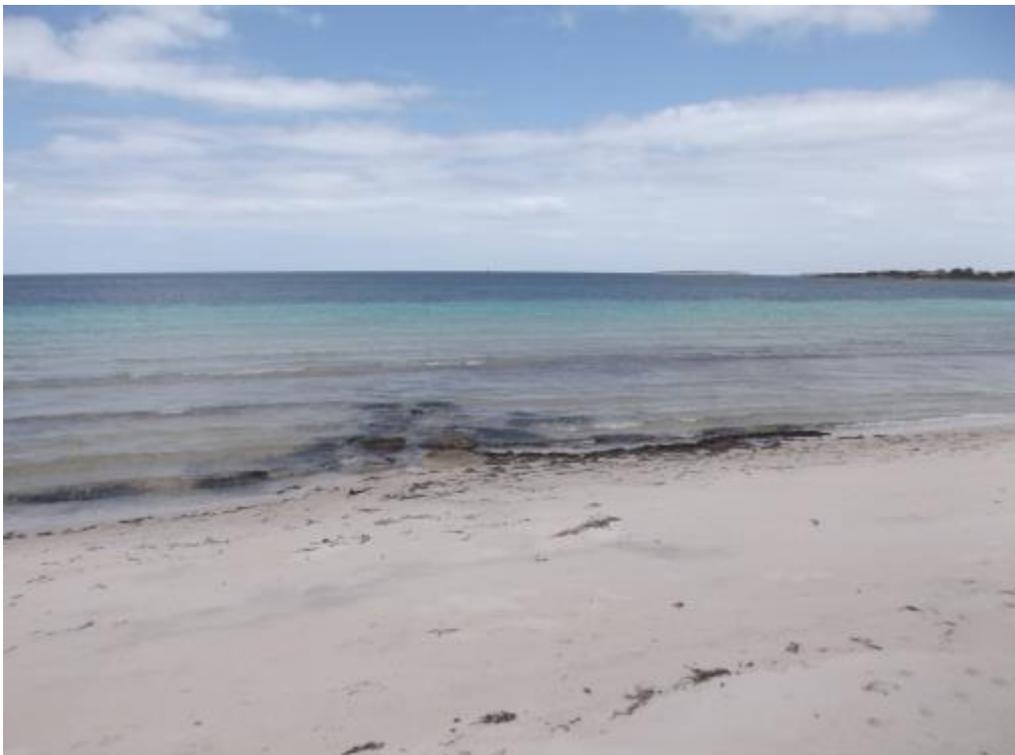
Figure 20 Existing sand groynes North and South of Jetty

- The three lateral sand groynes were evident approximately 50m south and 40m north of the jetty and at the north end of the township.
- The top of the two southern sand groynes were largely below the low water mark and well down the beach and are largely at the end of their useful life and ineffective, whereas the northern one was further out of the water and extended further up the beach, however no discernible change in sand levels on either side of the bag indicating the groynes in their current condition are ineffective in controlling littoral drift.

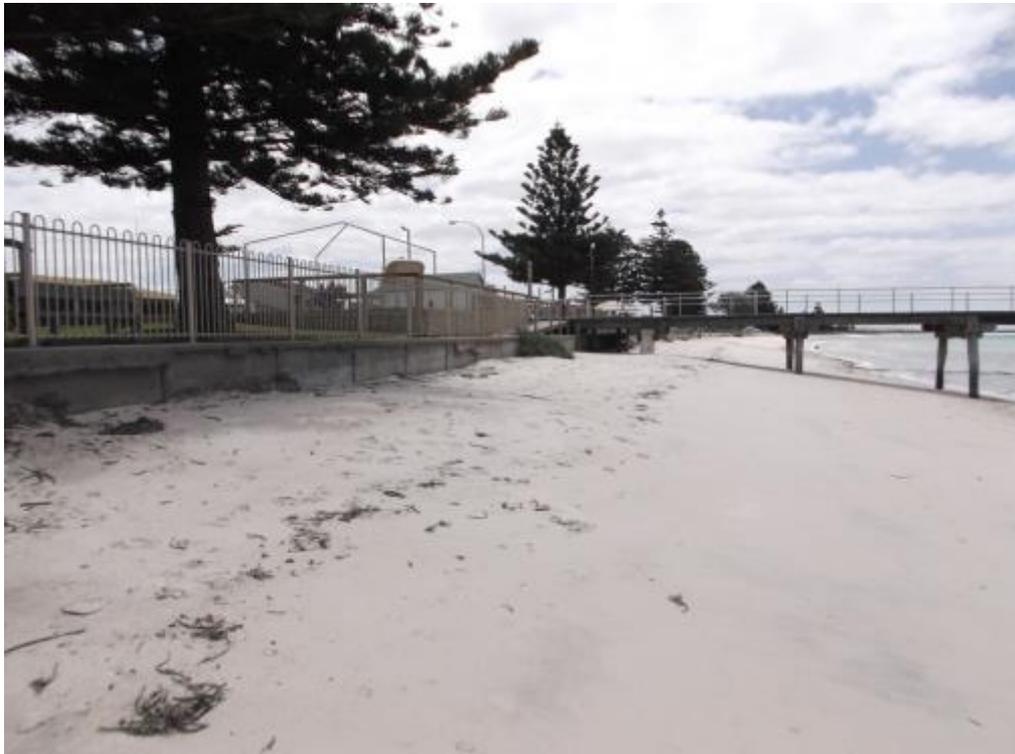
Figure 22 Example of upper beach profile

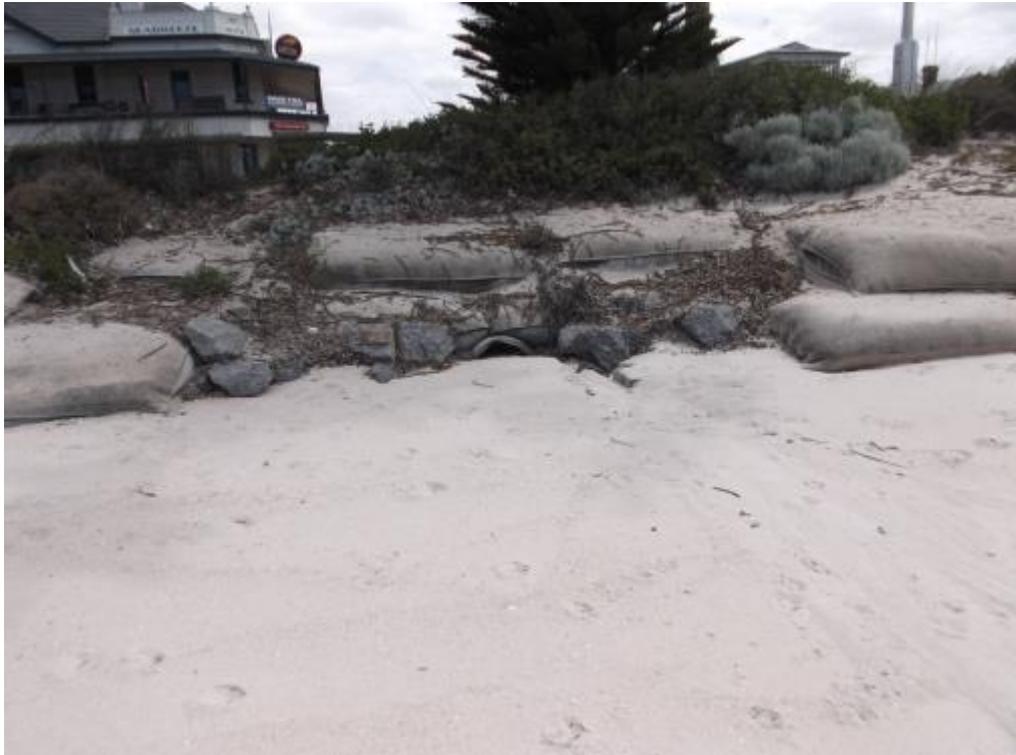
Figure 23 Example of silted up stormwater outlet

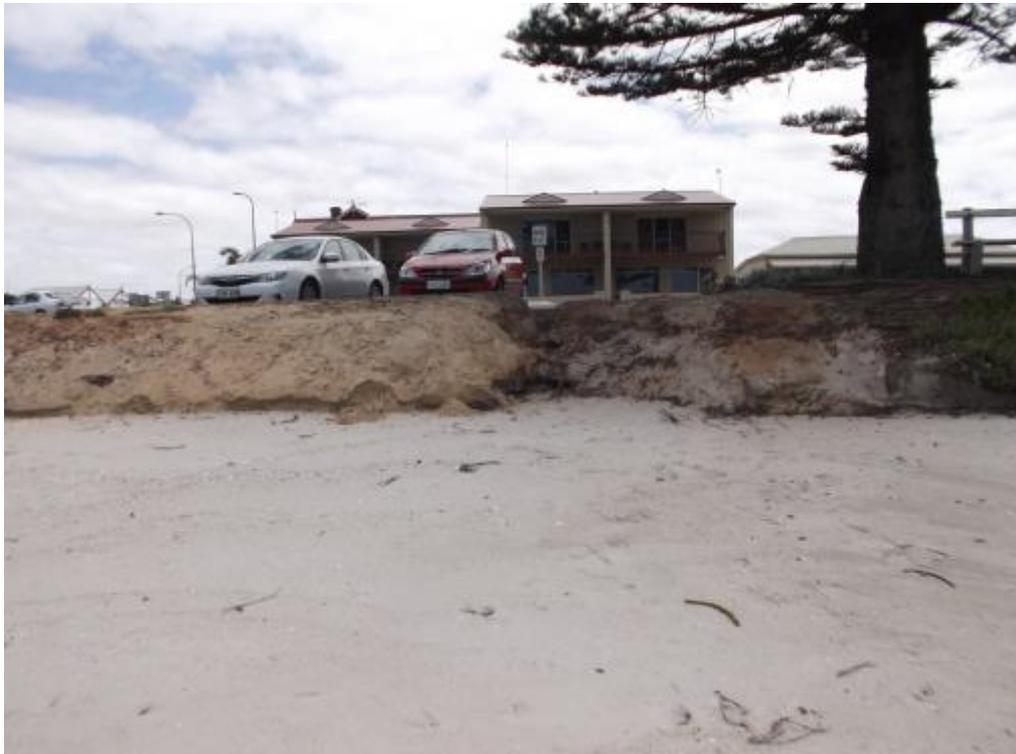
Figure 24 Drainage erosion scar at Ritz car park

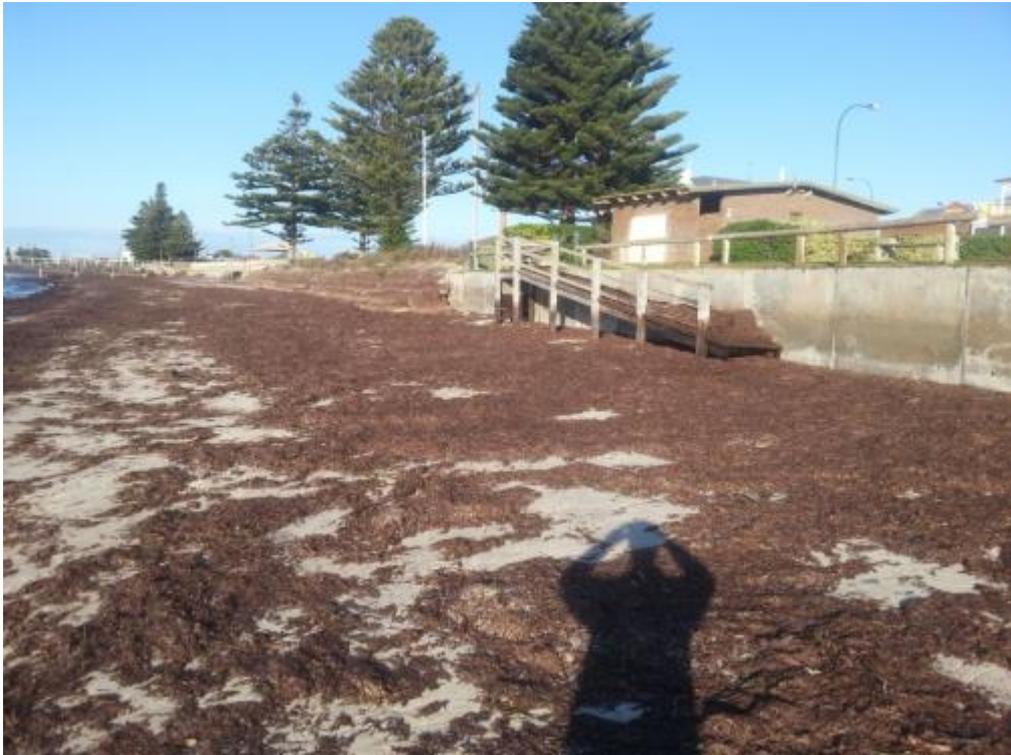
Figure 25 Existing Elcorock wall after June 2013 storm

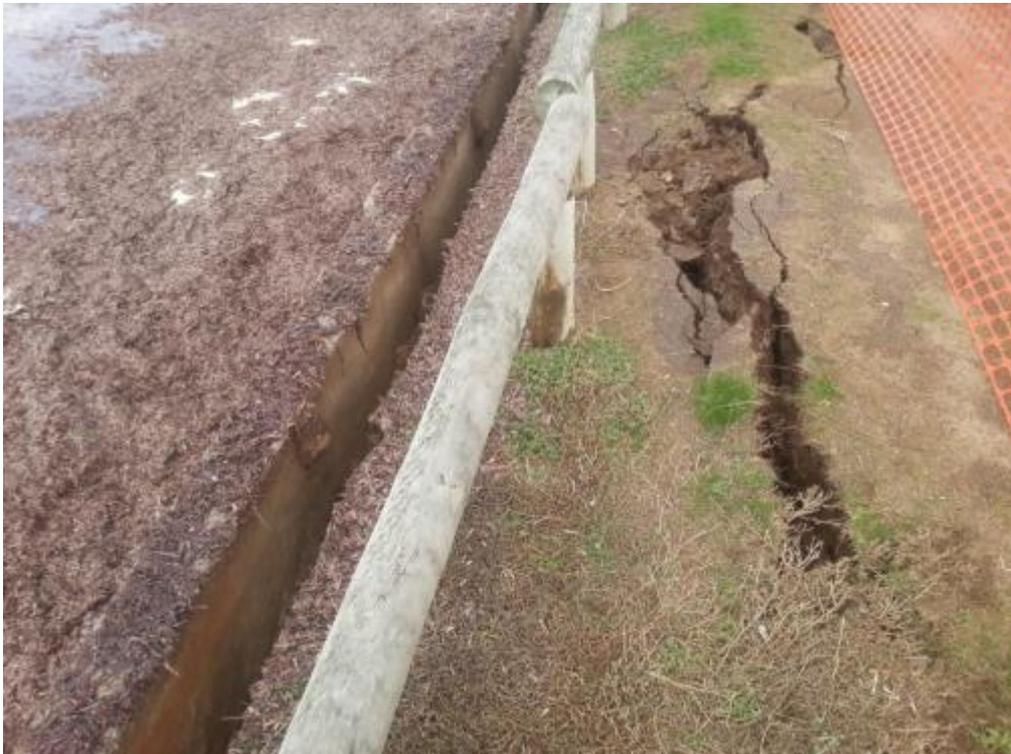
Figure 26 Damaged precinct wall and subsidence of backfill June 2013 Storm Note seagrass from wave overtopping

During a high tide and storm surge event on 23 June 2013, the central wall section north of the jetty abutting the Ritz café was overtopped, which led to the outwards rotation of approximately 100m of vertical concrete wall and slumping of the backfill material. This wall has been temporarily protected and supported through the installation of 'Elcorock' sandbags. Rapid sand loss from the beach in front of the wall was also observed.

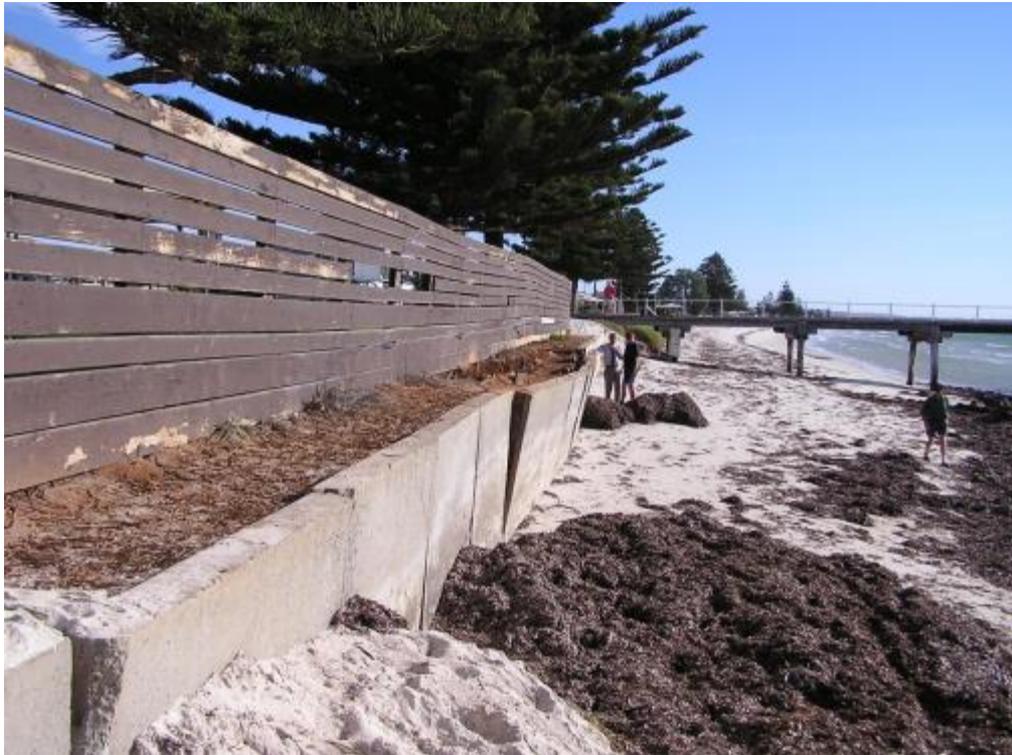
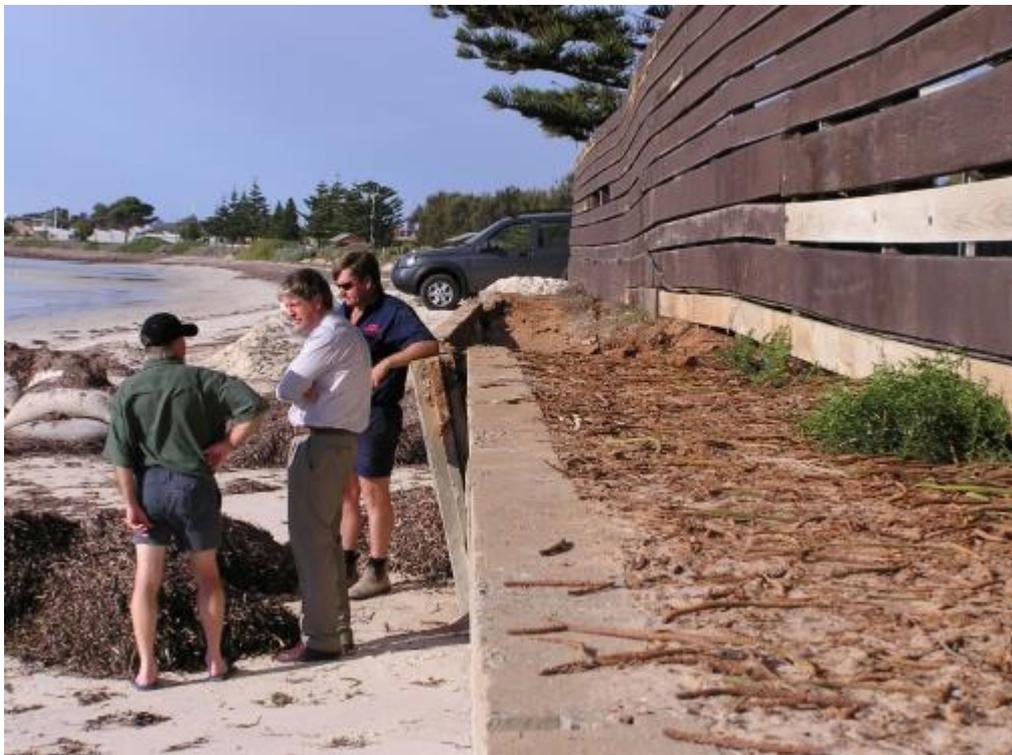
Figure 27 Damaged precast wall and subsidence at Lions Park March 2005

A localised 45 m section of the southern section of wall abutting the Lions Park was severely damaged in March 2005 and was subsequently repaired and extended further south with additional toe protection provided in the form of Elcorock sandbags. A concrete footpath and additional beach access ramps were also provided at this time.

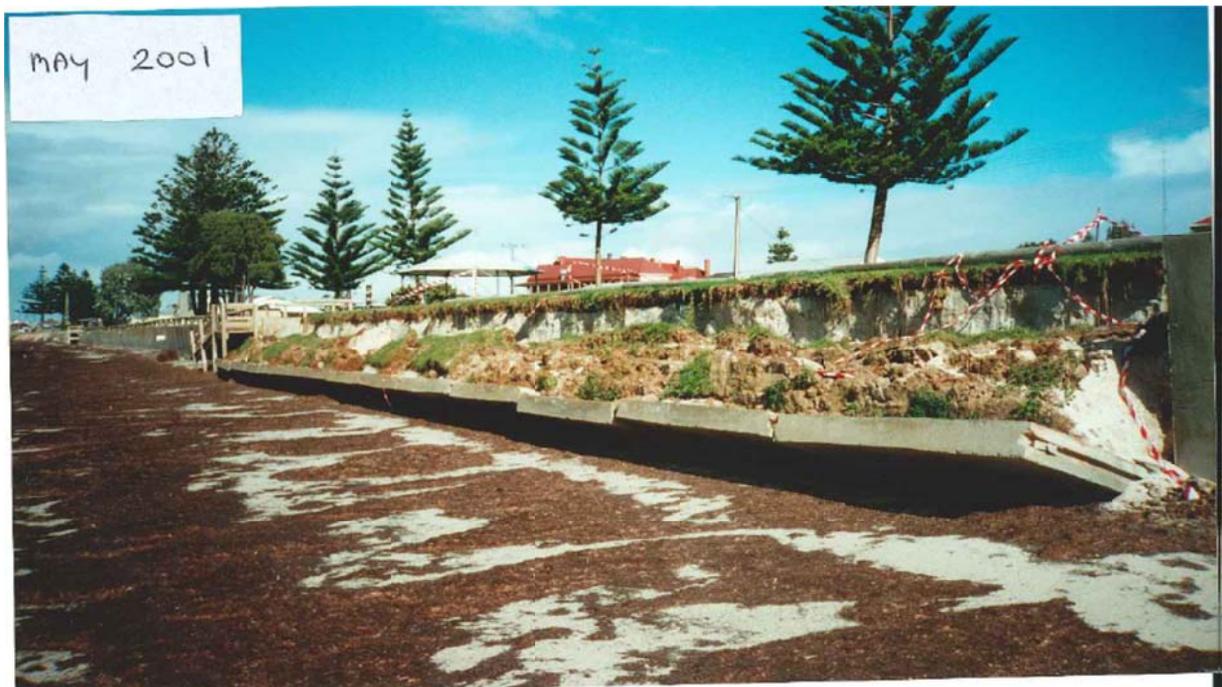
Figure 29 Failed precast wall May 2001

A short section of the wall to the north of the Ritz Café experienced complete failure and clockwise overtopping in December 2001 and by 2003 after several subsequent failures the entire wall section north of the Ritz Café was removed and the section north of the Ritz car park replaced with imported sand and revegetated. The creation of these revegetated dunes appears to have shown success in withstanding high tide and storm surge events since.
