Tumby Bay Foreshore Protection Consultancy Services

Final Concept Design Report

Client: District Council of Tumby Bay

28-Feb-2014

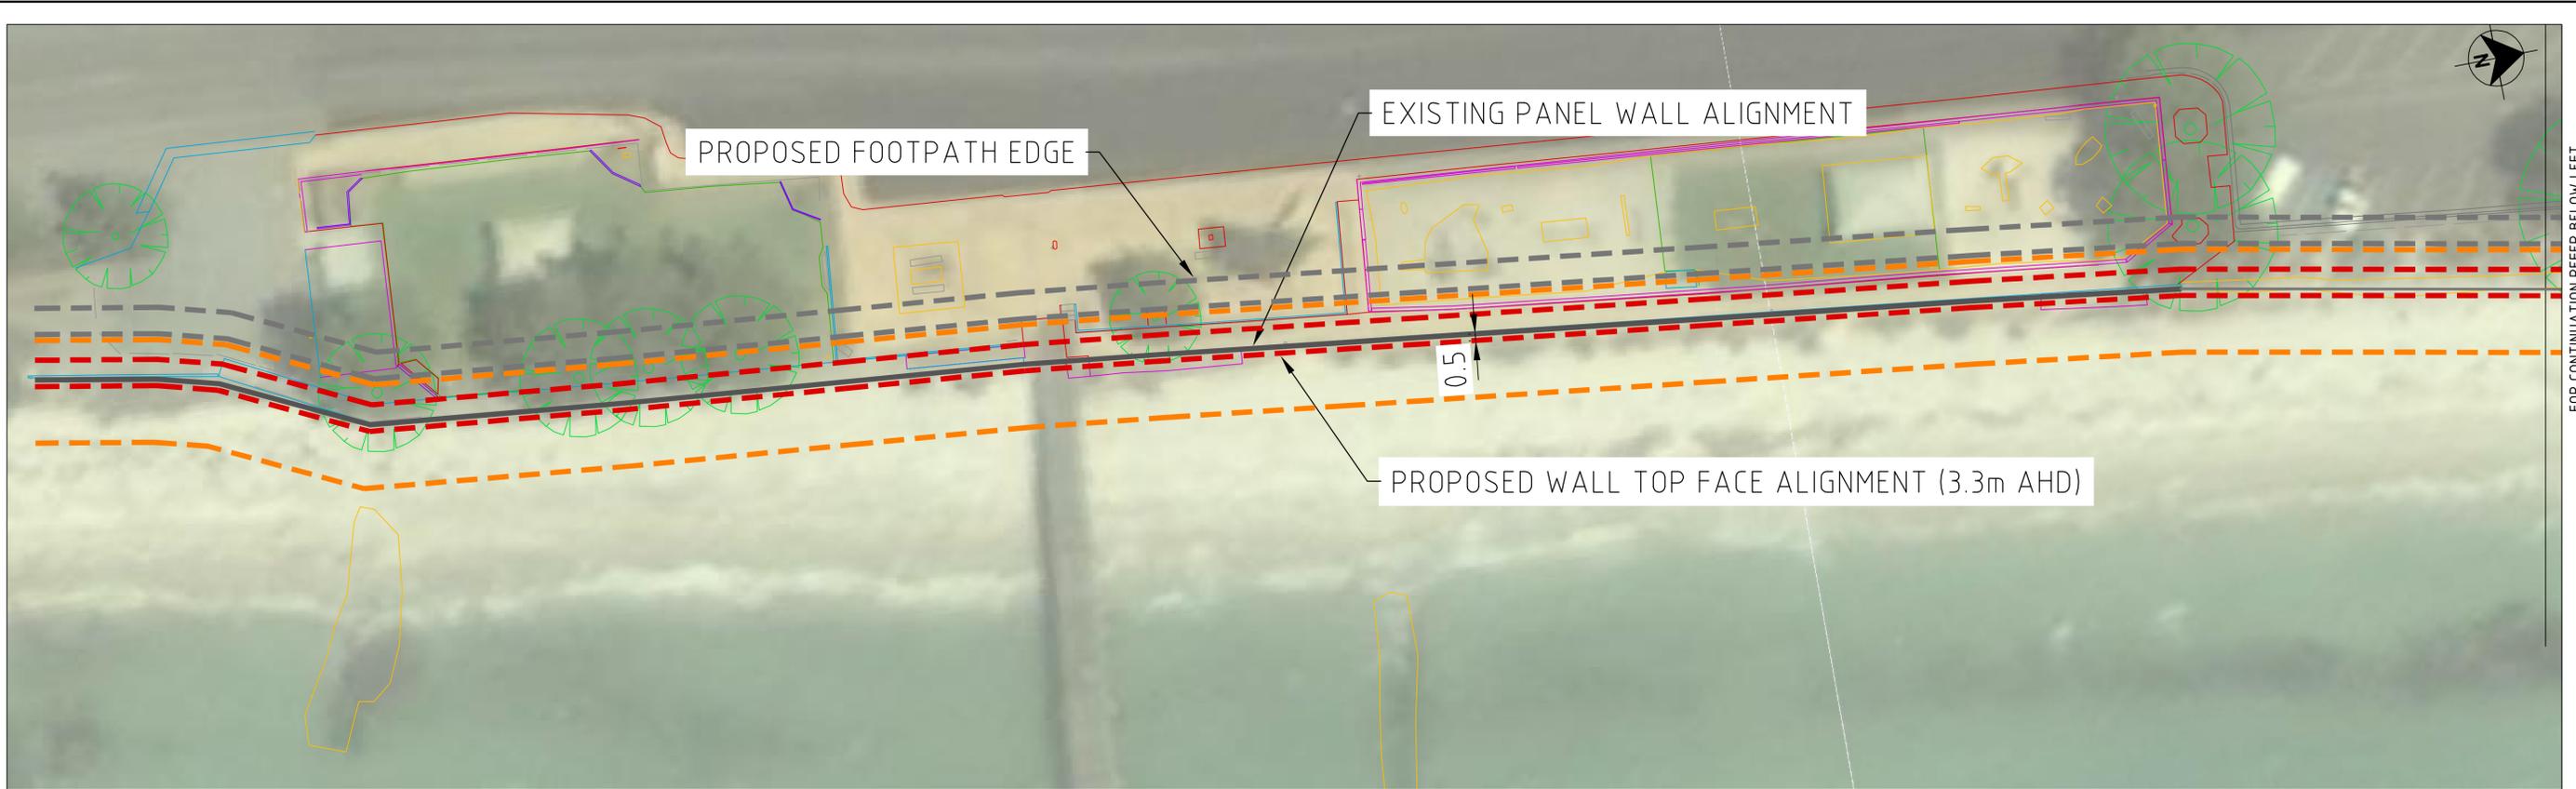
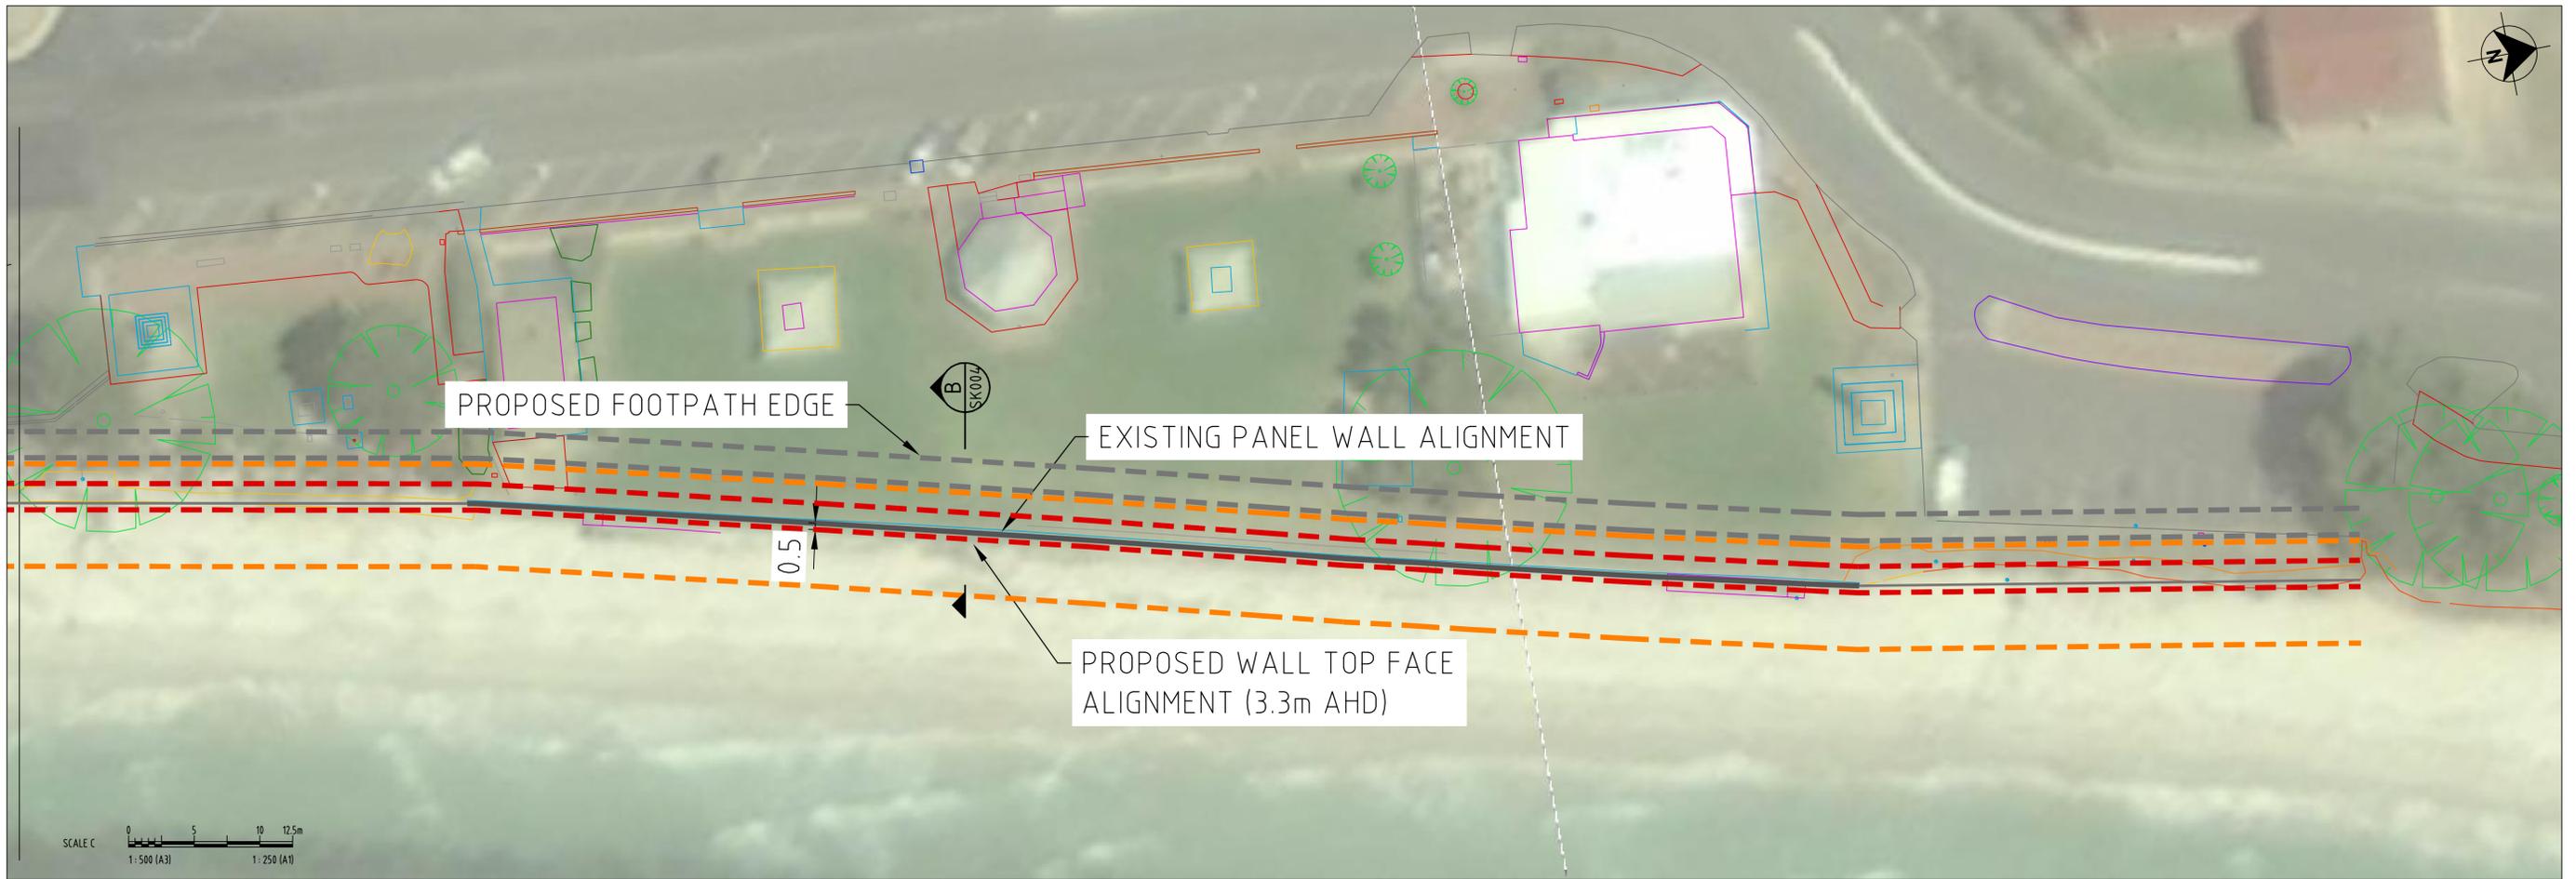
Project: DISTRICT COUNCIL OF TUMBY BAY		
Title: TUMBY BAY FORESHORE PROTECTION CONSULTANCY SERVICES PROPOSED SEAWALL CONCEPT PLAN OPTION 2		
Status: PRELIMINARY	Dwg No: 60310334-SK003	Rev: A

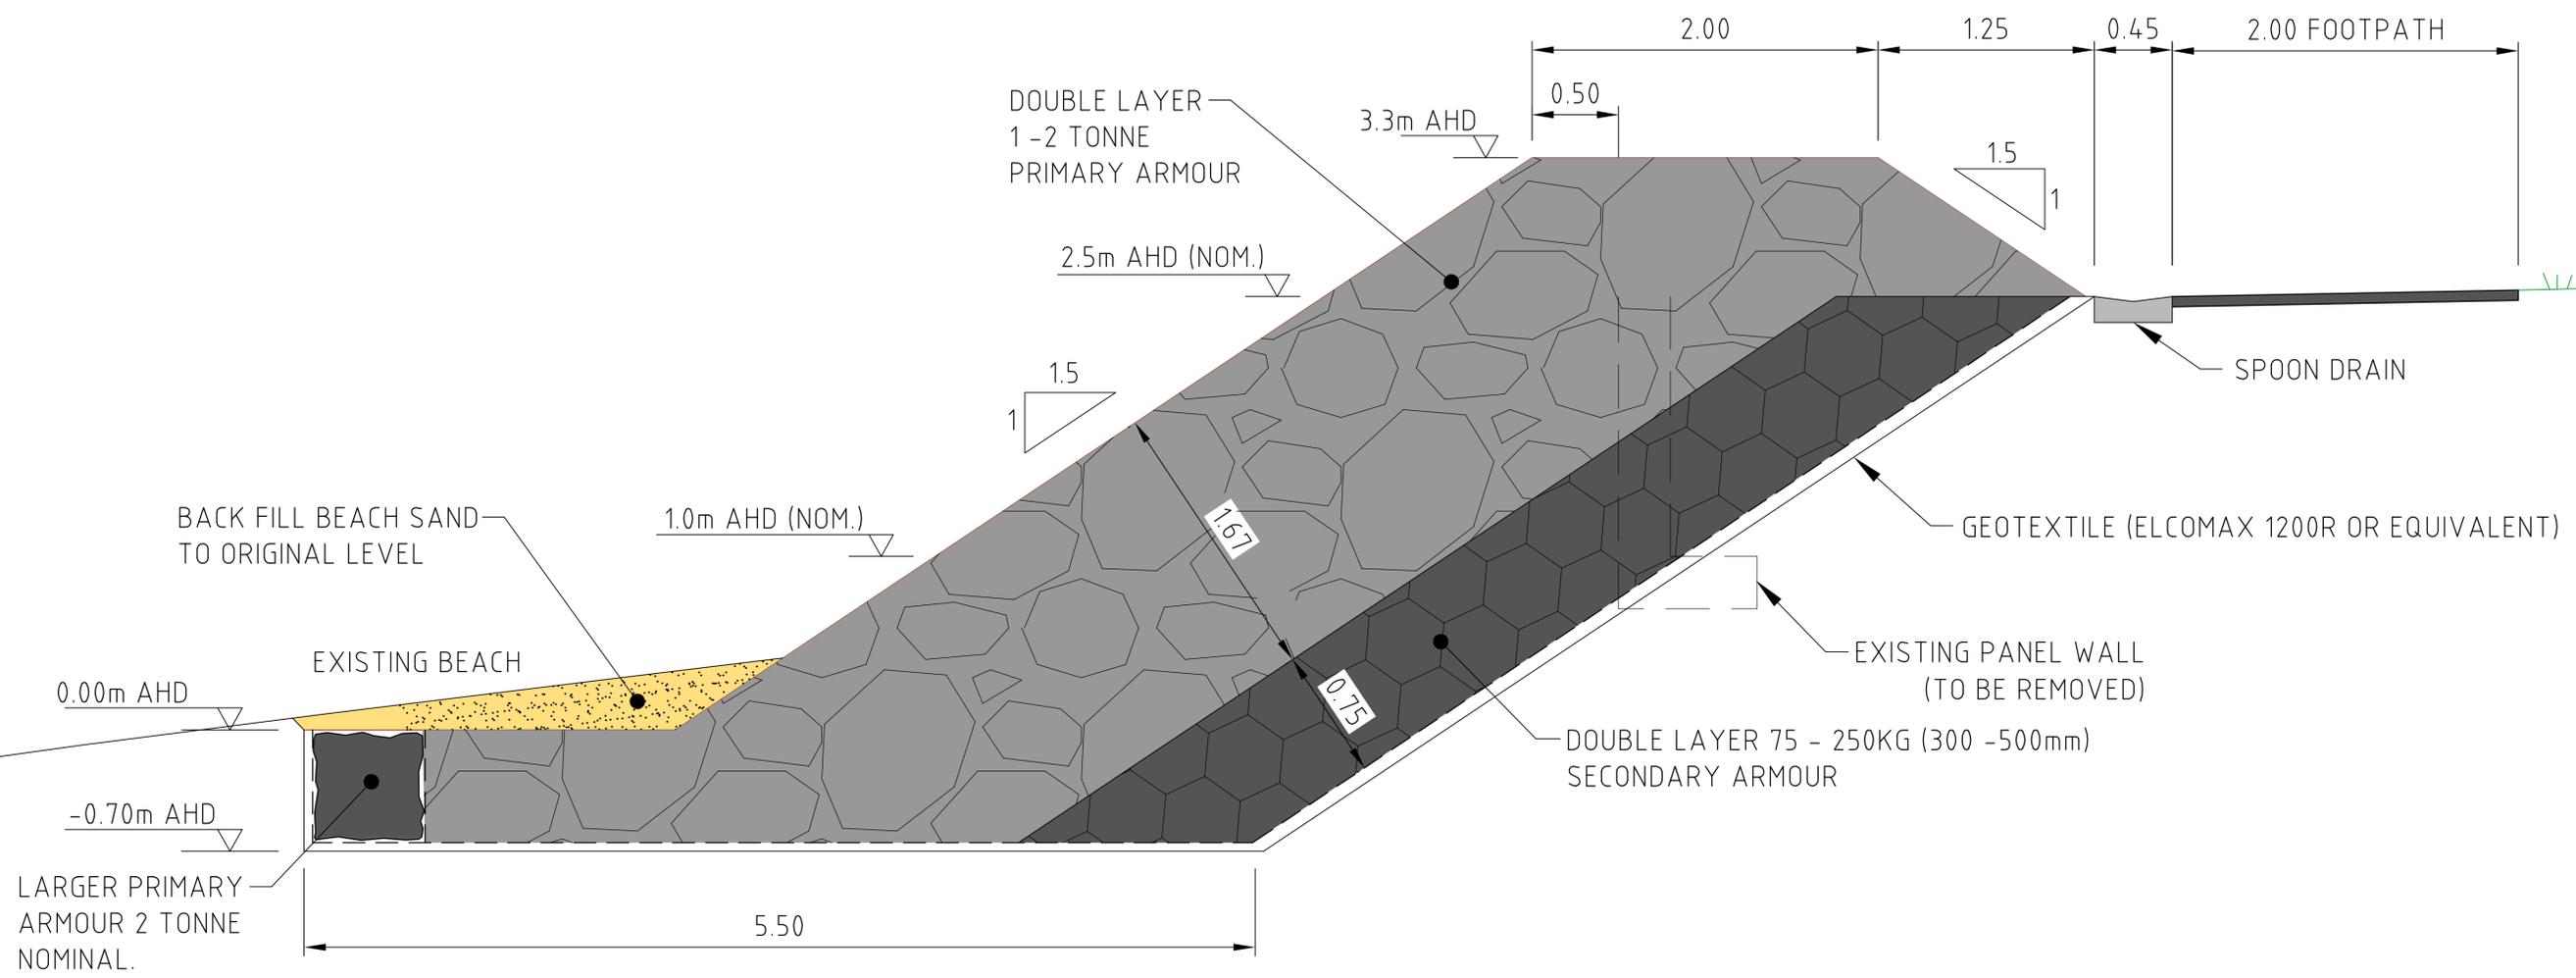
SECTION B
 NTS SK003

Project: DISTRICT COUNCIL OF TUMBY BAY
 Title: TUMBY BAY FORESHORE PROTECTION CONSULTANCY SERVICES PROPOSED SEAWALL TYPICAL SECTION OPTION 2
 Status: PRELIMINARY
 Drg No: 60310334-SK004
 Rev: B
